Your Ref: TP/IP/32267/2020  
Our Ref: CI/TPD20012452/P

13<sup>th</sup> January 2021

**Fatal Accident Investigation Team**

**MECHANICAL INSPECTION REPORT OF MOTOR LORRY YN 4215B**

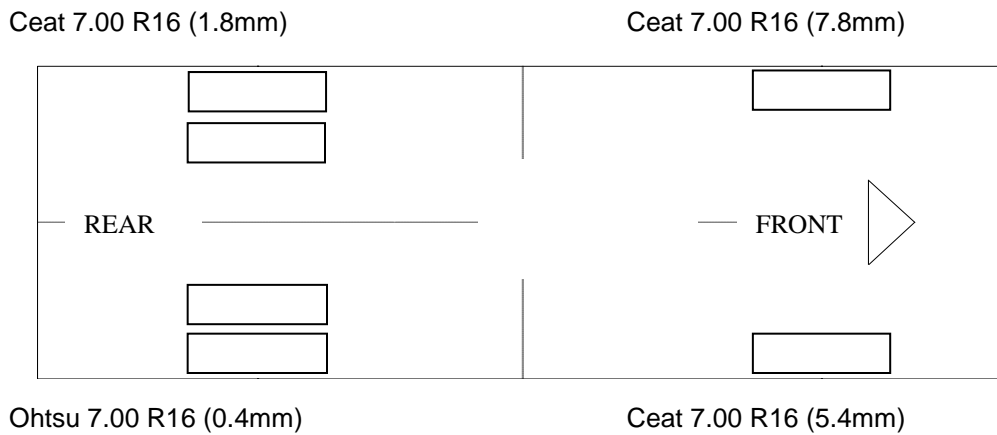
6. The 6 tyres of the Motor Lorry were observed to be in serviceable condition and sufficiently inflated for vehicular operation. I did not find any tear, cut or burst mark(s) on the outer and the inner sidewalls as well as across the tread of the 6 tyres. The tyre brand, tyre size and remaining tread depth of the 6 tyres of the Motor Lorry were recorded as follows:-
