Your Ref: TP/IP/77197/2020  
Our Ref : CI/TPD20012462/P

7<sup>th</sup> December 2020

**MECHANICAL INSPECTION REPORT OF MOTOR CAR SLG 6887P**

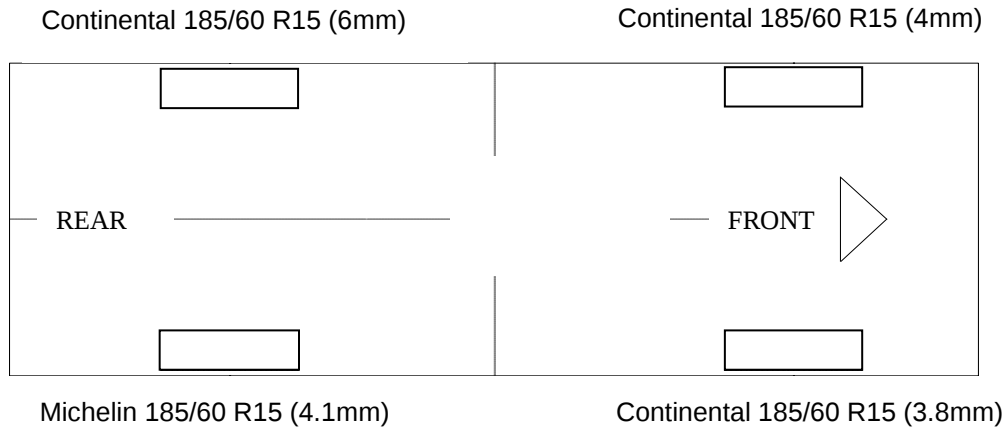
6. The 4 tyres of the Motor Car were observed to be in serviceable condition and sufficiently inflated for vehicular operation. I did not find any tear, cut or burst mark(s) on the outer and the inner sidewalls as well as across the tread of the 4 tyres. The tyre brand, tyre size and remaining tread depth of the 4 tyres of the Motor Car were recorded as follows:-
