LKK Auto Consultants Pte Ltd

Vehicle No. SHF 562T
Insured Veh. SKU 6575C
Claim No.
Policy No. DMCFHQ17-000185
Accident Date 29/11/2017
Inspection Date 30/11/2017

ADJUSTMENT ON REPAIR COST FOR VEHICLE NO. SHF 562T

PHOTOGRAPHS FOR VEHICLE NO. SHF 562T

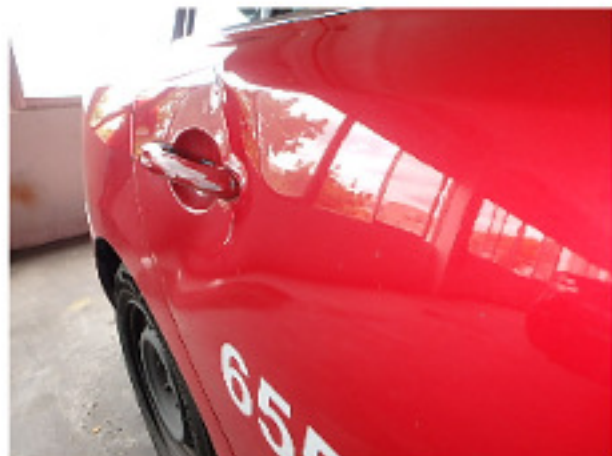
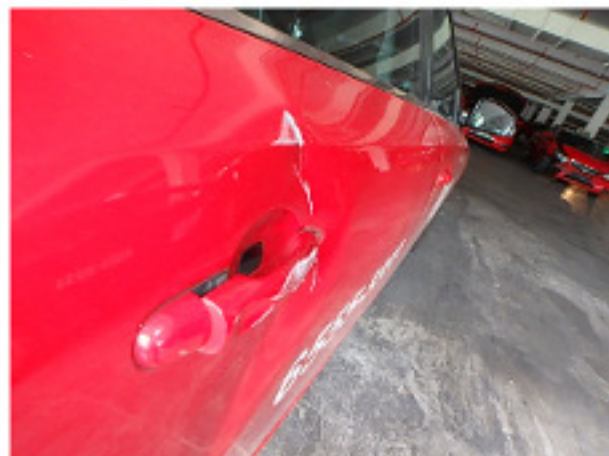
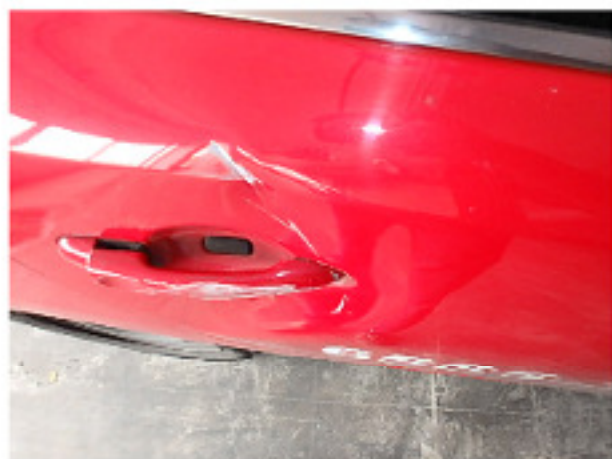
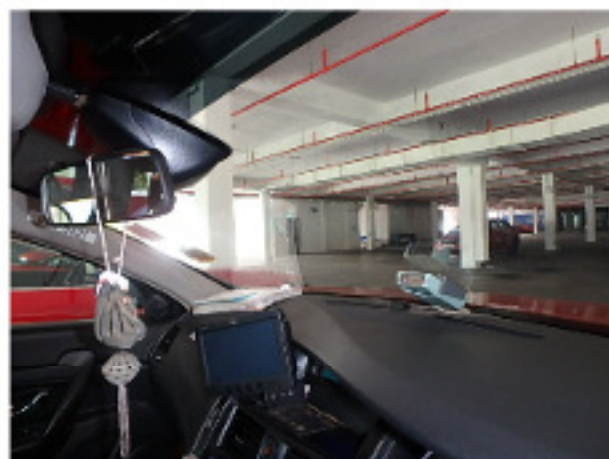
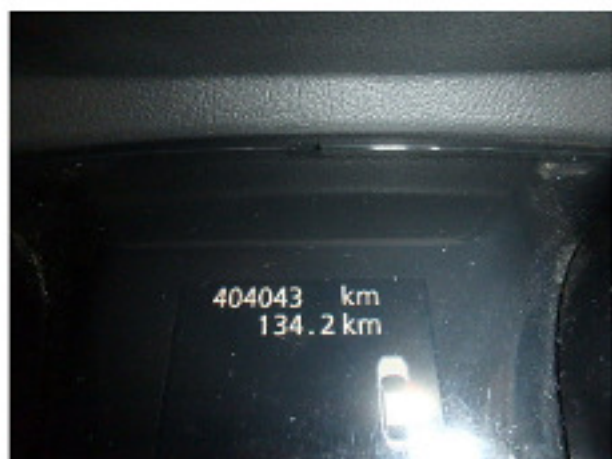
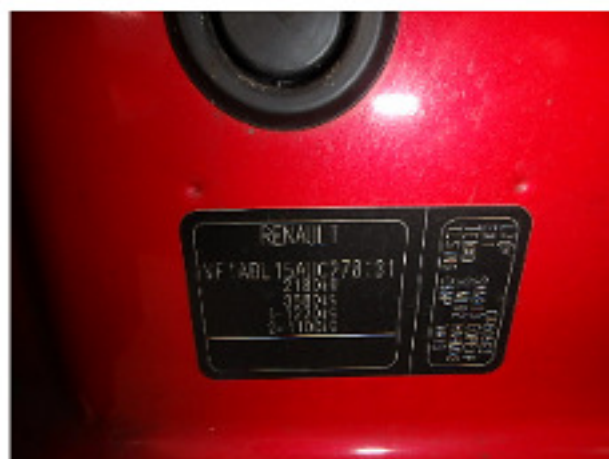
4. Description of Damages				
	THE VEHICLE SUSTAIEND DAMAGES AT THE REAR O/S DOOR. DAMAGES SEE DETAILS.			
5. General Information				
	Accident Date	29/11/2017	Inspection Date	30/11/2017
	Survey held at	TRANS-CAB AUTO SERVICES PTE LTD NO.2 ANG MO KIO ST 63 SINGAPORE 569111		
5a. Remarks				
	A)THE INSPECTION WAS CONDUCTED ON A"WITHOUT PREJUDICE" BASIS. B)IN ACCORDANCE TO YOUR INSTRUCTIONS, WE HAVE NOT AUTHORISED REPAIRS.			
5b. Estimate Days of Repair				
	ESTIMATED NORMAL PERIOD FOR REPAIR:		2 Working Days
