Your Ref: Honda Engine

(number R18A1758633)

Our Ref: CI/TP20014196/D

#### **INSPECTION REPORT OF A HONDA ENGINE WITH NUMBER R18A1758633**

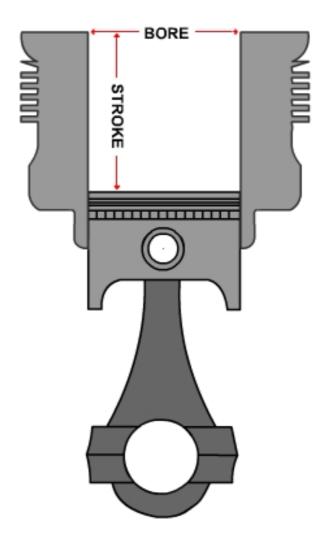
9. The bore refers to the measurement of the inside diameter of the cylinder while the stroke refers to the distance the piston moves in one direction of upward or downward movement in the cylinder. See diagram below for illustration purposes.
