Your Ref: SNM20D204954
Our Ref : CS/CTI20014255/P

TECHNICAL INVESTIGATION REPORT OF FLOODING INCIDENT INVOLVING THE INSURED VEHICLE SFH 5233Z ON 17th DECEMBER 2020

Vehicle Registration No.	: SFH 5233Z
Make / Model	: HONDA CIVIC 2.0L M
Chassis No	: JHMFD25408S201586
Year of Registration	: JUNE 2008

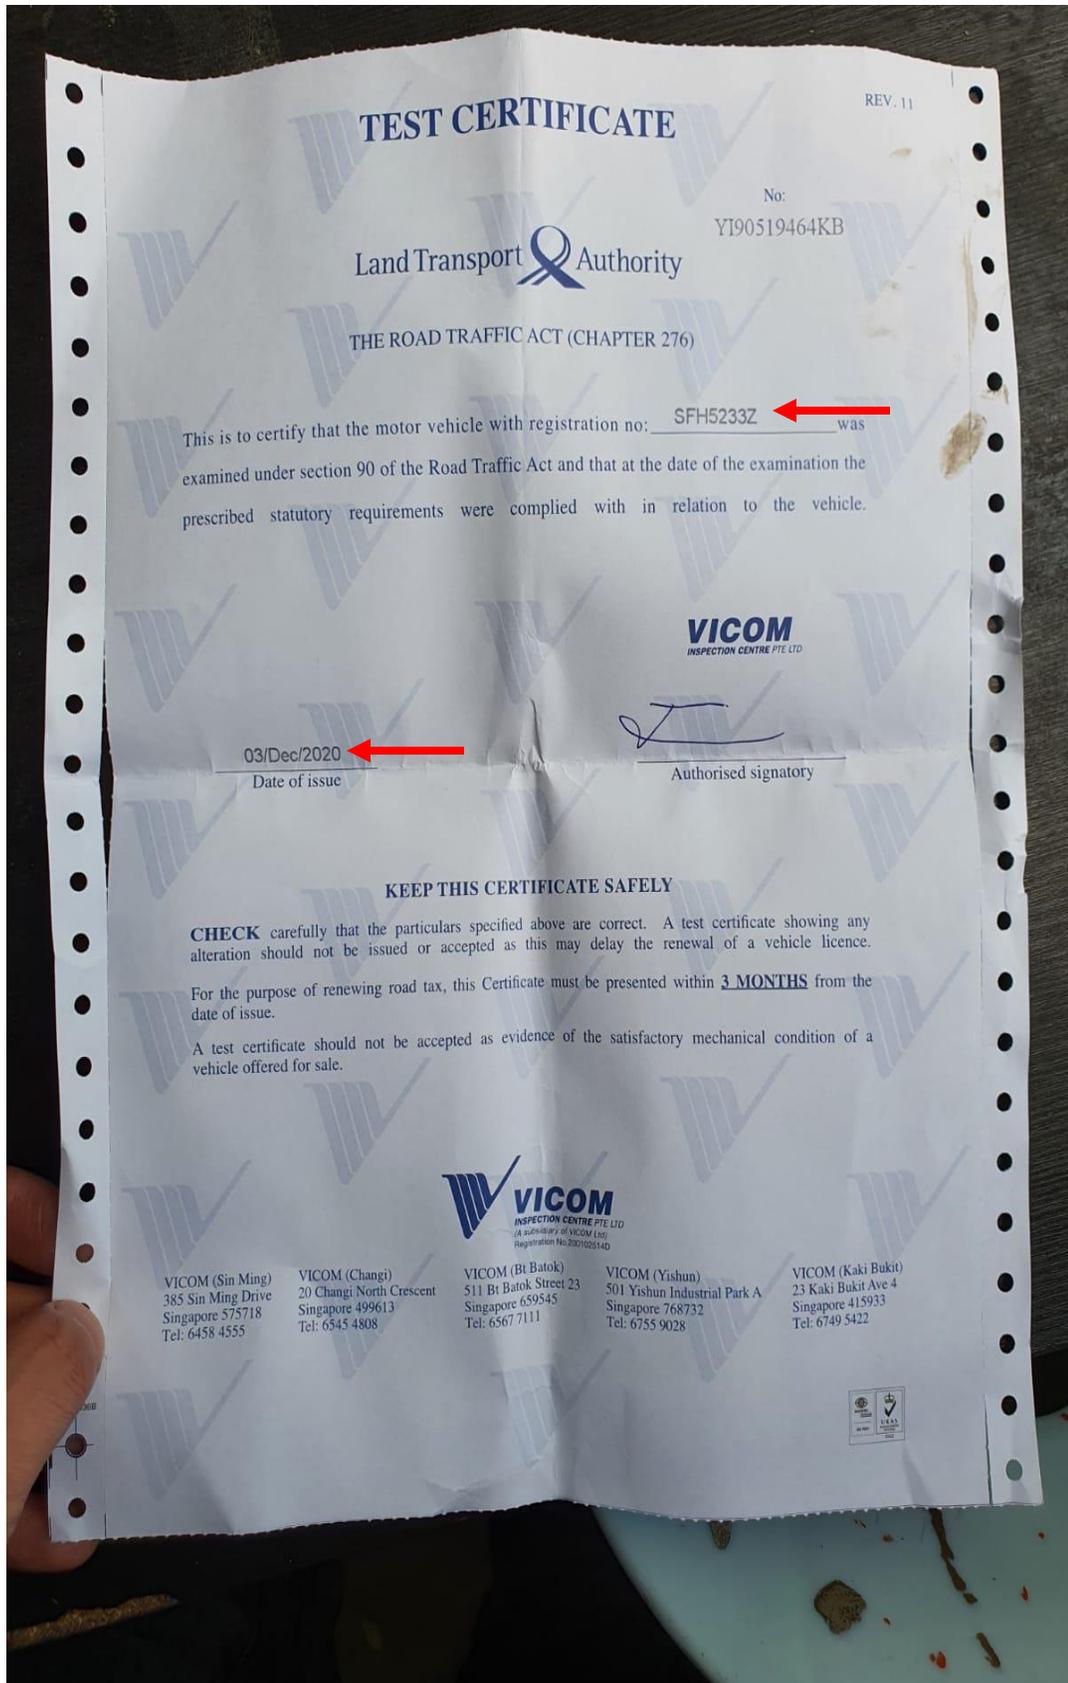
TEST CERTIFICATE

13. Pertaining to the maintenance aspect, Mr Nizzaar informs that the Insured Vehicle has not gone for periodical servicing as it was just bought. He provided us with his latest inspection certification and mentioned that there was no major overhaul done to the Insured Vehicle.
