Your Ref: TP/IP/50607/2020
Our Ref : CI/TPD20014314/P

22nd December 2020

MECHANICAL INSPECTION REPORT OF MOTOR TRAILER JRF 4239

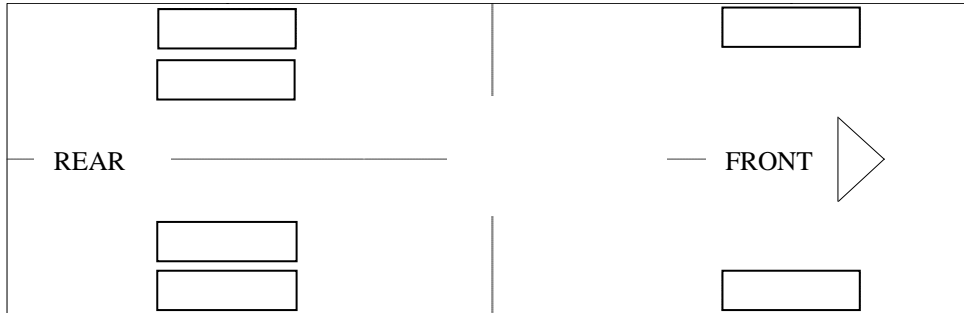
Motor Trailer

Yokohama 295/80 R22.5 (14.7mm)

Yokohama 295/80 R22.5 (12.4mm)

Yokohama 295/80 R22.5 (14.4mm)

Yokohama 295/80 R22.5 (12.6mm)

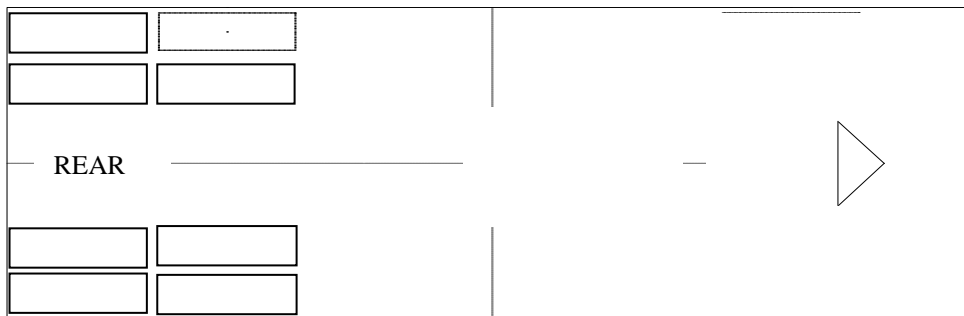
Trailer

Continental 295/80 R22.5 (6mm)

Yokohama 295/80 R22.5 (5.9mm)
