## LKK Auto Consultants Pte Ltd

## ADJUSTMENT ON REPAIR COST FOR VEHICLE NO. GBJ 9072G

PHOTOGRAPHS FOR VEHICLE NO. GBJ 9072G

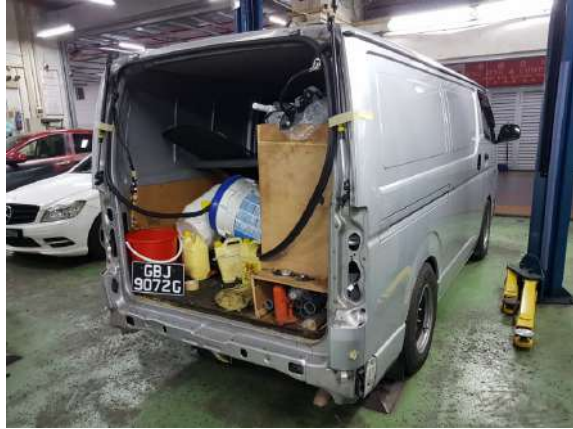
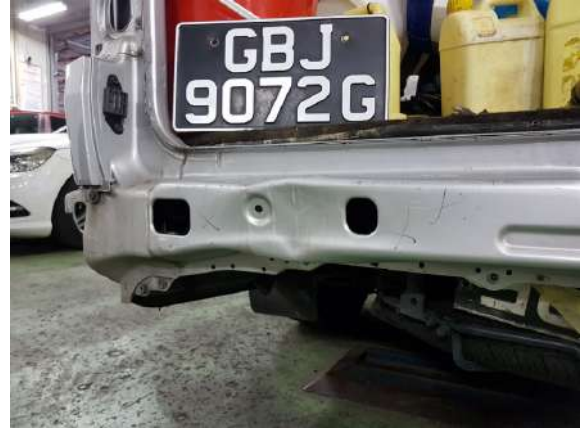
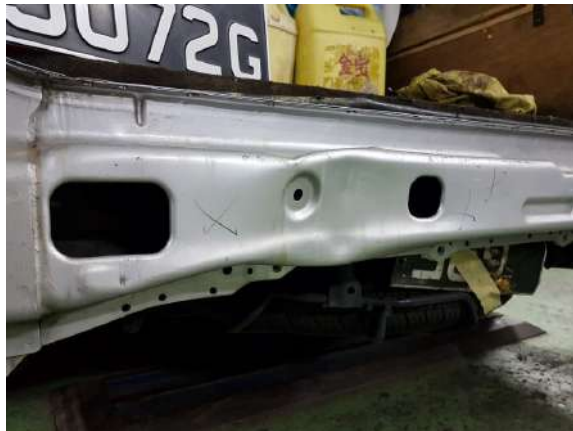
**RE-INSPECTION**

| Affiliated to Federation Internationale Des Experts En Automobile | | | | |
|---|---|---|---|--|
| THE VEHICLE SUSTAINED DAMAGES AT THE REAR N/S PORTION.<br>DAMAGES SEE DETAILS. | | | | |

| Qty | Description of Parts | Condition | Estimate By Workshop (\$) | Our Adjusted (\$) |
|---|---|---|---|---|
| | REMOVE & REFIX REAR BUMPER ASSY ,TAILGATE & ATTACHMENTS ,TAILLAMP,TO CUT ,WELD & RENEW REAR END PANEL OUTER ,KNOCKING & REPAIR REAR END PANEL INNER ,FLOORBOARD & REALIGN THE SAME .INCLUSIVE OF THE REPAIR OF TAILGATE INNER LOCK . | | 800.00 | 600.00 |
