Affiliated to Federation Internationale Des Experts En Automobile			
CHINA TAIPING INSURANCE (S) PTE LTD 3 ANSON ROAD #16-00 SPRINGLEAF TOWERSINGAPORE 079909		Ref: CC3/CTI20014485/Kra3q2 Date: 09/04/2021 Code: CTI

1. Policy Particulars :- THIRD PARTY CLAIM			
Insured Veh.	SJF 5985A	Veh. Inspected	SHD 401K
Policy No.	DMPCSNA00176252002	Coverage (\$)	0.00
Claim No.	SNM20D205066	Excess (\$)	0.00
Assign From		Assign Date	23/12/2020

ADJUSTMENT ON REPAIR COST FOR VEHICLE NO. SHD 401K

PHOTOGRAPHS FOR VEHICLE NO. SHD 401K

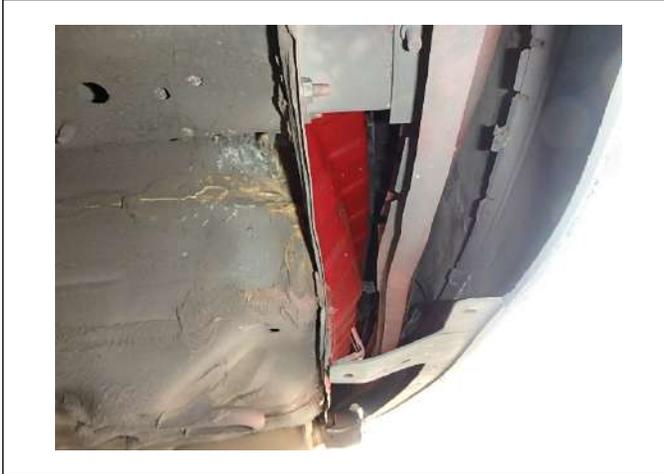
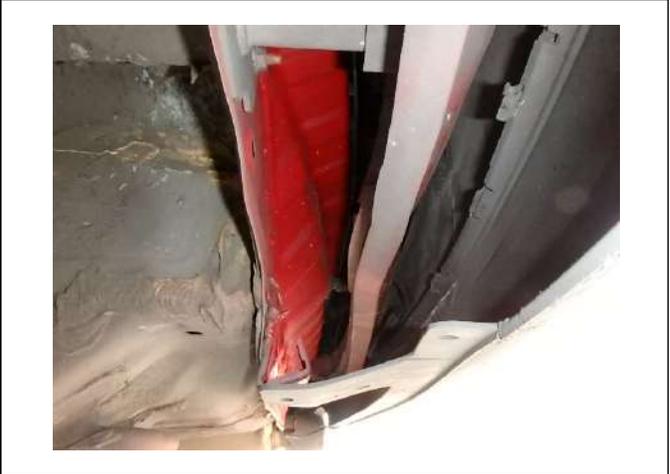
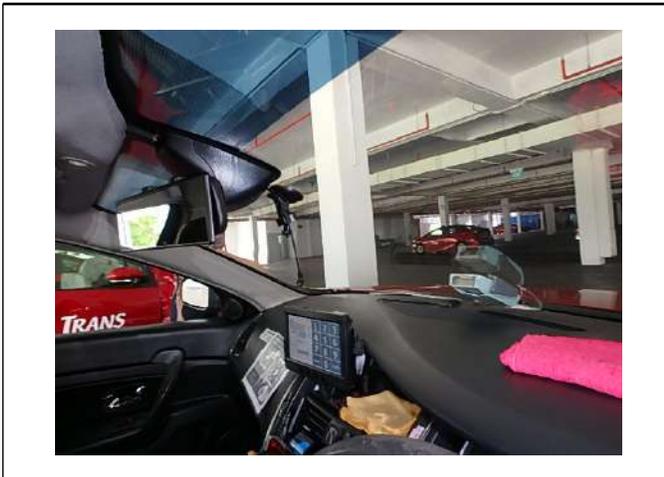
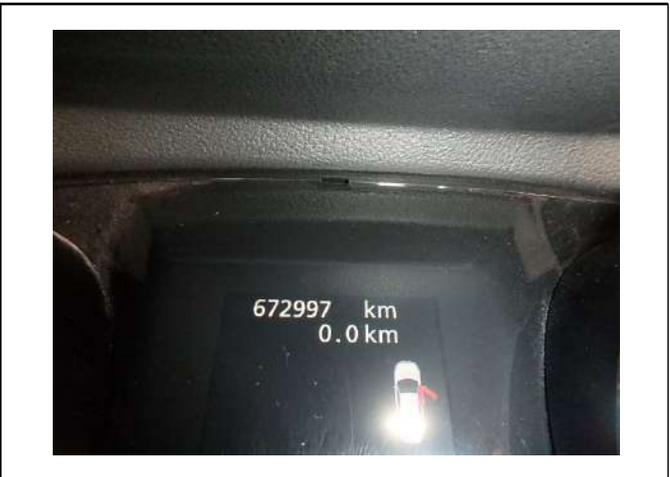
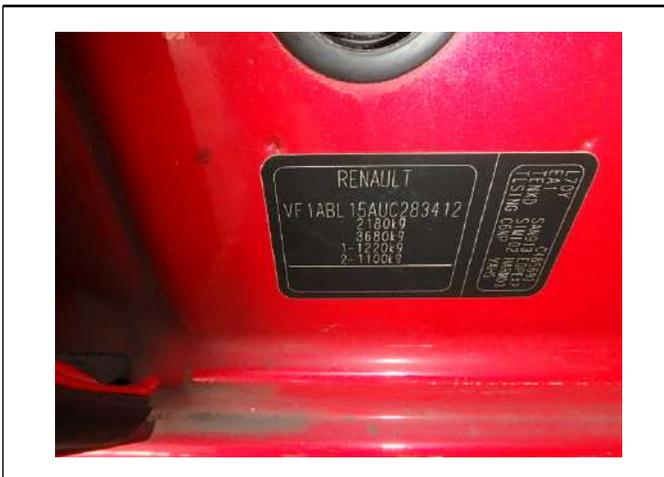
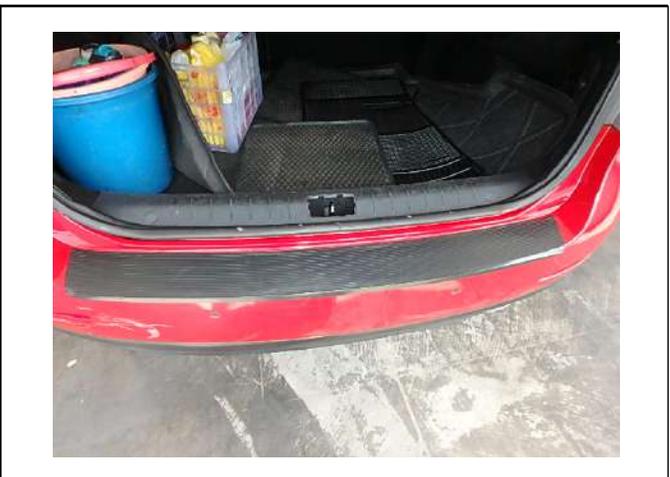
4. Description of Damages			
THE VEHICLE SUSTAINED DAMAGES AT THE REAR PORTION. DAMAGES SEE DETAILS.			
5. General Information			
Accident Date	21/12/2020	Inspection Date	23/12/2020
Survey held at	TRANS-CAB AUTO SERVICES PTE LTD NO.2 ANG MO KIO ST 63 SINGAPORE 569111		
5a. Remarks			
A)THE INSPECTION WAS CONDUCTED ON A"WITHOUT PREJUDICE" BASIS. B)IN ACCORDANCE TO YOUR INSTRUCTIONS, WE HAVE NOT AUTHORISED REPAIRS.			
5b. Estimate Days of Repair			
ESTIMATED NORMAL PERIOD FOR REPAIR:		2 Working Days

Qty	Description of Parts	Condition	Estimate By Workshop (\$)	Our Adjusted (\$)
<u>REPLACEMENT OF PARTS</u>				
1	BUMPER COVER REAR	BUCKLED	561.70	561.70
1	BUMPER LOWER REAR	DENTED	411.90	411.90
1	BUMPER REFLECTOR LH	SERVICEABLE	16.60	-
1	BUMPER BRACKET CTR REAR	SERVICEABLE	98.10	-
1	BUMPER BRACKET SIDE RH REAR	SERVICEABLE	82.10	-
1	BUMPER RETAINER RH REAR	SERVICEABLE	59.80	-
1	BUMPER BRACKET SIDE LH REAR	SERVICEABLE	80.80	-
1	BUMPER RETAINER LH REAR	SERVICEABLE	54.20	-
1	BUMPER BEAM REAR	BENT	547.80	547.80
	LESS 10% DISCOUNT		-191.30	-152.14
			1,721.70	1,369.26
<u>SPECIAL NETT ITEMS</u>				
1	SET PARKING AID (SN)	SERVICEABLE	700.00	-
1	SET REAR BUMPER CLIP (SN)	NECESSARY	66.00	66.00
1	SET BUMPER BRACKET CTR CLIP (SN)	NOT NECESSARY	33.00	-
1	SET BUMPER BRACKET SIDE CLIP RH RR (SN)	NOT NECESSARY	10.00	-
1	SET BUMPER RETAINER RH CLIP RR (SN)	NOT NECESSARY	20.00	-
1	SET BUMPER BRACKET SIDE CLIP LH RR (SN)	NOT NECESSARY	10.00	-

Qty	Description of Parts	Condition	Estimate By Workshop (\$)	Our Adjusted (\$)
	TO TRANSFER OF REAR END PANEL FITTINGS ,ATTACHMENTS AND PERFORM WATER SEEPAGE TEST.	NOT NECESSARY	170.00	-
	TO TRANSFER OF REAR WINDSCREEN FITTINGS AND CONDUCT WATER SEEPAGE TEST .	NOT NECESSARY	170.00	-
	TO CHECK STEERING GEOMETRY AND COMPUTER WHEEL ALIGNMENT .	NOT NECESSARY	220.00	-
	TO CHECK ELECTRICAL LIGHTING CONCERNED.	NOT NECESSARY	170.00	-
			7,580.00	480.00
	GRAND TOTAL		10,140.70	1,915.26
	RECOMMENDED COST OF LUMP SUM REPAIRS (TO ITS PRE-ACCIDENT CONDITION)			1,550.00
