Your Ref: TP/IP/50553/2020  
Our Ref : CI/TPD21000233/P

18<sup>th</sup> February 2021

**MECHANICAL INSPECTION REPORT OF MOTOR CAR SKF 9185D**

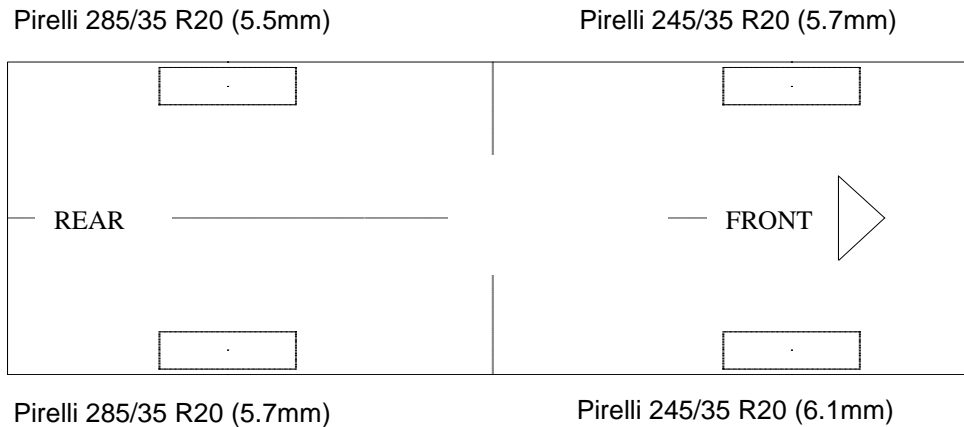
6. The Motor Car's front left tyre and rim had broken off as a result of the accident. However, all 4 tyres was observed to be in serviceable condition. I did not find any tear, cut or burst mark(s) on the outer and the inner sidewalls as well as across the tread of the 4 tyres. The 4 tyres were also observed to be sufficiently inflated for vehicular operation. The tyre brand, tyre size and remaining tread depth of the 4 tyres were recorded as follows:-
