You're Ref: TP/IP/54933/2020
Our Ref: CI/TPD21000234/P

2nd February 2021

MECHANICAL INSPECTION REPORT OF MOTOR VAN GBB 2538T

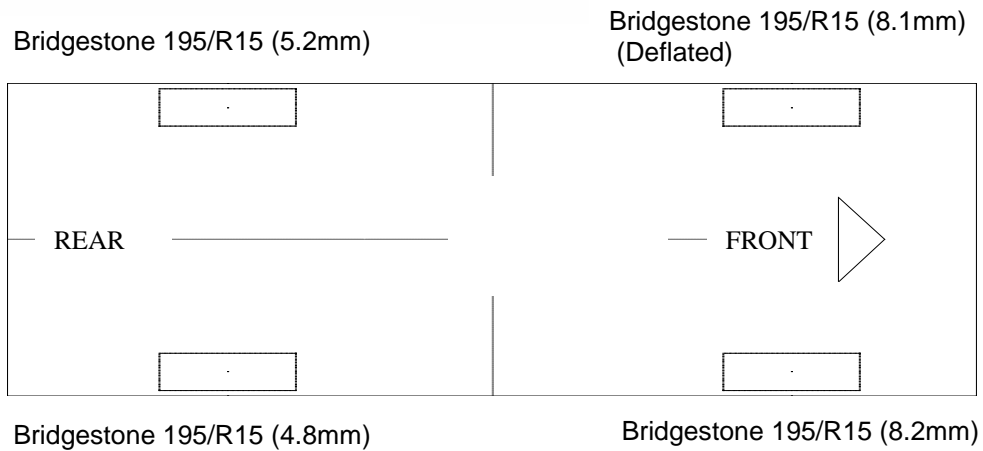
6. The condition of the Motor Van's 3 tyres was observed to be in serviceable condition. I did not find any tear, cut or burst mark(s) on the outer and the inner sidewalls as well as across the tread of the 4 tyres. The 3 tyres were also observed to be sufficiently inflated for vehicular operation. However the front left tyre was observed to be deflated likely due to the result of the accident. The tyre brand, tyre size and remaining tread depth of the 4 tyres were recorded as follows:-
