You're Ref: TP/IP/53687/2020  
Our Ref: CI/TPD21000235/P

2<sup>nd</sup> February 2021

**MECHANICAL INSPECTION REPORT OF MOTOR CAR SLK 3954C**

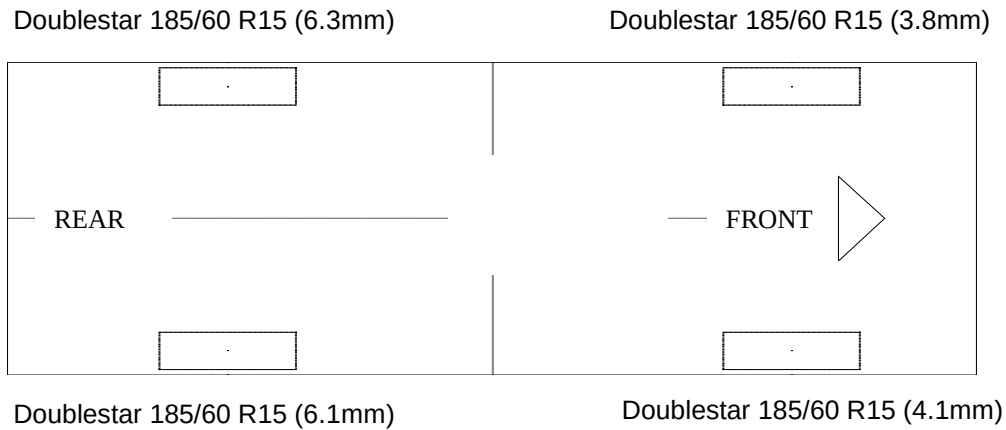
6. The condition of the Motor Car's 4 tyres observed to be in serviceable condition and sufficiently inflated for vehicular operation. I did not find any tear, cut or burst mark(s) on the outer and the inner sidewalls as well as across the tread of the 4 tyres. The tyre brand, tyre size and remaining tread depth of the 4 tyres of the Motor Car were recorded as follows:-
