Your Ref: TP/IP/54791/2020  
Our Ref : CI/TPD21000243/P

24<sup>th</sup> February 2021

**MECHANICAL INSPECTION REPORT OF MOTOR CAR SMA 4853U**

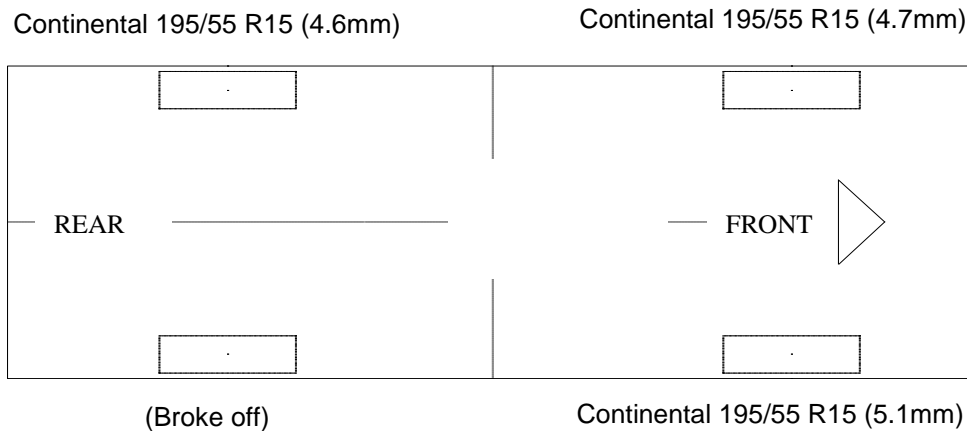
6. The rear right wheel rim was observed to be broke off from the Motor Car as a result of the accident. However the condition of the Motor car's other 3 tyres was observed to be in serviceable condition. I did not find any tear, cut or burst mark(s) on the outer and the inner sidewalls as well as across the tread of the 3 tyres. The 3 tyres were also observed to be sufficiently inflated for vehicular operation. The tyre brand, tyre size and remaining tread depth of the 3 tyres were recorded as follows:-
