Vehicle No. GBJ 1972L  
Insured Veh. YN 7527G  
Claim No. 20/21/21/VC05/024135  
Policy No. Z20VC05006070  
Accident Date 12/01/2021  
Inspection Date 15/01/2021

## ADJUSTMENT ON REPAIR COST FOR VEHICLE NO. GBJ 1972L

### PHOTOGRAPHS FOR VEHICLE NO. GBJ 1972L

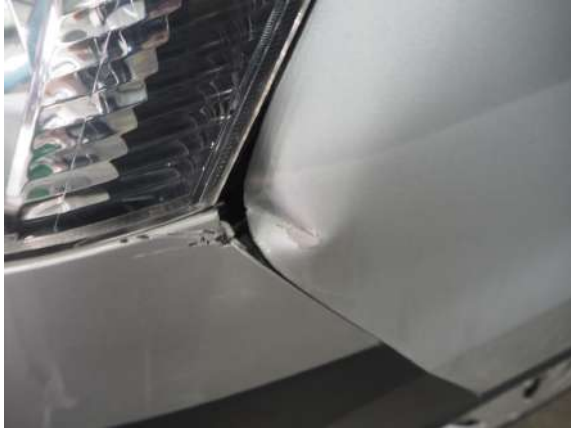
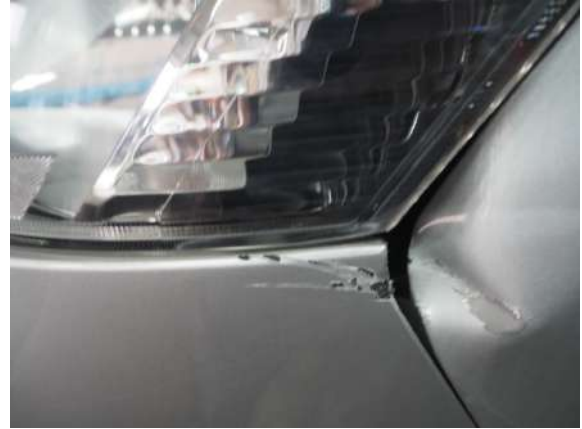
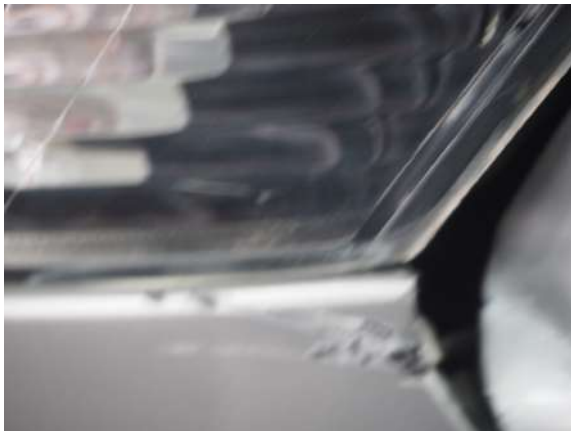
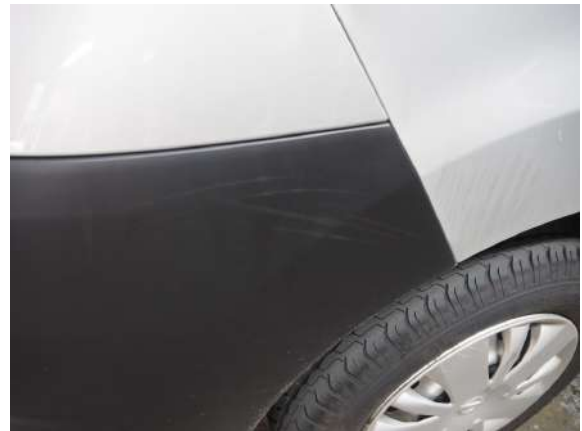
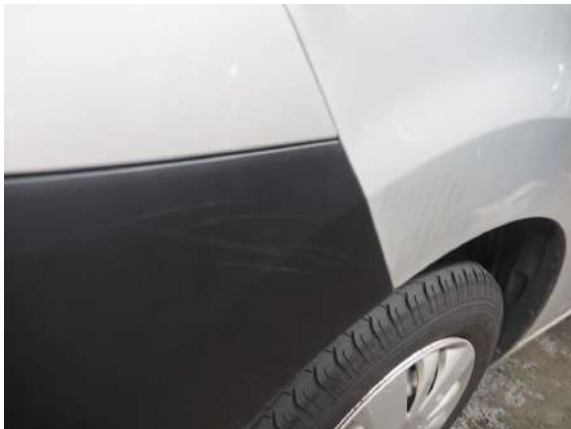
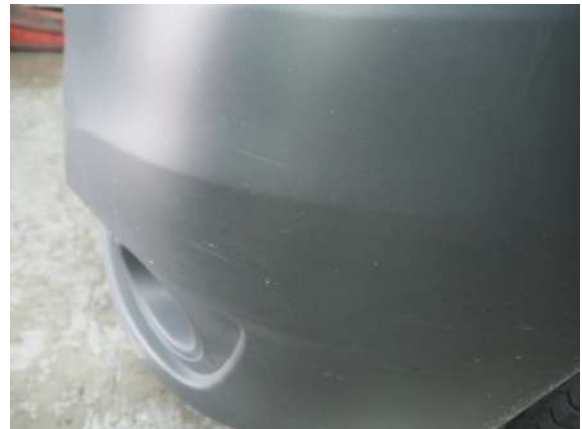
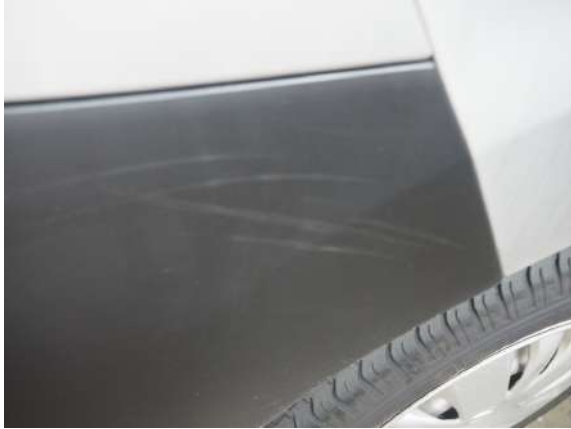
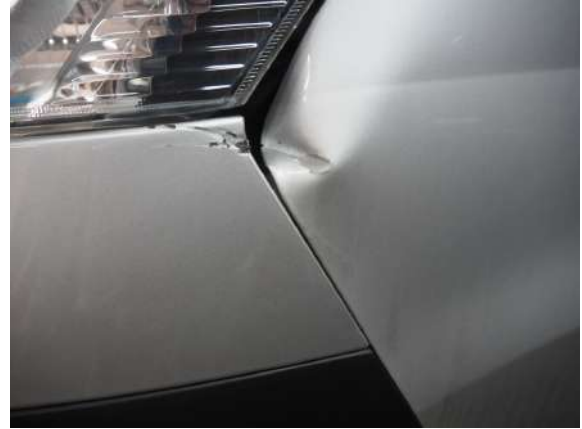
| Affiliated to Federation Internationale Des Experts En Automobile | | | | |
|---|---|---|---|--|
| THE VEHICLE SUSTAINED DAMAGES AT THE FRONT N/S PORTION.<br>DAMAGES SEE DETAILS. | | | | |
