Our Reference : KAAS/TA/6133/9114/TP/10.20
Date : 07 January 2021

VEHICLE APPRAISAL REPORT

Registration No.	: YP 9114R	Chassis Frame No.	: JALFRR907J7000125
Make / Model	: Isuzu FRR90SUQA-C AMT	Engine No. (Logcard)	: 4HK1718740
Year of Manufacture/Reg	: 2018	Odometer Reading	: 123,284 KM
Colour	: Yellow		
Class / Type	: Truck

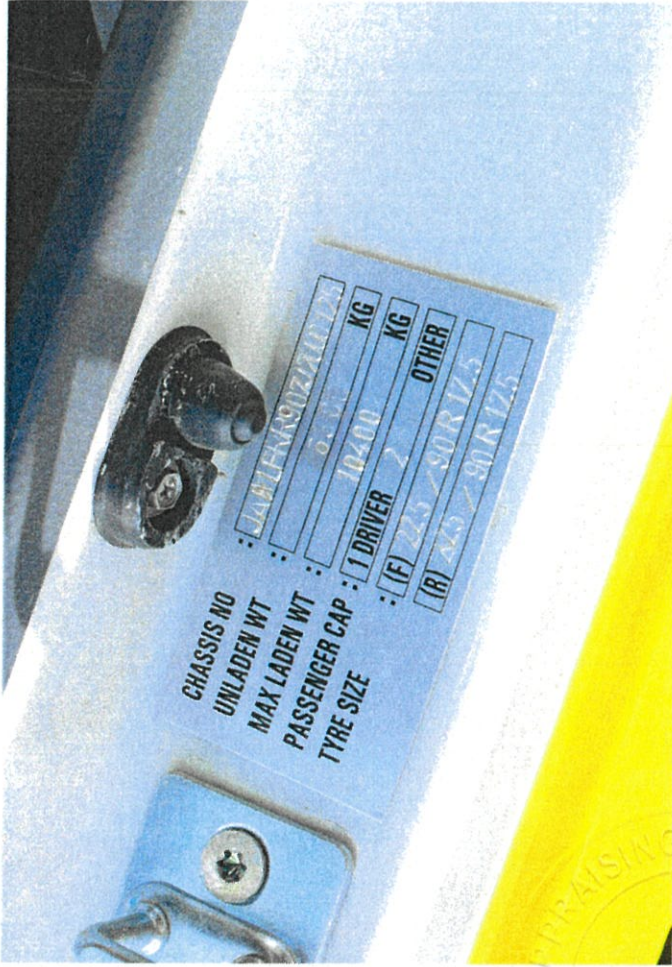
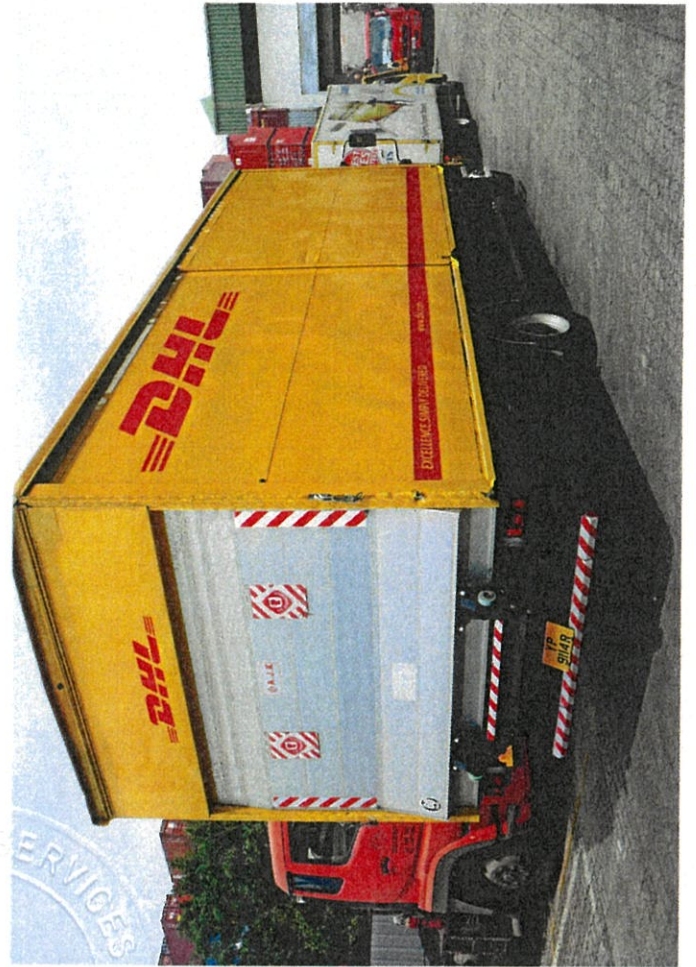
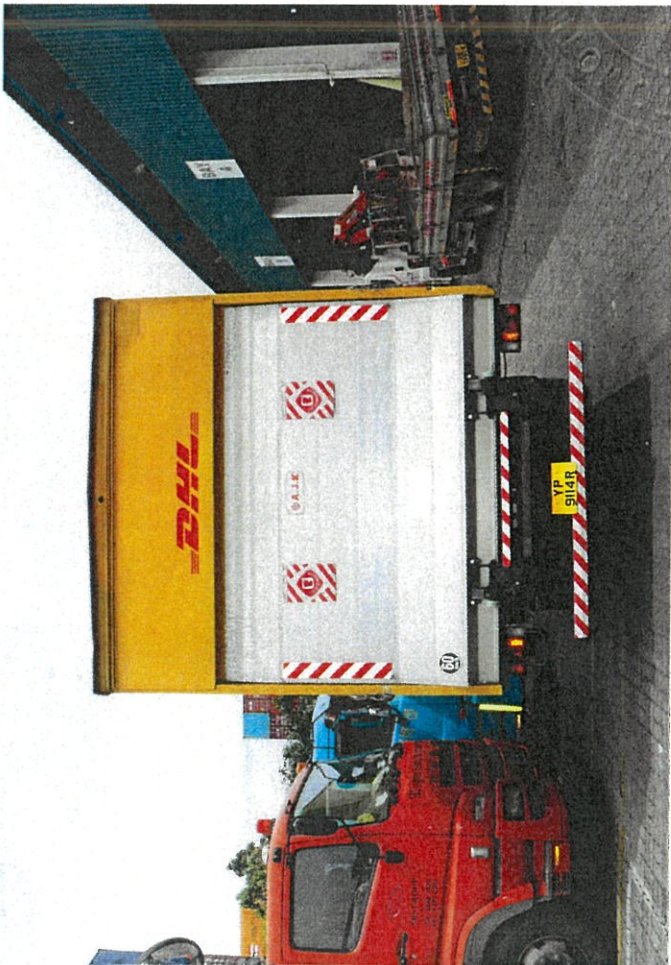
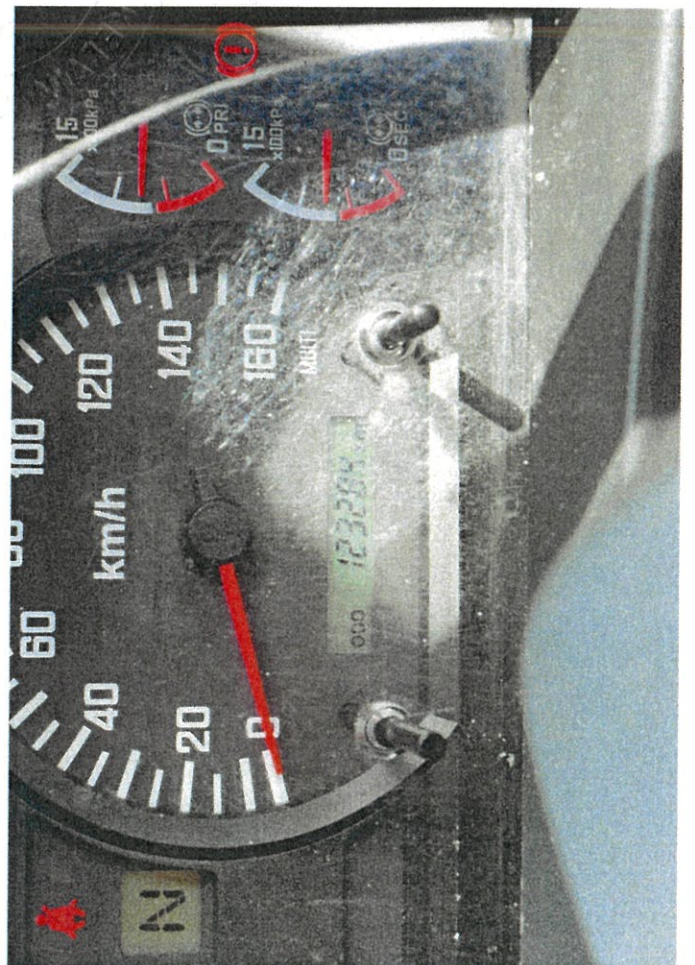
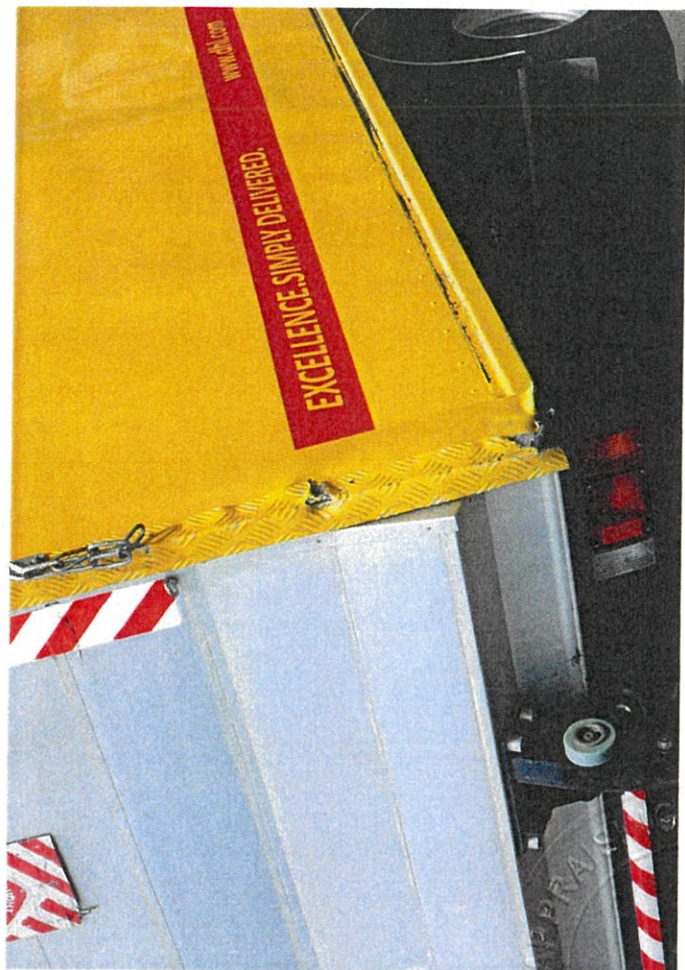
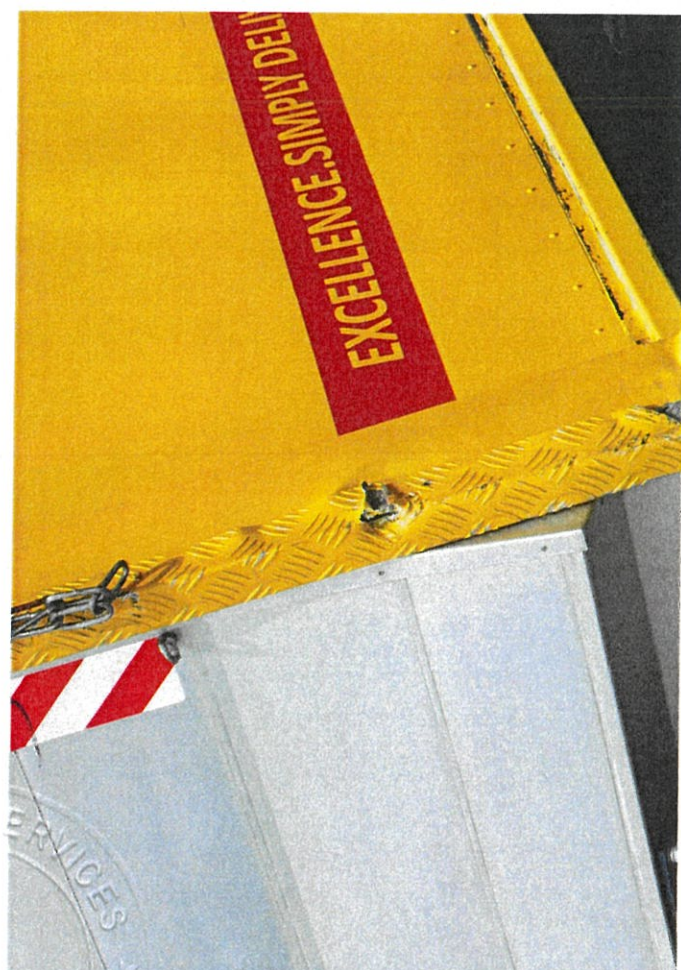
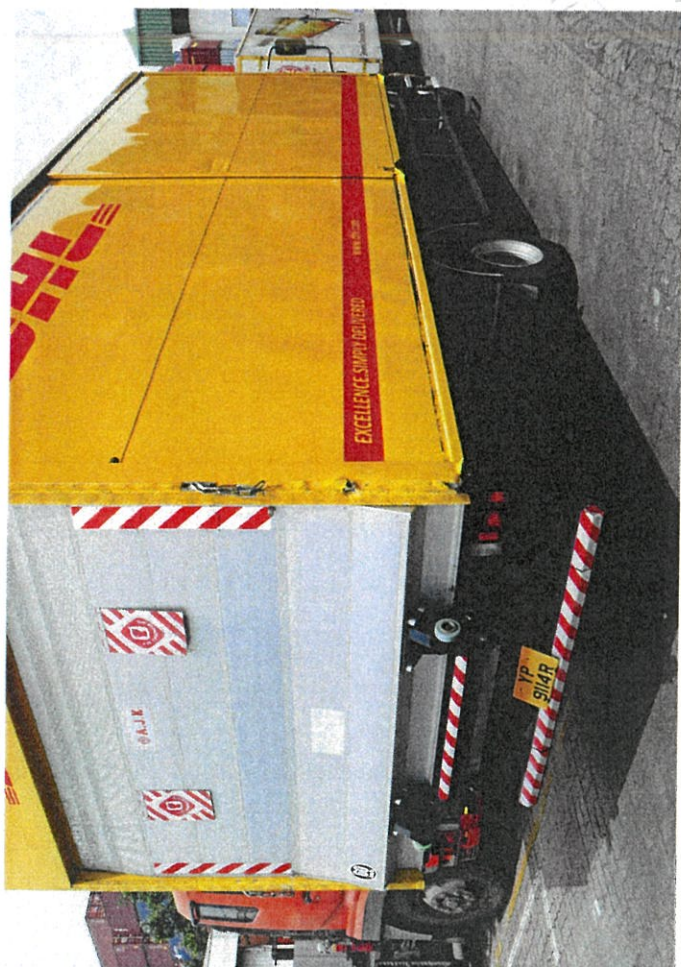
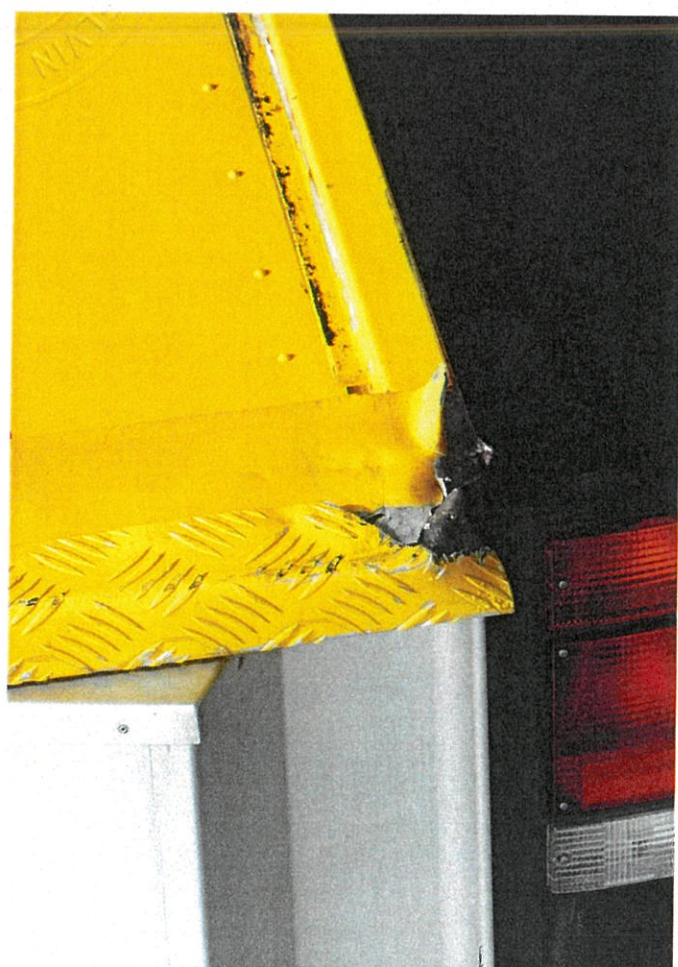
S/N	Qty	Descriptions	Conditions	Repairer's Estimate	Revised Amount
		SPECIAL NETT ITEMS:-			
1	1 pc	rear box rh rear pillar	buckled	\$ 800.00	\$ 800.00
2	1 pc	rear box rh lower frame	buckled	\$ 1,100.00	\$ 1,100.00
				\$ 1,900.00	\$ 1,900.00
		LABOUR & OTHER CHARGES:-			
3		To remove and replace rear pillar and lower frame		\$ 1,600.00	\$ 1,200.00
4		To carry out electrical check		\$ 60.00	\$ 50.00
5		To putty and spray-paint of affected areas		\$ 800.00	\$ 600.00
				\$ 2,460.00	\$ 1,850.00
Sub - Total				\$ 4,360.00	\$ 3,750.00

Damages sustained were consistent with the subject vehicle being involved in a collision with another vehicle and the impact was delivered **Diagonally to the RH Rear from left to right; rear to front;** portion of the vehicle.

The general area of damages is at the **RH Rear portion**
(Please refer to the parts list and photographs as attached for more information)

The estimated repair costs submitted by Messrs **R&S Engineering Works Pte Ltd** is \$ **4,360.00** .
We have adjusted the cost to \$ **3,750.00** and the repairer has agreed to undertake the repairs at a
Contract Lump Sum of \$ 3,000.00 to a acceptable quality and standards.
However, we have not given authorization and instruction to the repairer to proceed with the repairs.
