**PROPERTY DAMAGES CLAIMS AS A RESULT OF A ROAD TRAFFIC ACCIDENT INVOLVING
MOTOR VEHICLES NO. VBK5018 AND SML3333C ALONG AYE TOWARDS CITY ON 02.12.2020.**

Re : Third Party Claim For Vehicle Registration No. VBK5018

VEHICLE INSPECTION REPORT

Registration no. : VBK5018
 Our reference : UAM21.01.04-PT-STP-CSM-VBK5018

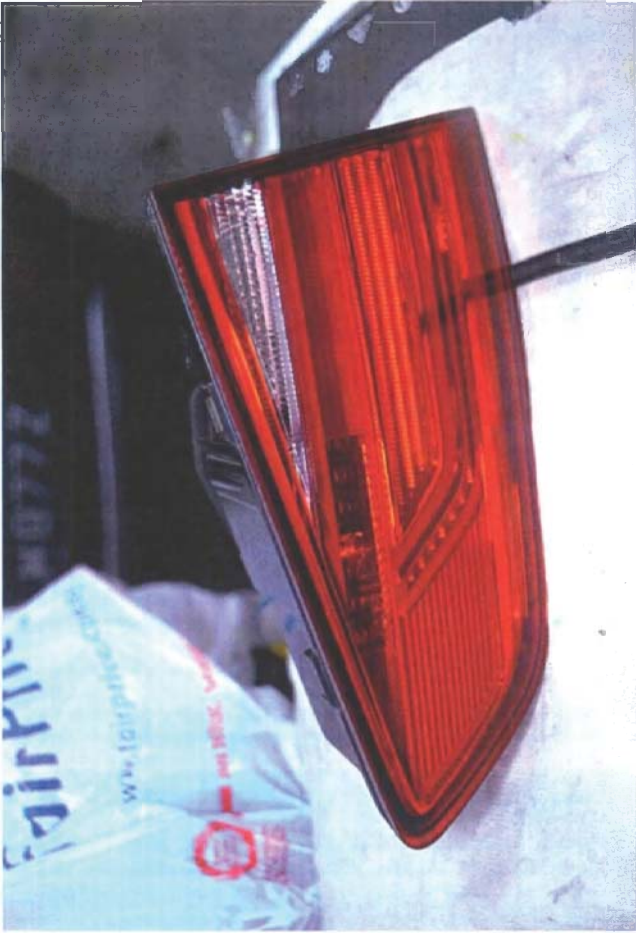
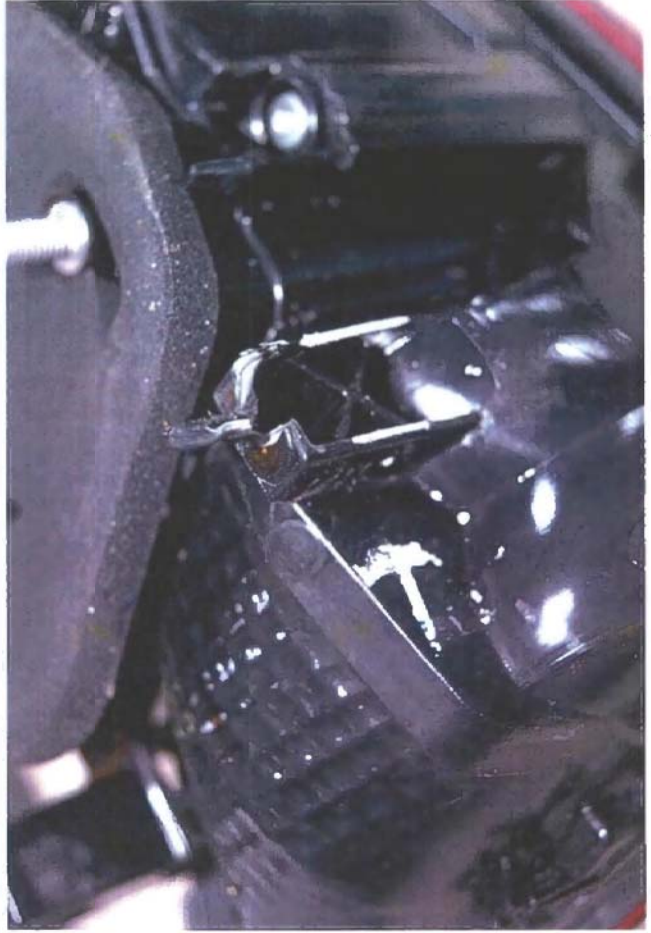
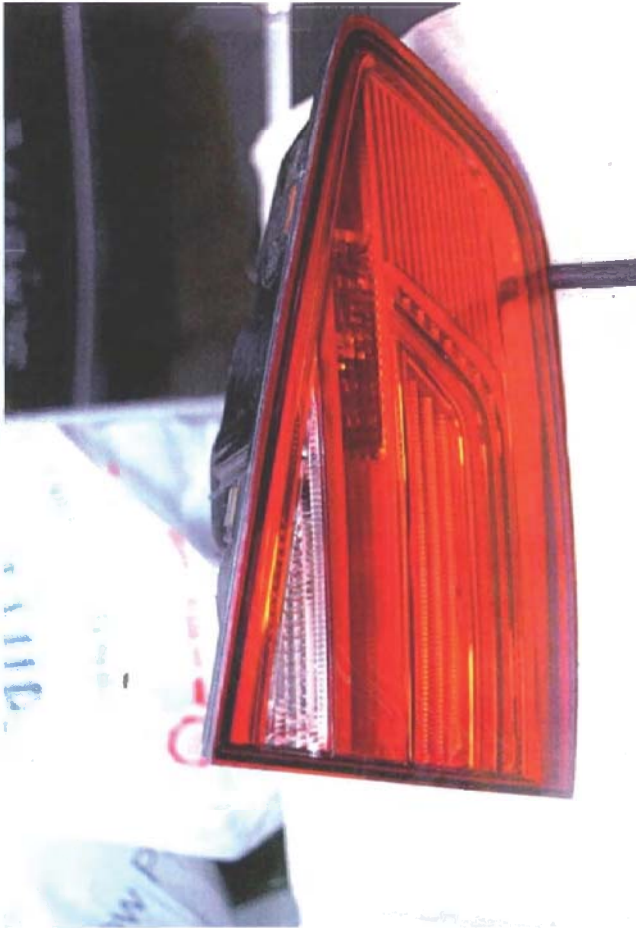
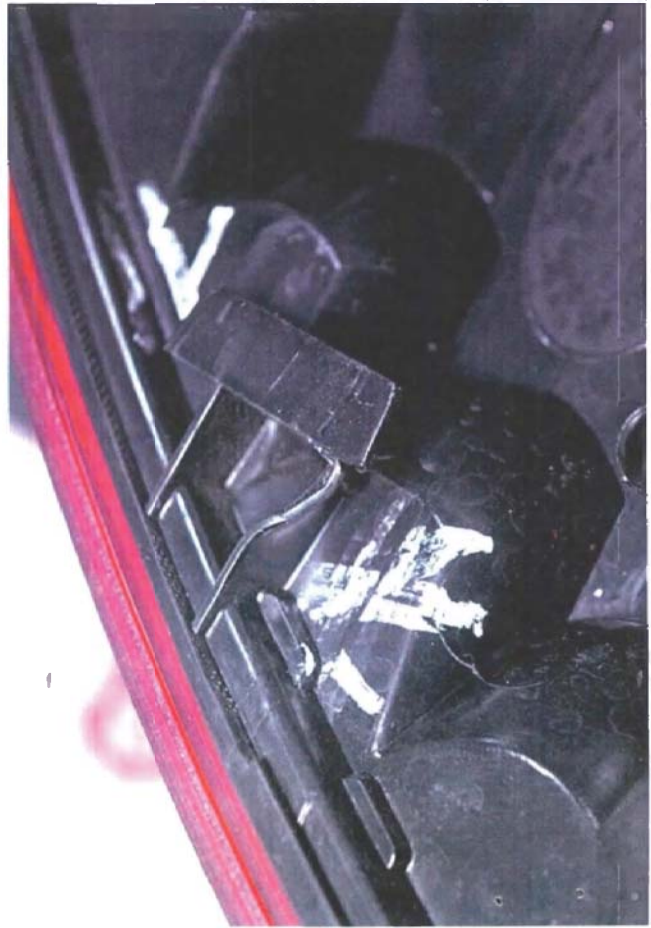
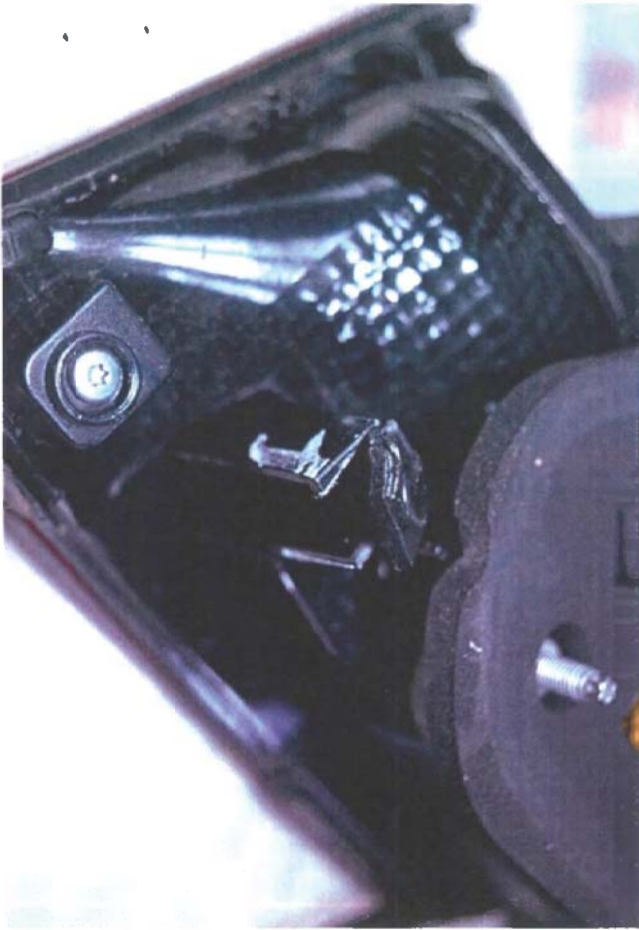
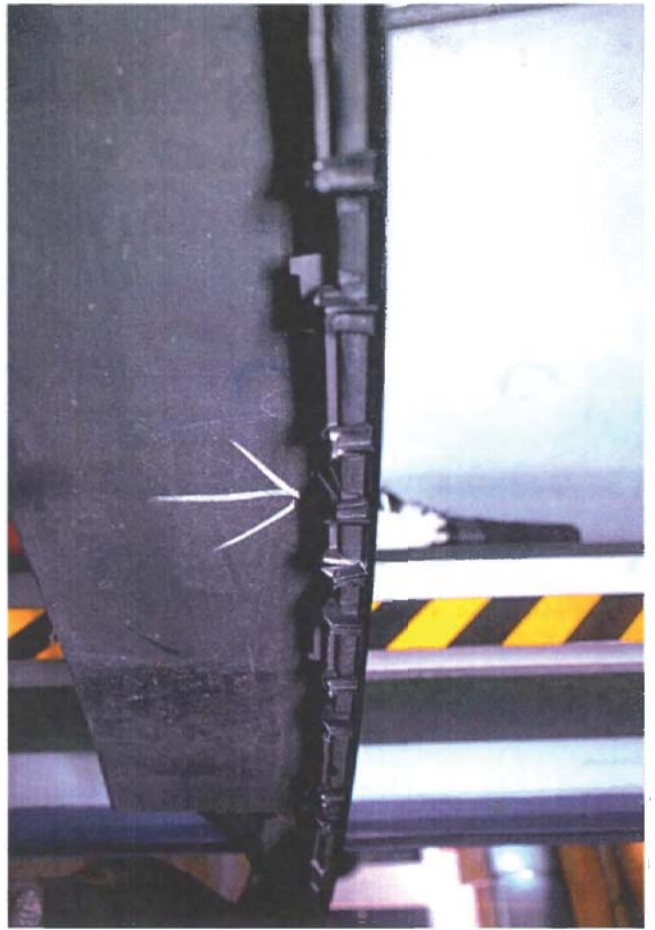
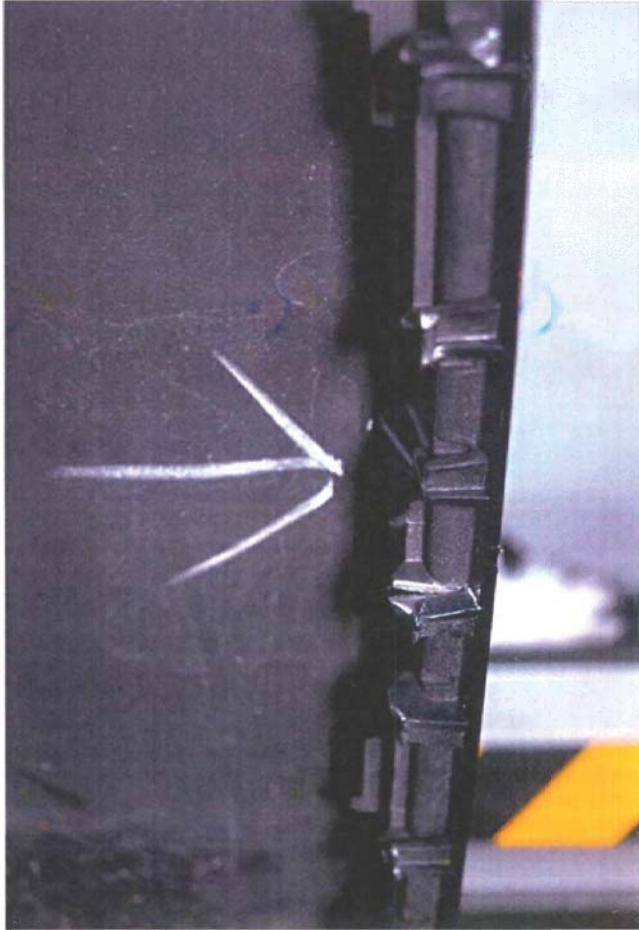
The impact of the collision has damaged / affected the bootlid, taillamps, rear bumper, rear end panel and etc...

Please refer to Annex A (Appraisement Schedule) for a detailed account of the damages and photographs taken.
