Insured : -
Policy No. : -
Sum Insured : -
Excess : -
Our Reference : KAAS/TA/5138/0076/TP/08.18
Date : 11 September 2018

VEHICLE APPRAISAL REPORT

Registration No.	: SKX 76A	Engine No.	: Hidden From View
Make/Model	: Mercedes Benz GLC250 4matic Coupe (A)	Chassis Frame No.	: WDC2533462F442770
Year of Manufacture/Reg	: 2018	Colour	: White
Class/Type	: Coupe	Odometer Reading	: 3,957 KM

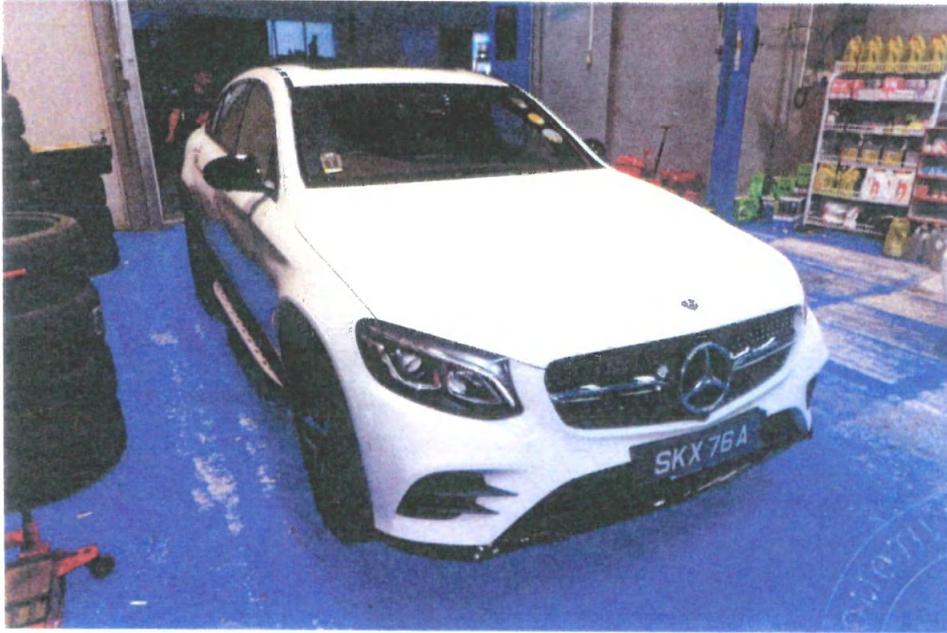
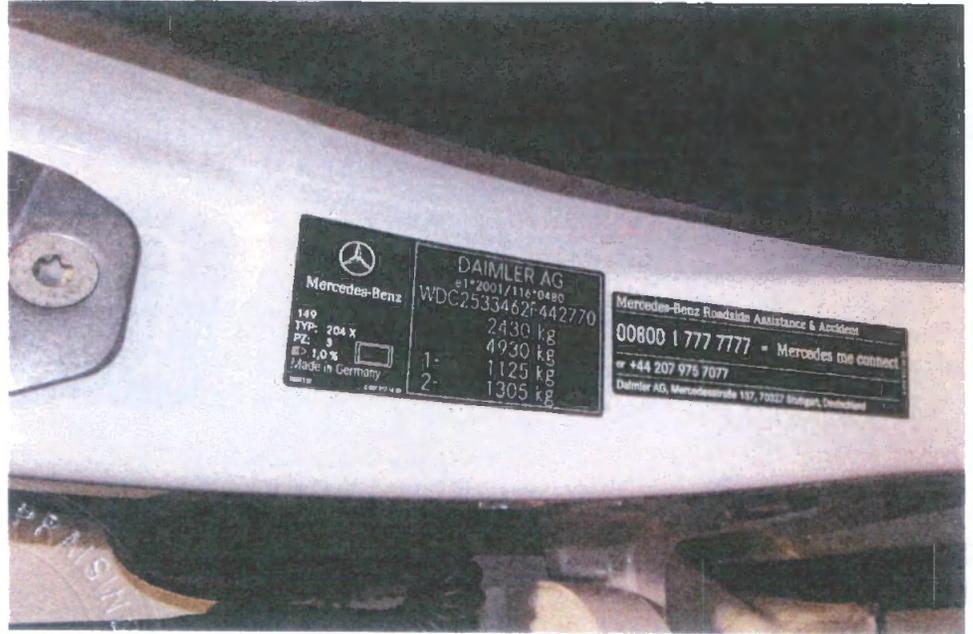
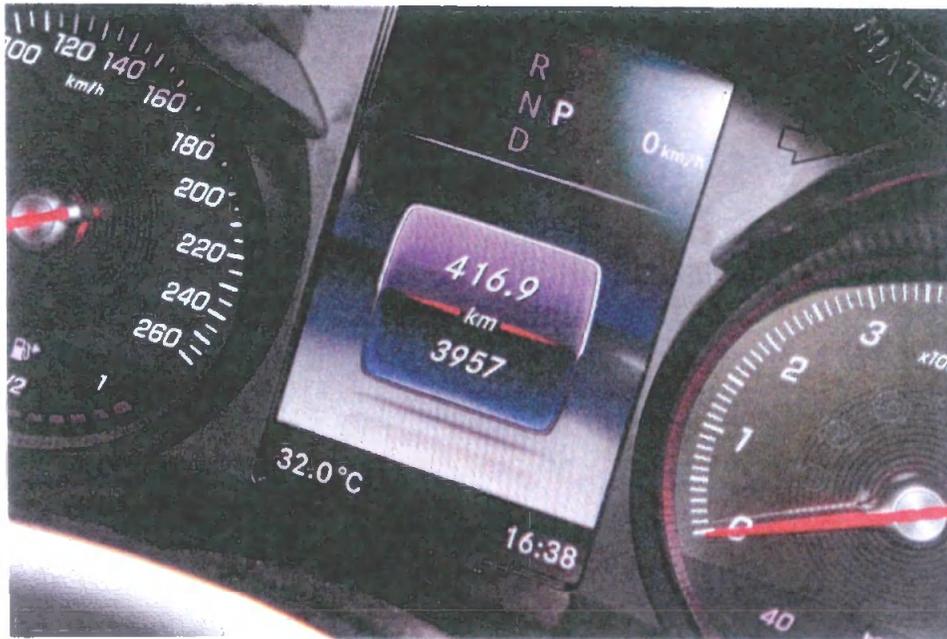
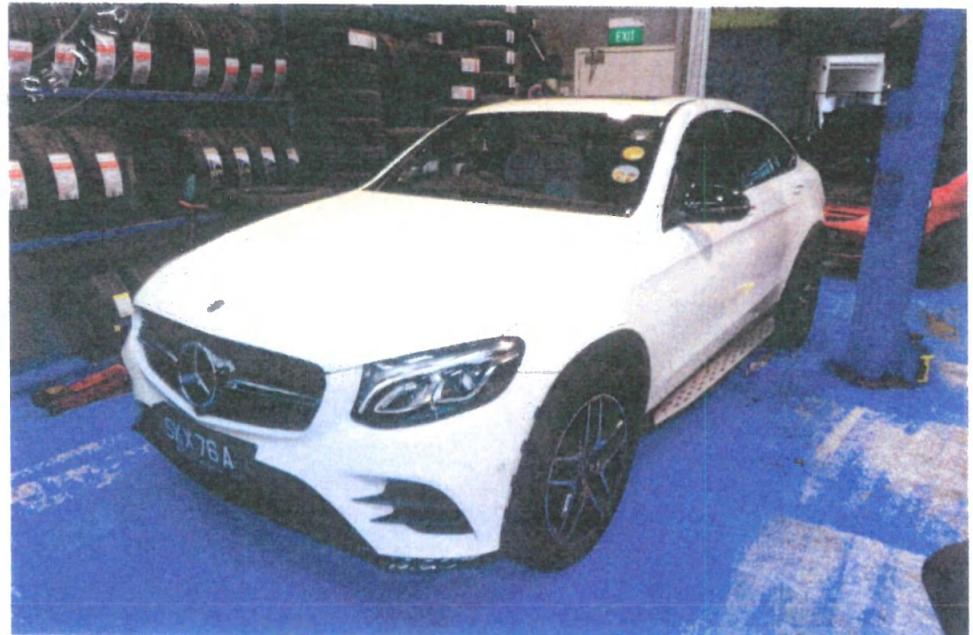
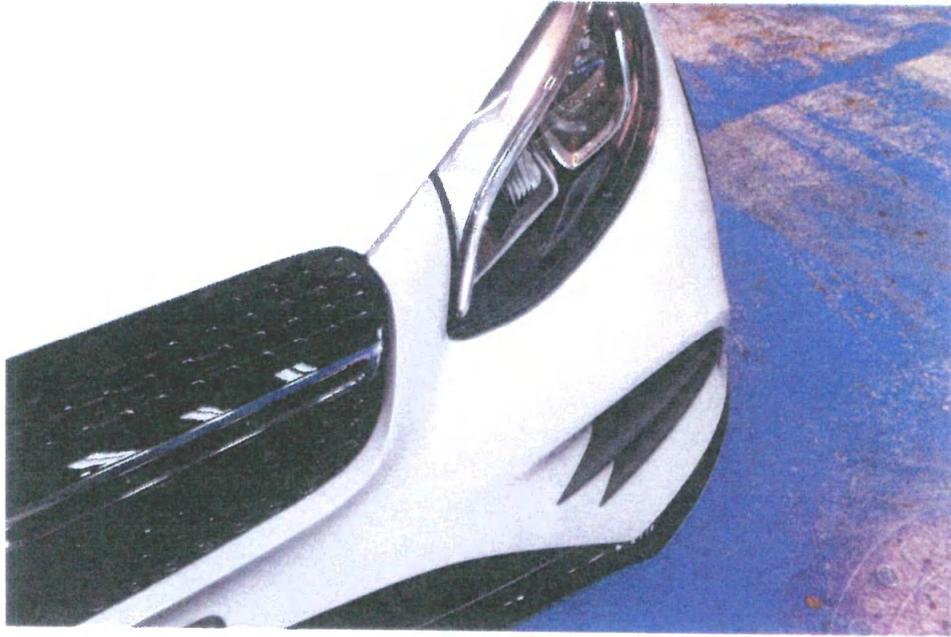
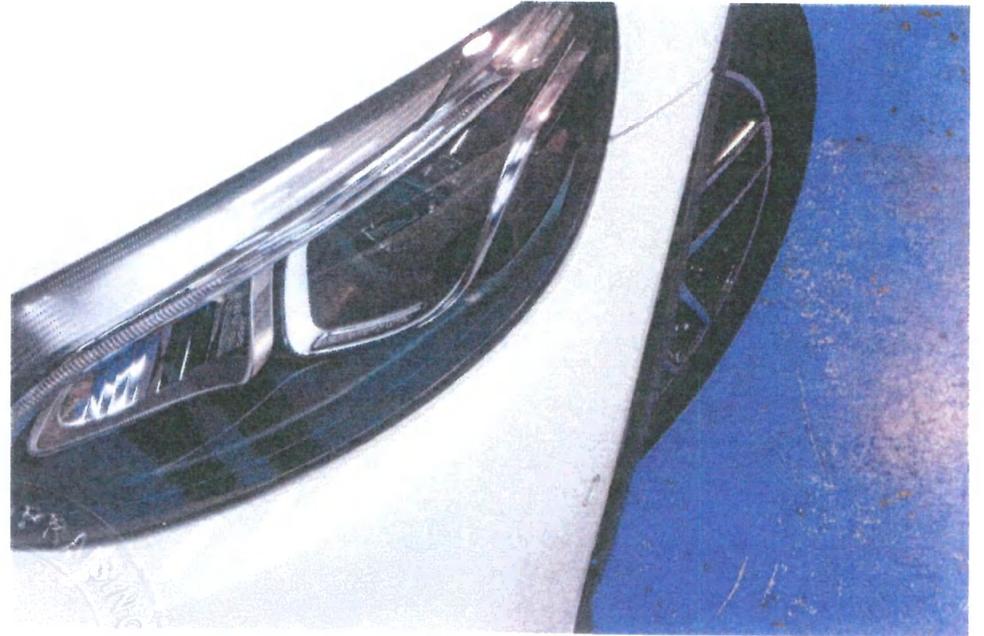
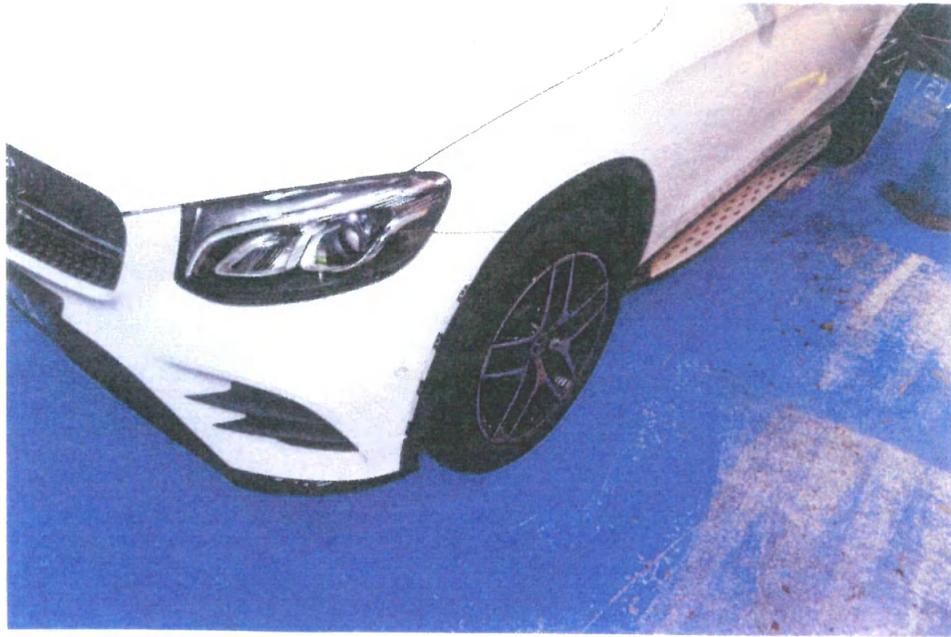
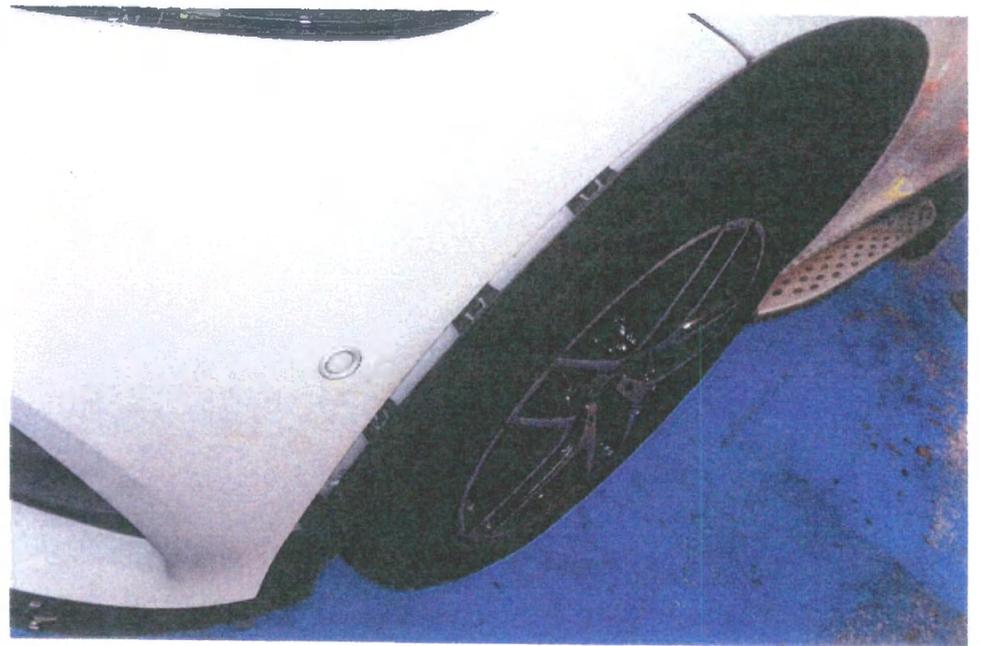
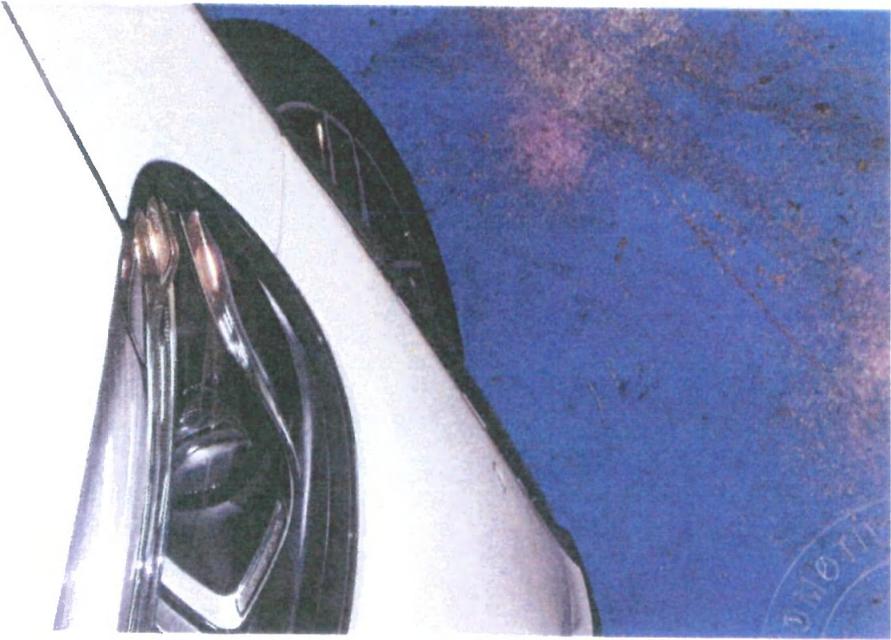
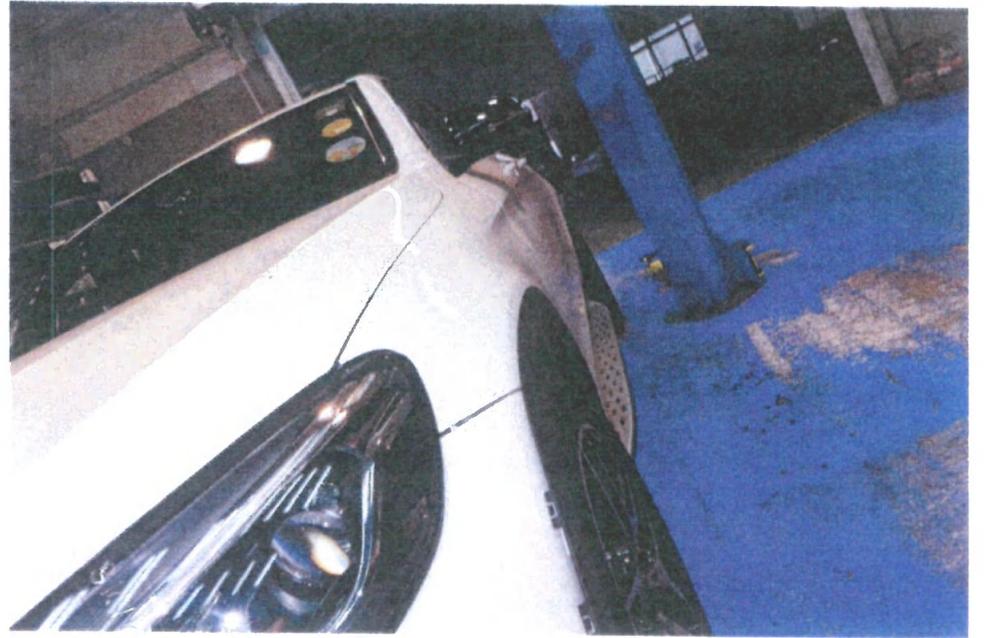
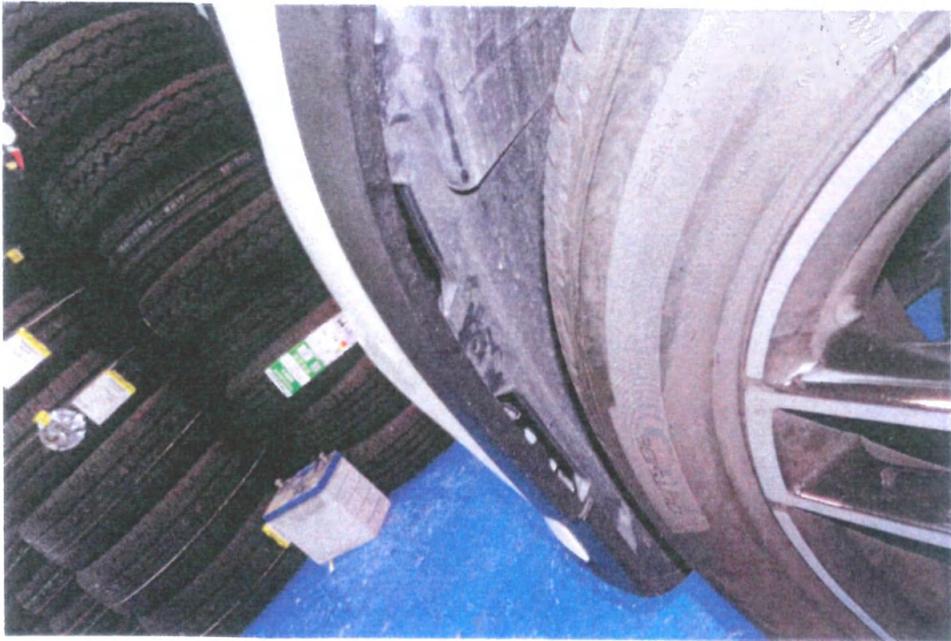
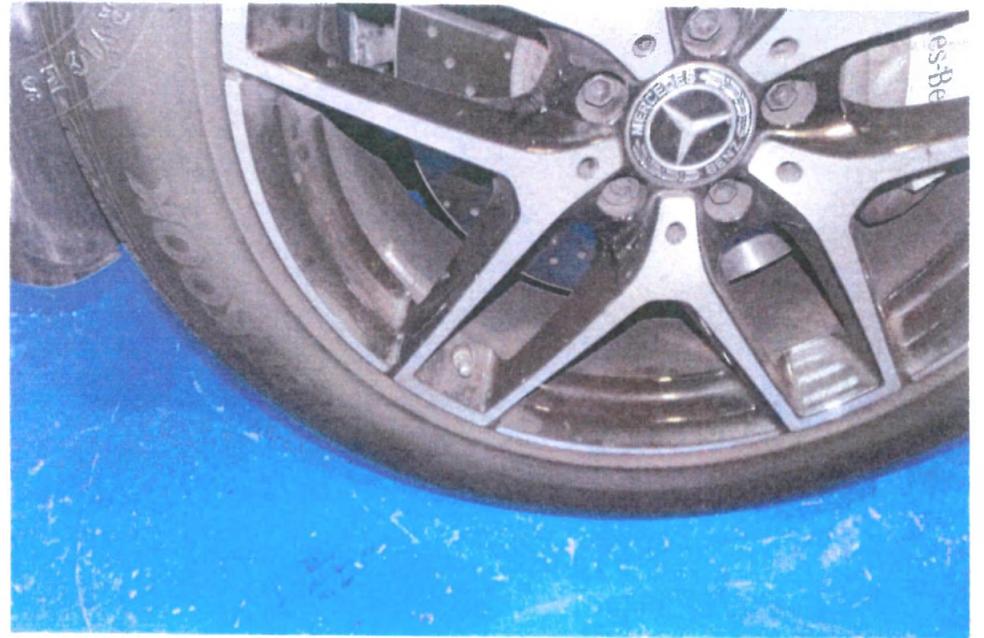
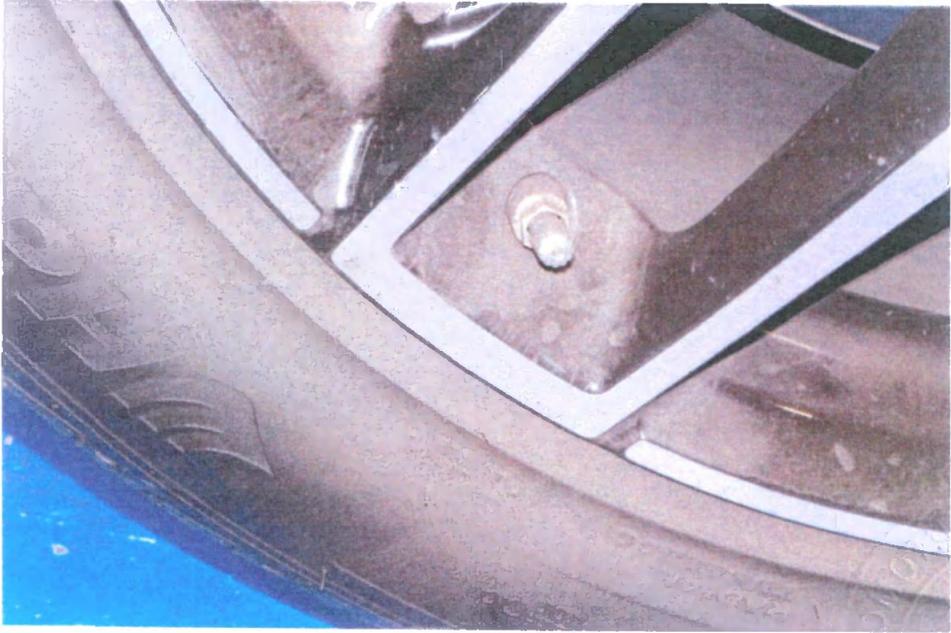
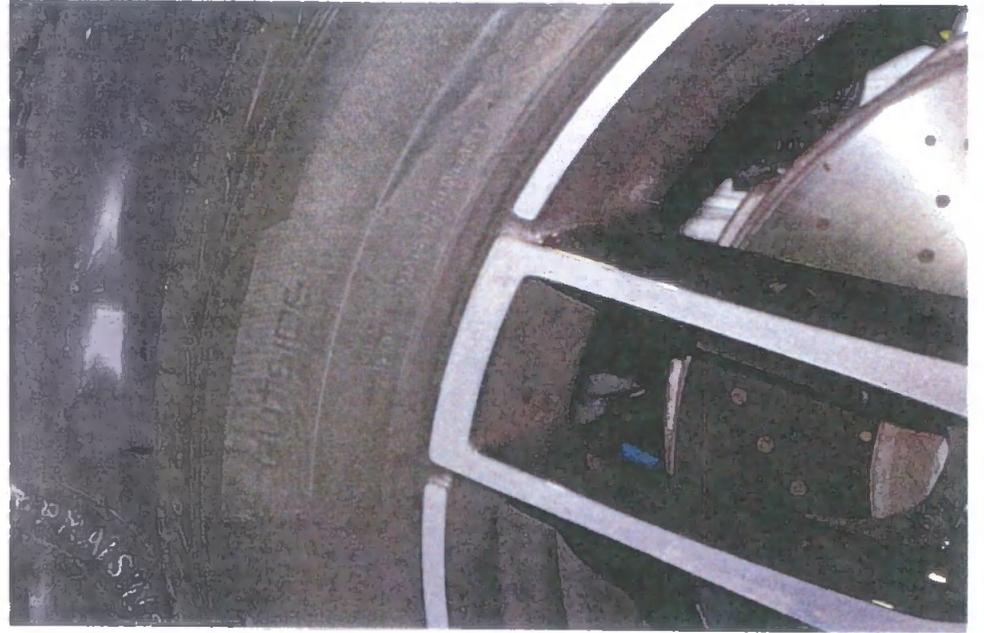
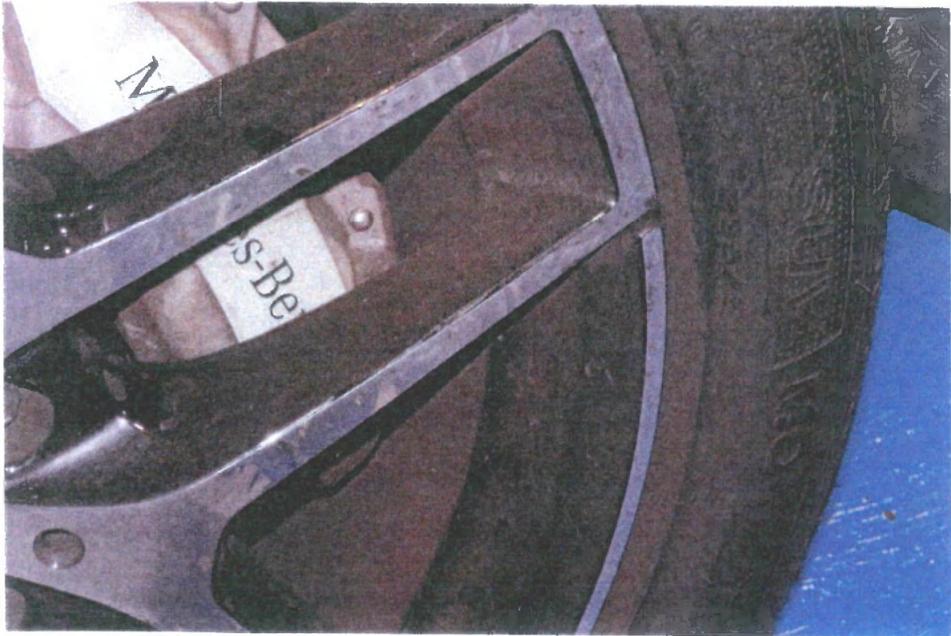
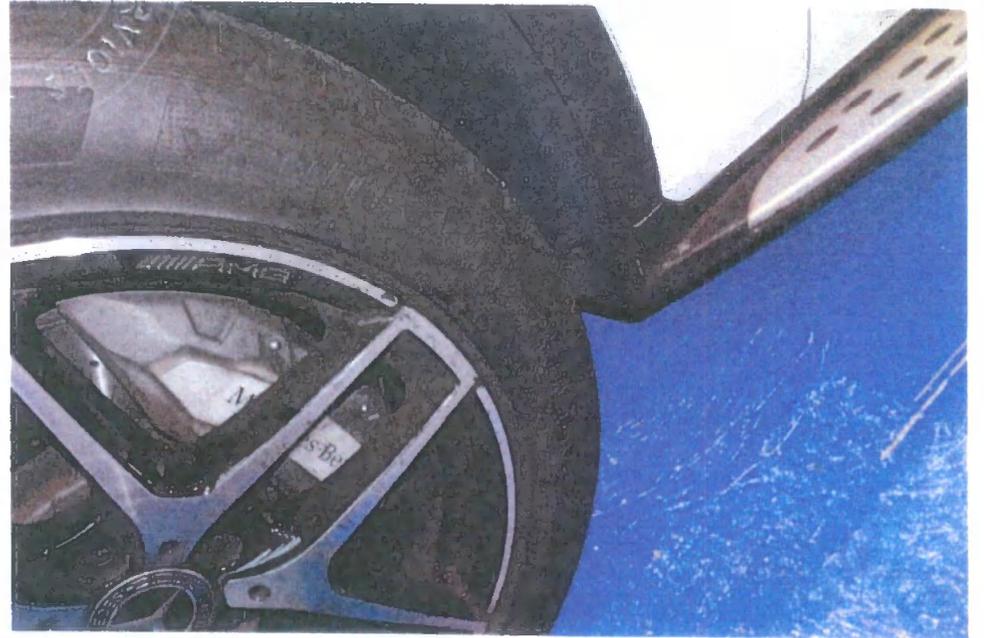
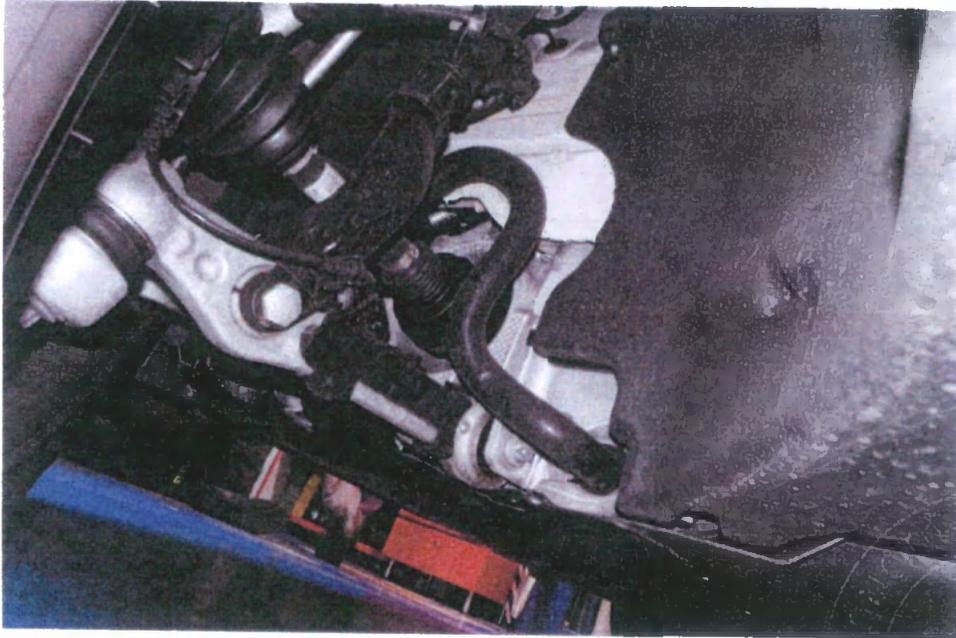
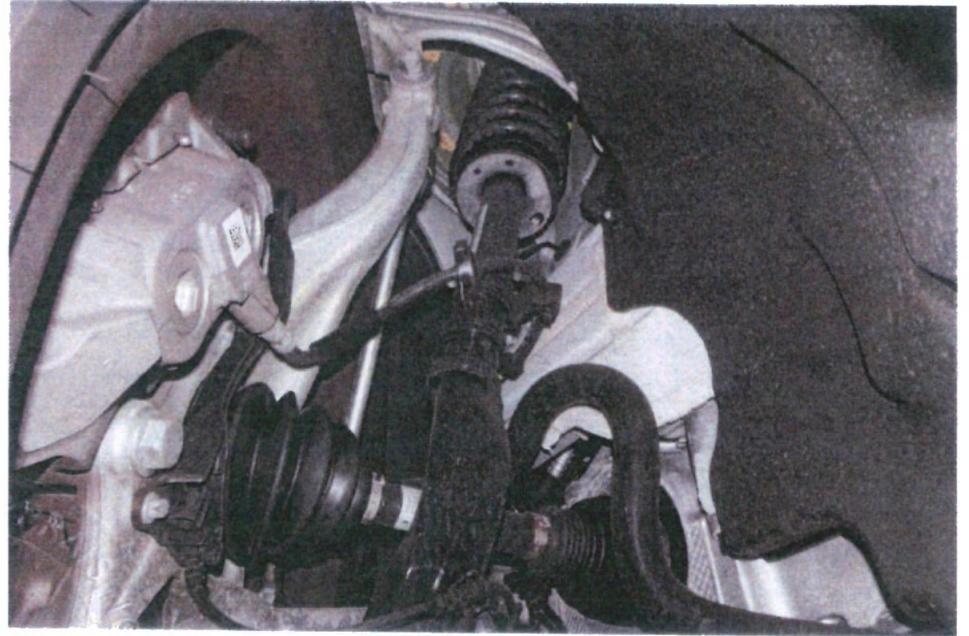
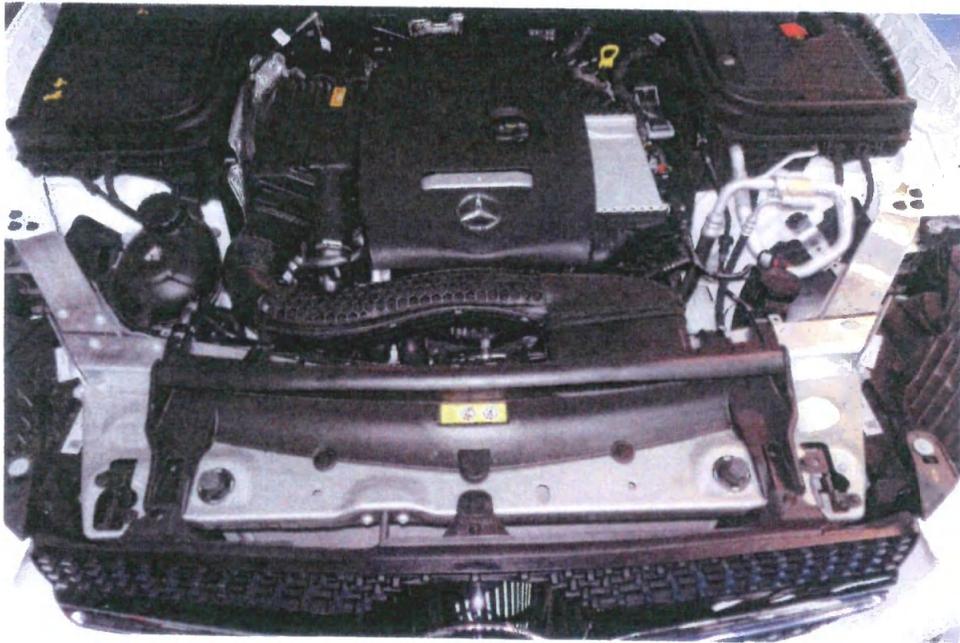
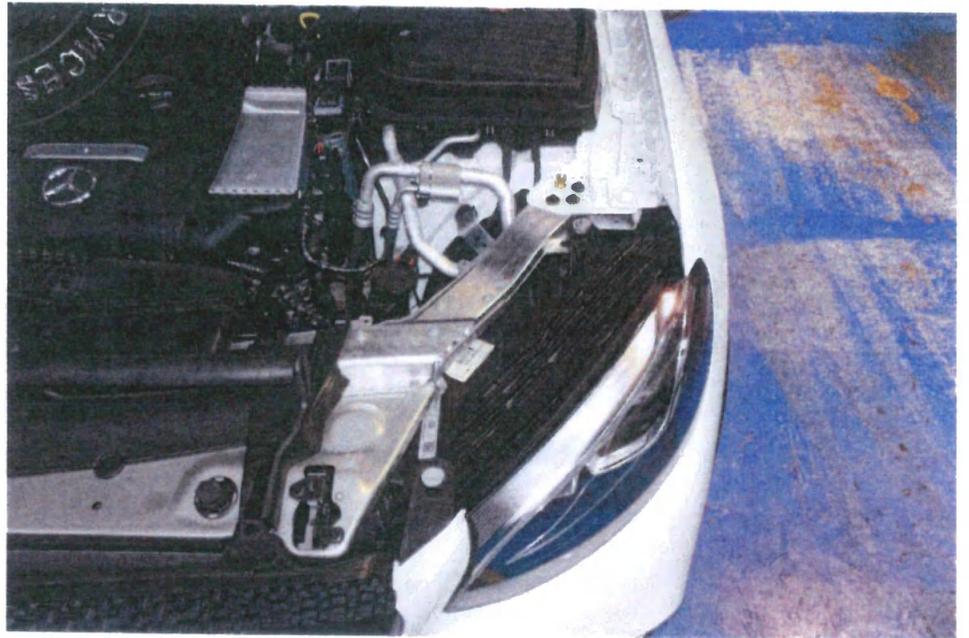
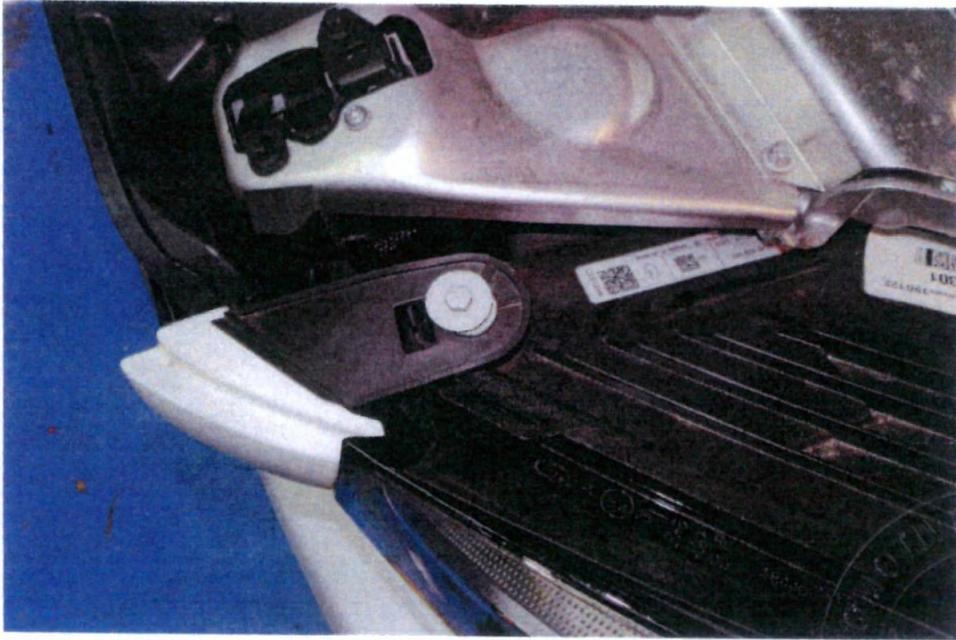
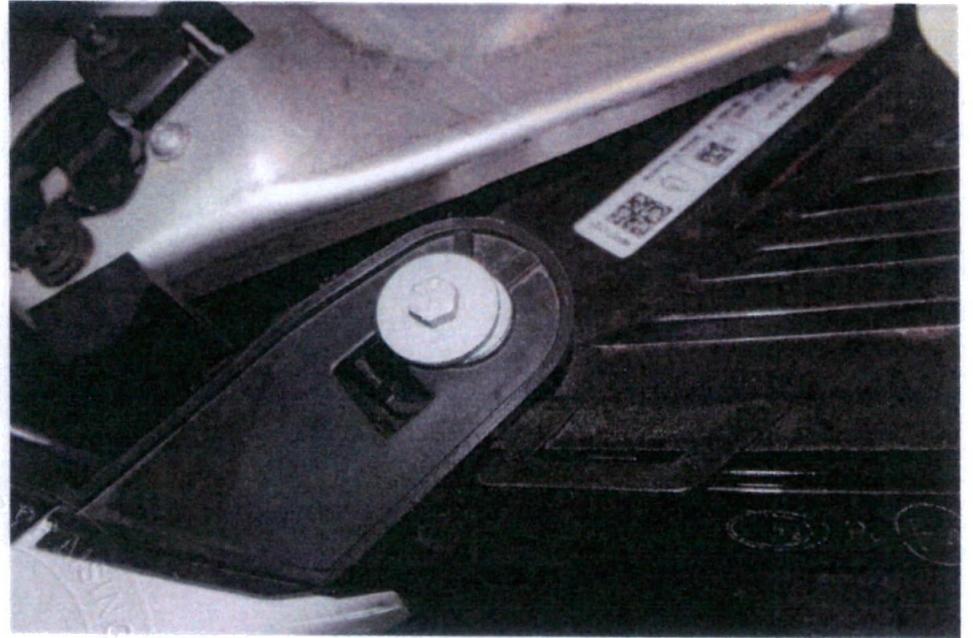
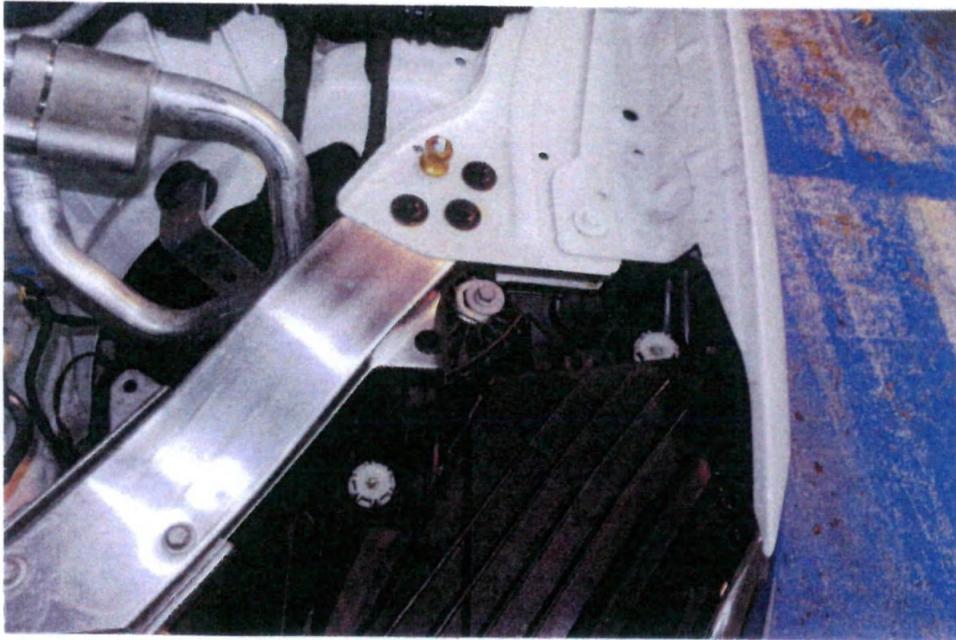
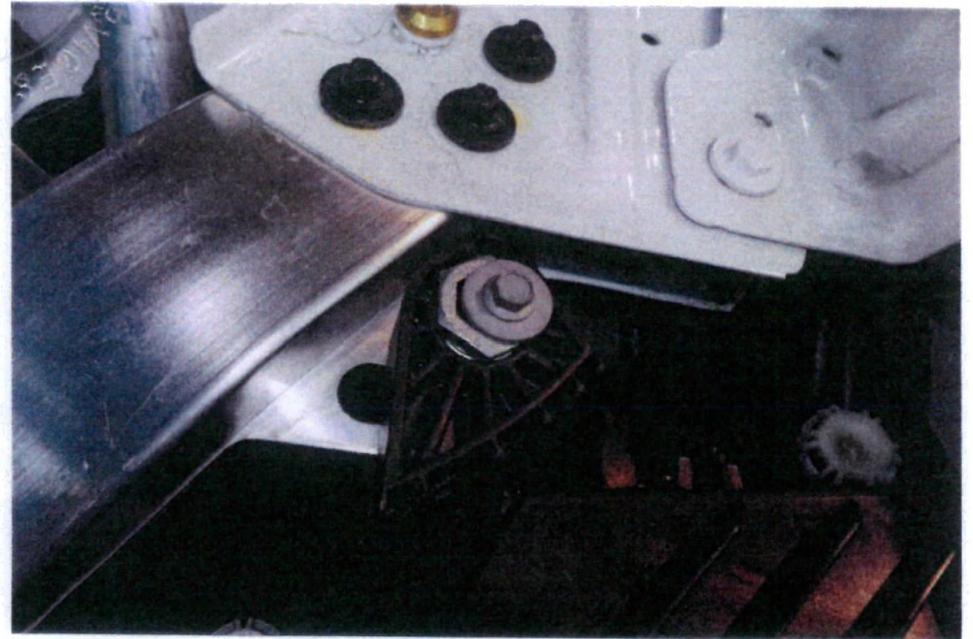
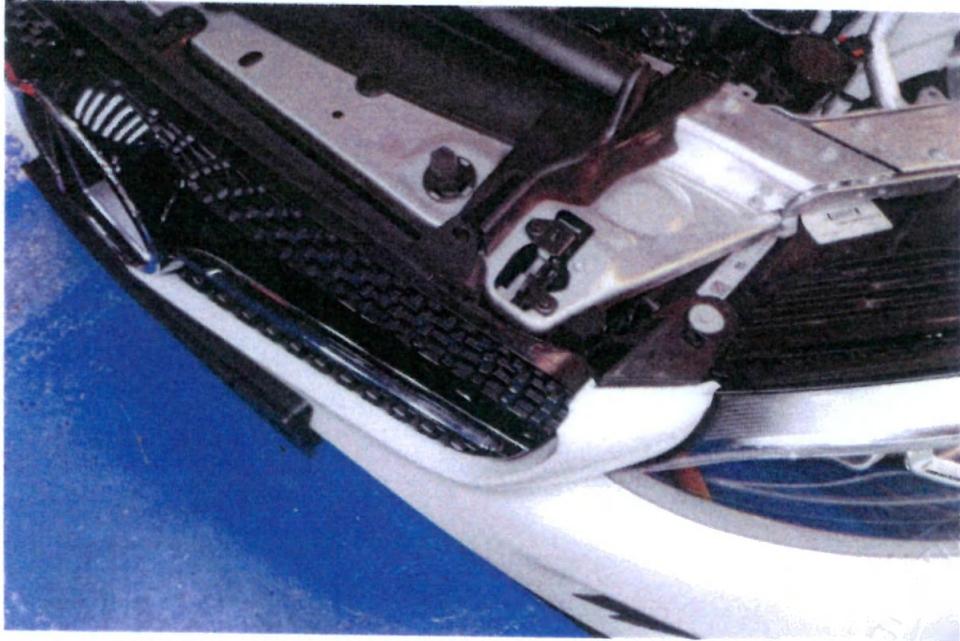
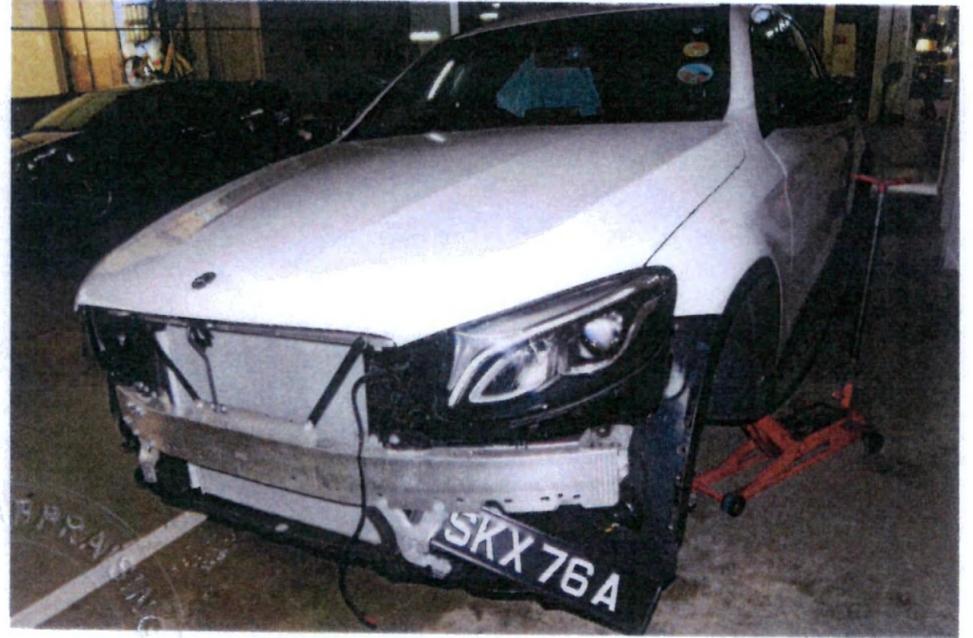
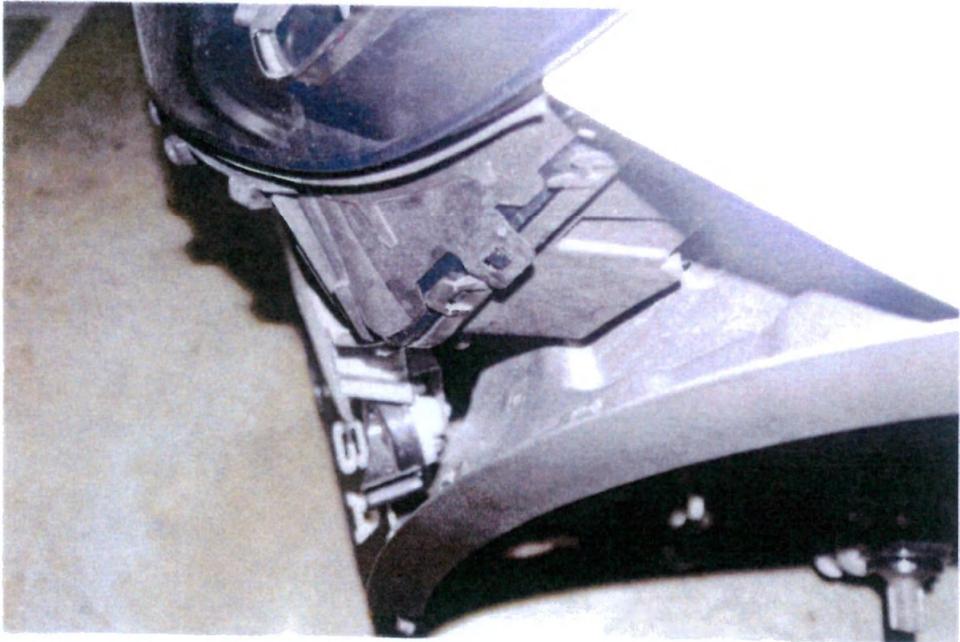
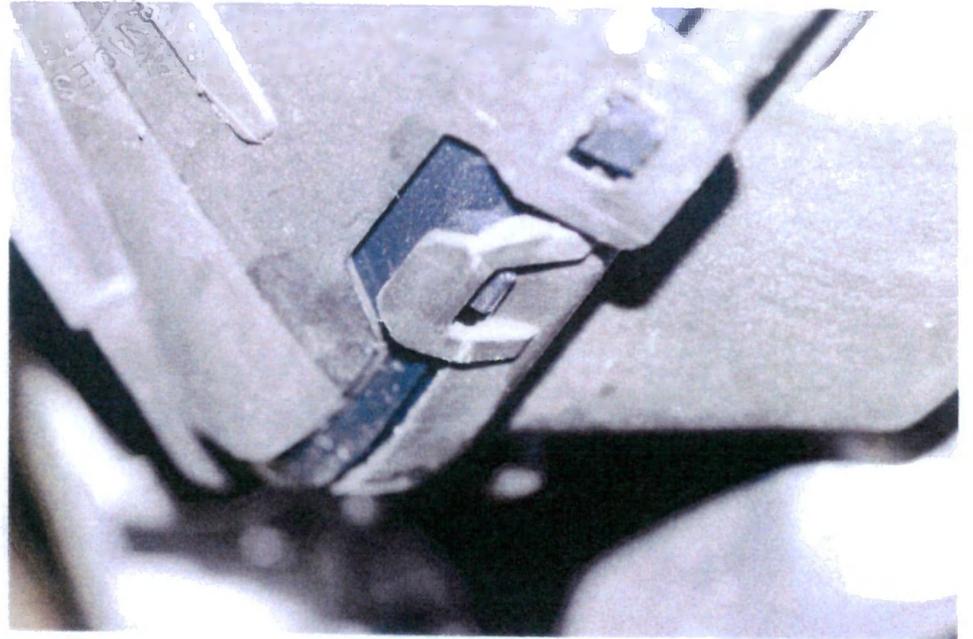
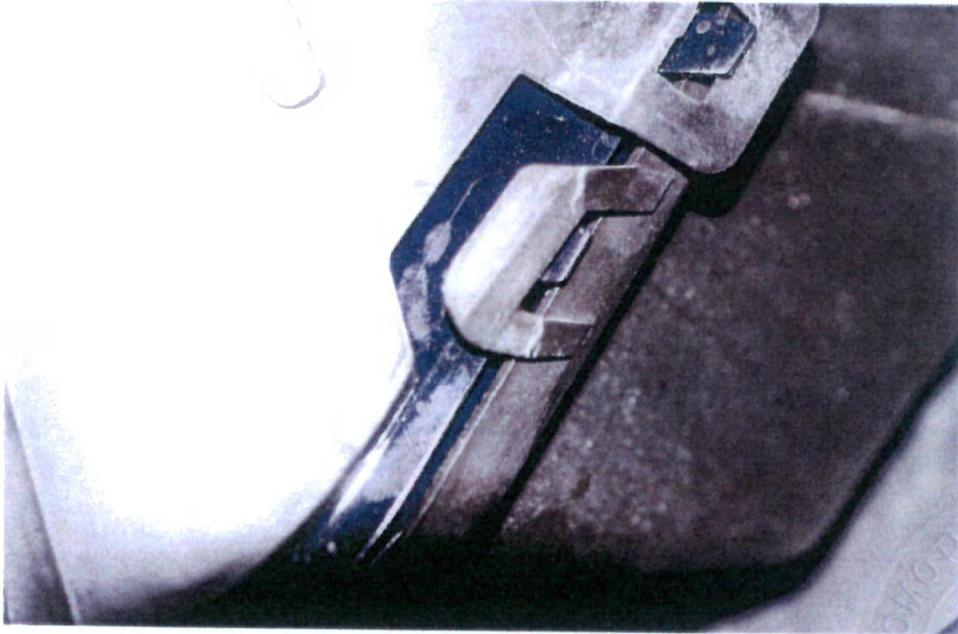
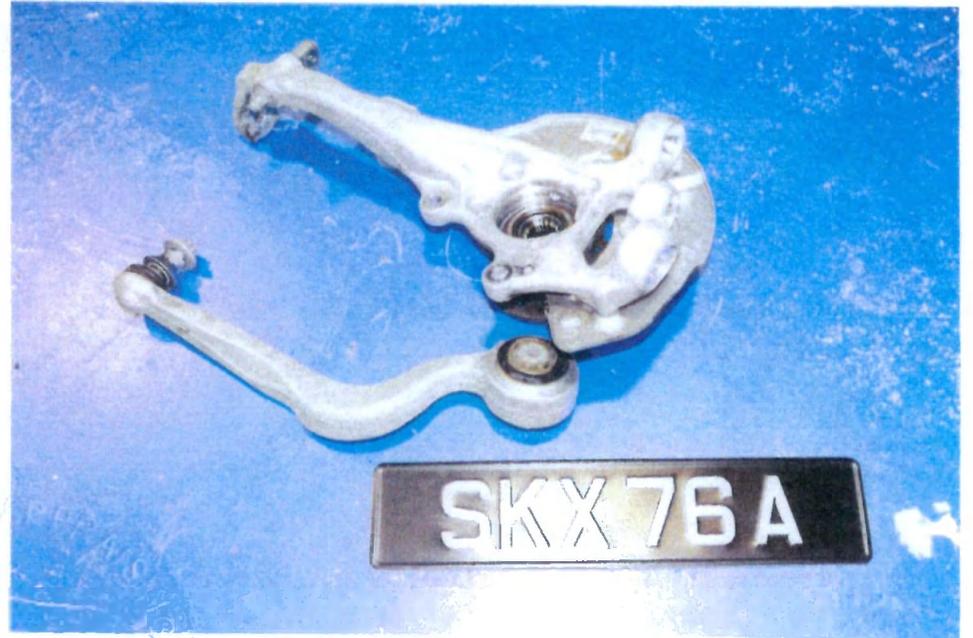
Damages sustained were consistent with the subject vehicle being involved in a collision with another vehicle and the impact was delivered to the LH Front portion from rear to front; left to right; of the vehicle.

The general area of damages is at the **LH Front portion**
(Please refer to the parts list and photographs as attached for more information)

The estimated repair costs submitted by Messrs **Apex Motoring** is \$ 11,900.00 .
We have adjusted the cost to \$ 9,963.00 and the repairer has agreed to undertake the repairs at a **Contract Lump Sum of \$ 8,450.00** to a acceptable quality and standards.
However, we have not given authorization and instruction to the repairer to proceed with the repairs.
