Your Ref: TP/IP/50171/2020
Our Ref : CI/TPD21002934/P

19th April 2021

MECHANICAL INSPECTION REPORT OF TRAILER XE 3670K

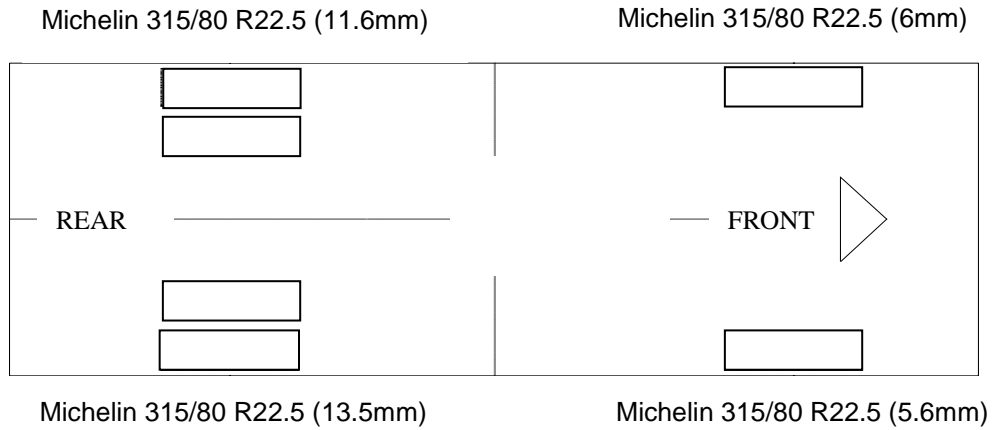
6. The 6 tyres of the Trailer were observed to be in serviceable condition and sufficiently inflated for vehicular operation. I did not find any tear, cut or burst mark(s) on the outer and the inner sidewalls as well as across the tread of the 6 tyres. The tyre brand, tyre size and remaining tread depth of the 6 tyres of the Trailer were recorded as follows:-
