**Fatal Accident Investigation Team**

**MECHANICAL INSPECTION REPORT OF LORRY YP 6810J**

1. I refer to your request on 25<sup>th</sup> February 2021 to conduct a visual inspection of a Lorry bearing registration number YP 6810J (herein referred to as "**Lorry**"), which was involved in a fatal road traffic accident on 8<sup>th</sup> February 2021
2. The objective of this inspection is to determine if there was any possible mechanical failure to the Lorry that may have contributed to the accident.
3. Following the request, I had carried out a visual inspection of the Lorry on 25<sup>th</sup> June 2021 at the premises of Traffic Police vehicle pound, 517 Airport Road Singapore 539942. I now set out below my observations and comments with respect to this inspection.

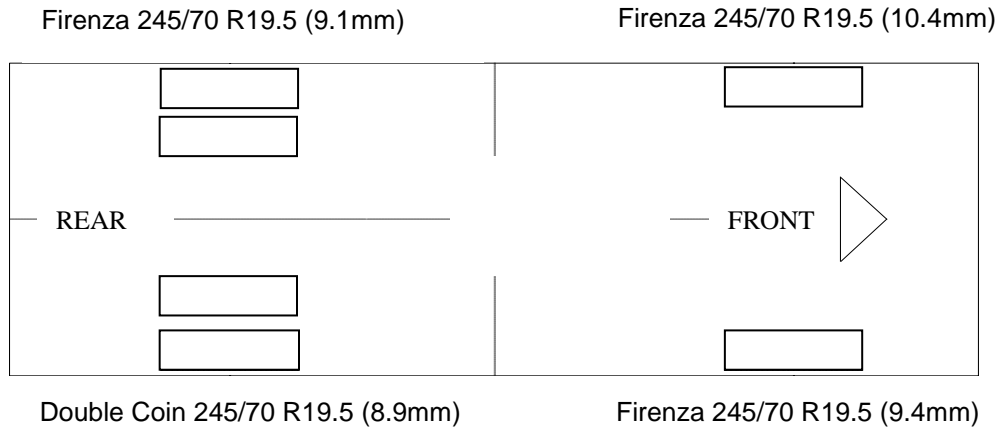
6. The 6 tyres of the Lorry was observed to be in serviceable condition; sufficiently inflated for vehicular operation. I did not find any tear, cut or burst mark(s) on the outer and the inner sidewalls as well as across the tread of the 6 tyres. However, the remaining tread depth of the both rear right tyres was observed to be insufficient for vehicular operation. The tyre brand, tyre size and remaining tread depth of the 6 tyres of the Lorry were recorded as follows:-
