# LKK Auto Consultants Pte Ltd

## ADJUSTMENT ON REPAIR COST FOR VEHICLE NO. GBH 8937D

PHOTOGRAPHS FOR VEHICLE NO. GBH 8937D

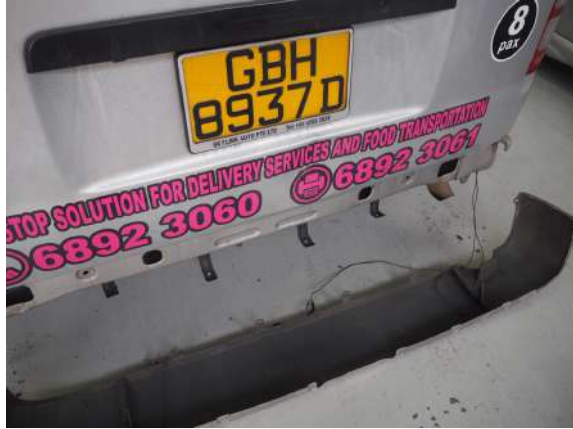
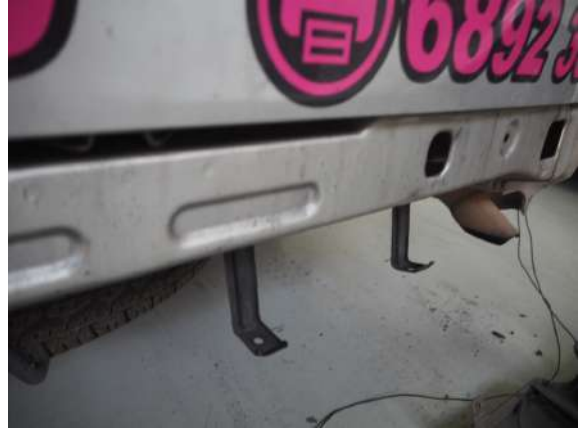
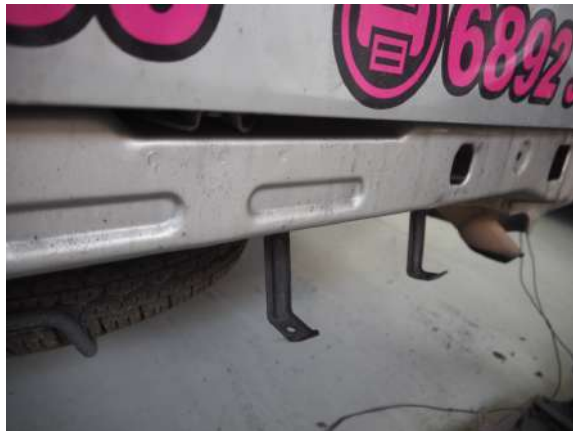
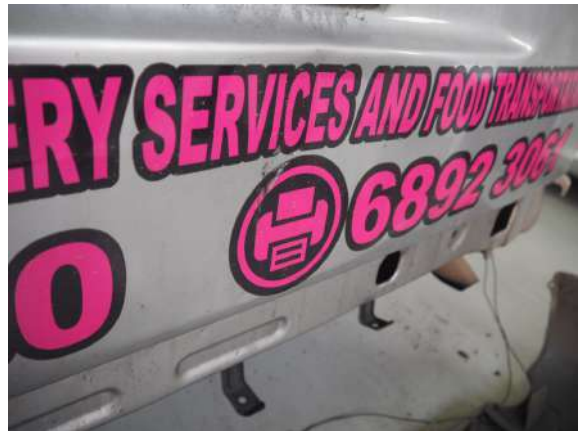
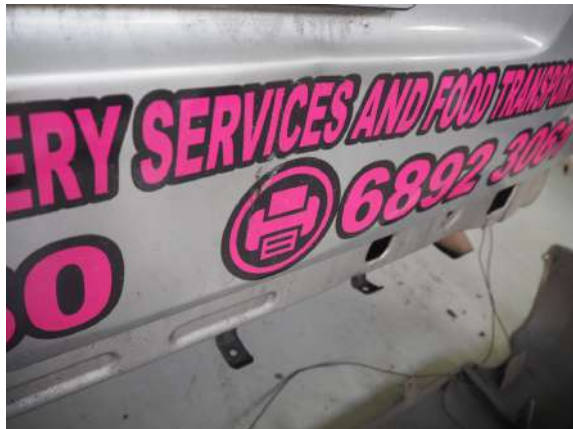
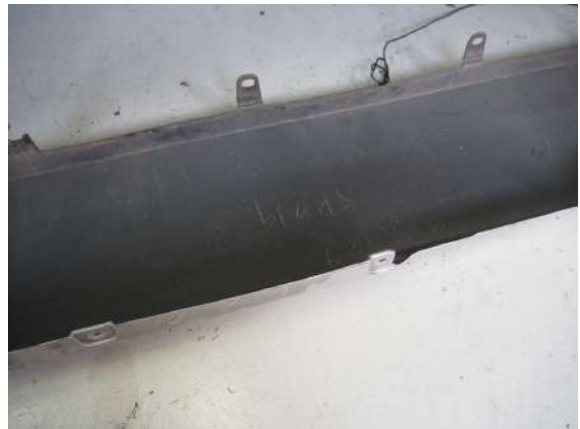
RE-INSPECTION

| Affiliated to Federation Internationale Des Experts En Automobile | | | | |
|---|---|---|---|--|
| THE VEHICLE SUSTAINED DAMAGES AT THE REAR PORTION.<br><br>DAMAGES SEE DETAILS. | | | | |
