You're Ref: TP/IP/06549/2021  
Our Ref: CI/TPD21003582/P

24<sup>th</sup> March 2021

**MECHANICAL INSPECTION REPORT OF MOTOR CAR SMC 8216Y**

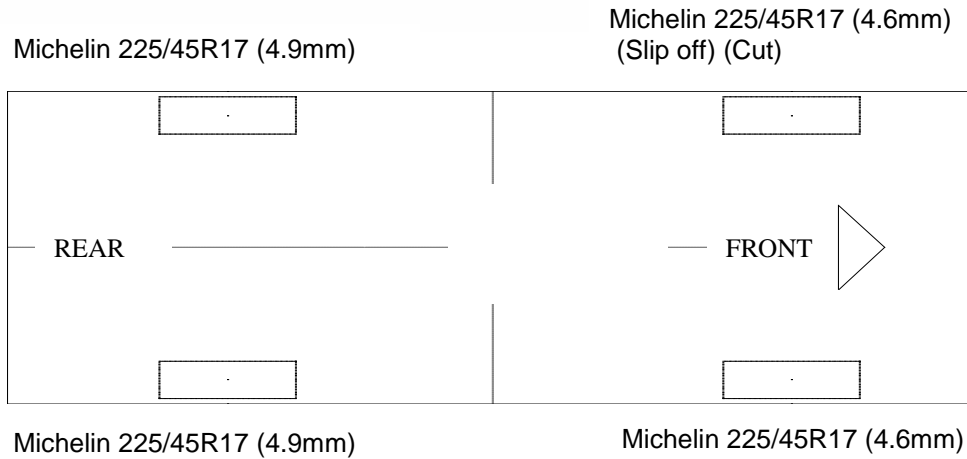
6. The condition of the Motor Car's front left tyre was observed to be in unserviceable condition as the front left tyre had slip out of the wheel rim and cut as a result of the accident. However the other 3 tyres was observed to be in serviceable condition. I did not find any tear, cut or burst mark(s) on the outer and the inner sidewalls as well as across the tread of the 3 tyres. The 3 tyres were also observed to be sufficiently inflated for vehicular operation. The tyre brand, tyre size and remaining tread depth of the 4 tyres were recorded as follows:-
