Your Ref: TP/IP/12719/2021  
Our Ref : CI/TPD21003845/P

26<sup>th</sup> March 2021

**MECHANICAL INSPECTION REPORT OF MOTOR LORRY YM 8290L**

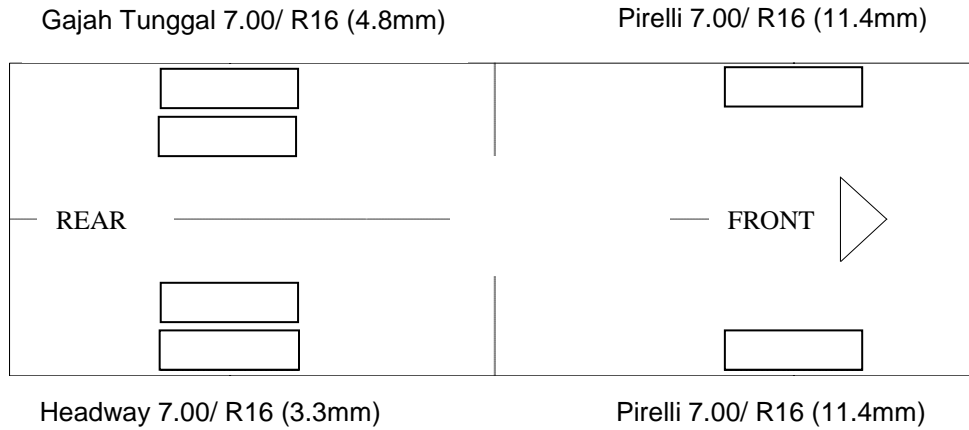
6. The 6 tyres of the Motor Lorry were observed to be in serviceable condition and sufficiently inflated for vehicular operation. I did not find any tear, cut or burst mark(s) on the outer and the inner sidewalls as well as across the tread of the 6 tyres. The tyre brand, tyre size and remaining tread depth of the 6 tyres of the Motor Lorry were recorded as follows:-
