Your Ref: TP/IP/12995/2021
Our Ref : CI/TPD21003847/P

12th April 2021

MECHANICAL INSPECTION REPORT OF MOTOR LORRY YP 9680Y

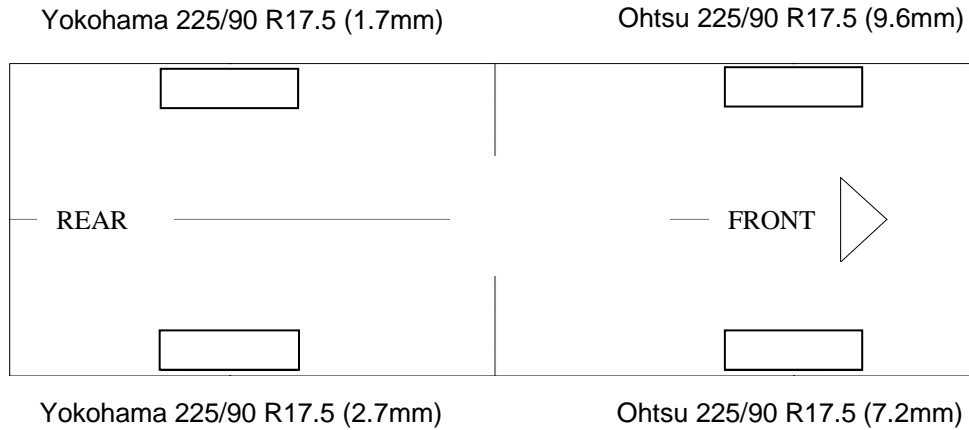
6. The 6 tyres of the Motor Lorry were observed to be in serviceable condition and sufficiently inflated for vehicular operation. I did not find any tear, cut or burst mark(s) on the outer and the inner sidewalls as well as across the tread of the 6 tyres. The tyre brand, tyre size and remaining tread depth of the 6 tyres of the Motor Lorry were recorded as follows:-
