Your Ref: TP/IP/12091/2021  
Our Ref : CI/TPD21003850/P

29<sup>th</sup> March 2021

**MECHANICAL INSPECTION REPORT OF MOTOR CAR SLF 8012P**

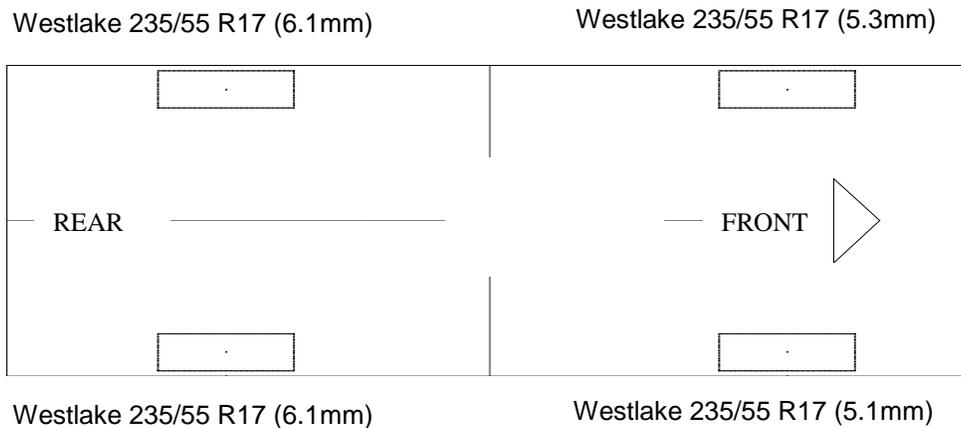
6. The 4 tyres of the Motor Car were observed to be in serviceable condition and sufficiently inflated for vehicular operation. I did not find any tear, cut or burst mark(s) on the outer and the inner sidewalls as well as across the tread of the 4 tyres. The tyre brand, tyre size and remaining tread depth of the 4 tyres of the Motor Car were recorded as follows:-
