Your Ref: TP/IP/47421/2020  
Our Ref : CI/TPD21004823/P

16<sup>th</sup> April 2021

**MECHANICAL INSPECTION REPORT OF MINI BUS PC 1879U**

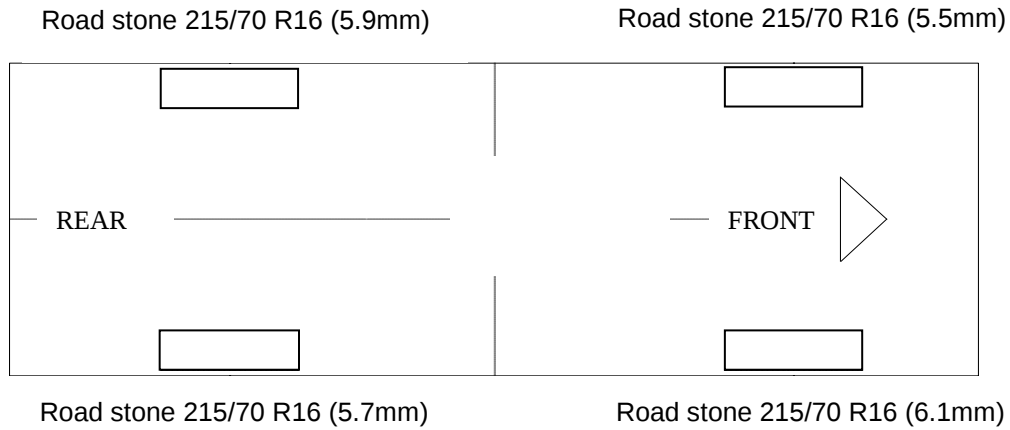
6. The 4 tyres of the Mini Bus were observed to be in serviceable condition and sufficiently inflated for vehicular operation. I did not find any tear, cut or burst mark(s) on the outer and the inner sidewalls as well as across the tread of the 4 tyres. The tyre brand, tyre size and remaining tread depth of the 4 tyres of the Mini Bus were recorded as follows:-
