Your Ref: TP/IP/02429/2021
Our Ref : CI/TPD21004896/P

Fatal Accident Investigation Team

MECHANICAL INSPECTION REPORT OF MOTOR CAR SGG 349A

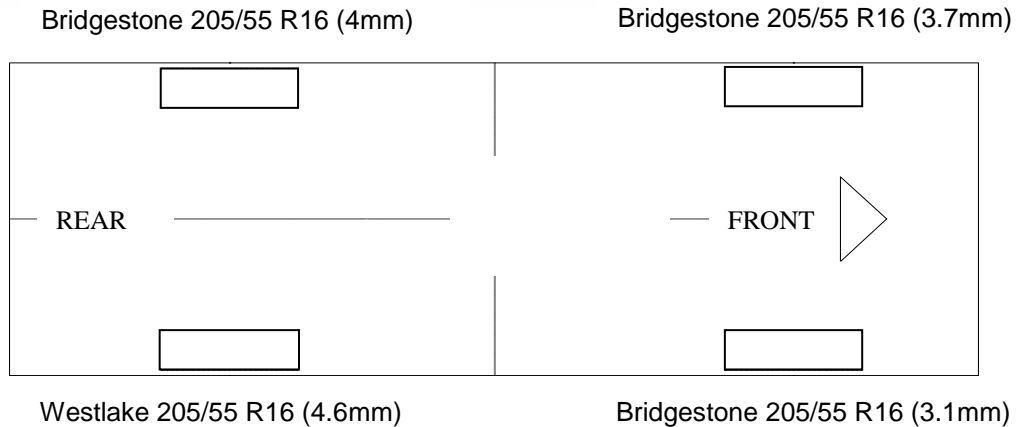
6. The condition of the Motor Car's 4 tyres was observed to be in serviceable condition. The 4 tyres were also observed to be sufficiently inflated for vehicular operation. I did not find any tear, cut or burst mark(s) on the outer and the inner sidewalls as well as across the tread of the 4 tyres. The tyre brand, tyre size and remaining tread depth of the 4 tyres were recorded as follows:-
