Your Ref: TP/IP/15481/2021
Our Ref : CI/TPD21004898/P

18th May 2021

MECHANICAL INSPECTION REPORT OF MOTOR VAN GBD 5545S

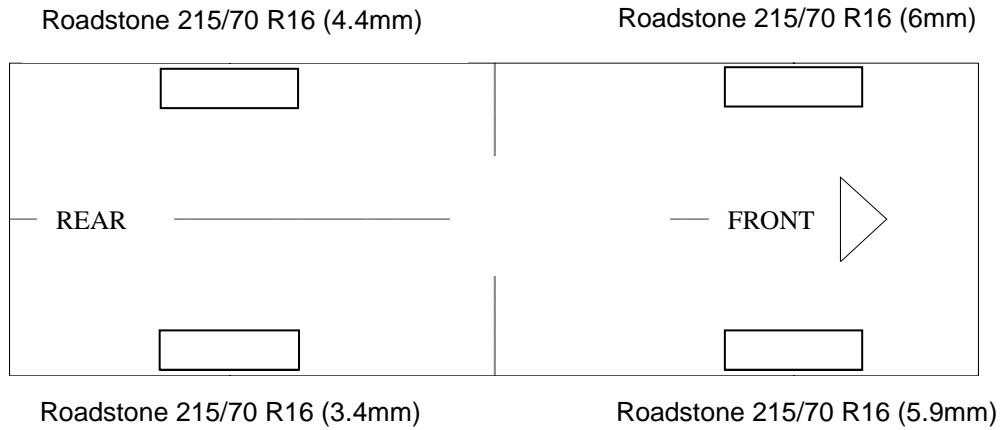
6. The 4 tyres of the Motor Van were observed to be in serviceable condition and sufficiently inflated for vehicular operation. I did not find any tear, cut or burst mark(s) on the outer and the inner sidewalls as well as across the tread of the 4 tyres. The tyre brand, tyre size and remaining tread depth of the 4 tyres of the Motor Van were recorded as follows:-
