Your Ref: TP/IP/10545/2021  
Our Ref : CI/TPD21005747/P

**Fatal Accident Investigation Team**

**MECHANICAL INSPECTION REPORT OF MOTOR LORRY GBD 4265G**

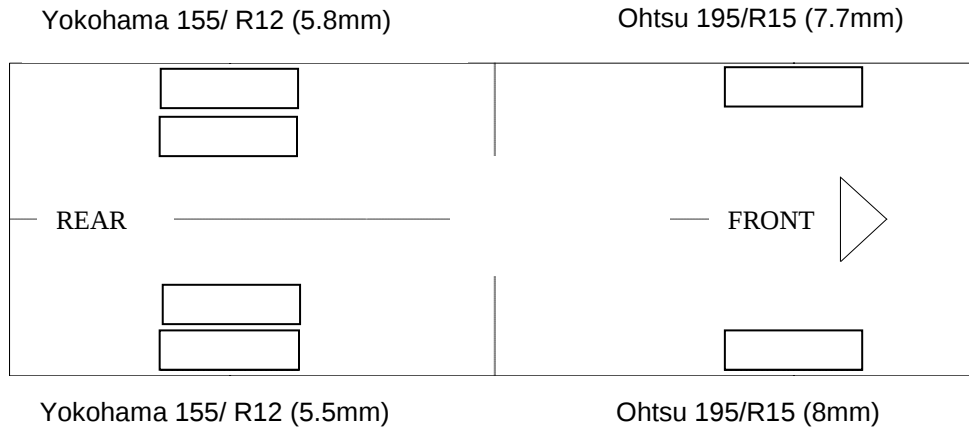
6. The 6 tyres of the Motor Lorry were observed to be in serviceable condition and sufficiently inflated for vehicular operation. I did not find any tear, cut or burst mark(s) on the outer and the inner sidewalls as well as across the tread of the 6 tyres. The tyre brand, tyre size and remaining tread depth of the 6 tyres of the Motor Lorry were recorded as follows:-
