Your Ref: S1M03A1Q
Our Ref : CS4/ASM21005793/P

25th May 2021

TECHNICAL INVESTIGATION REPORT OF FIRE INCIDENT INVOLVING THE INSURED VEHICLE SMY 4982D ON 11th May 2021

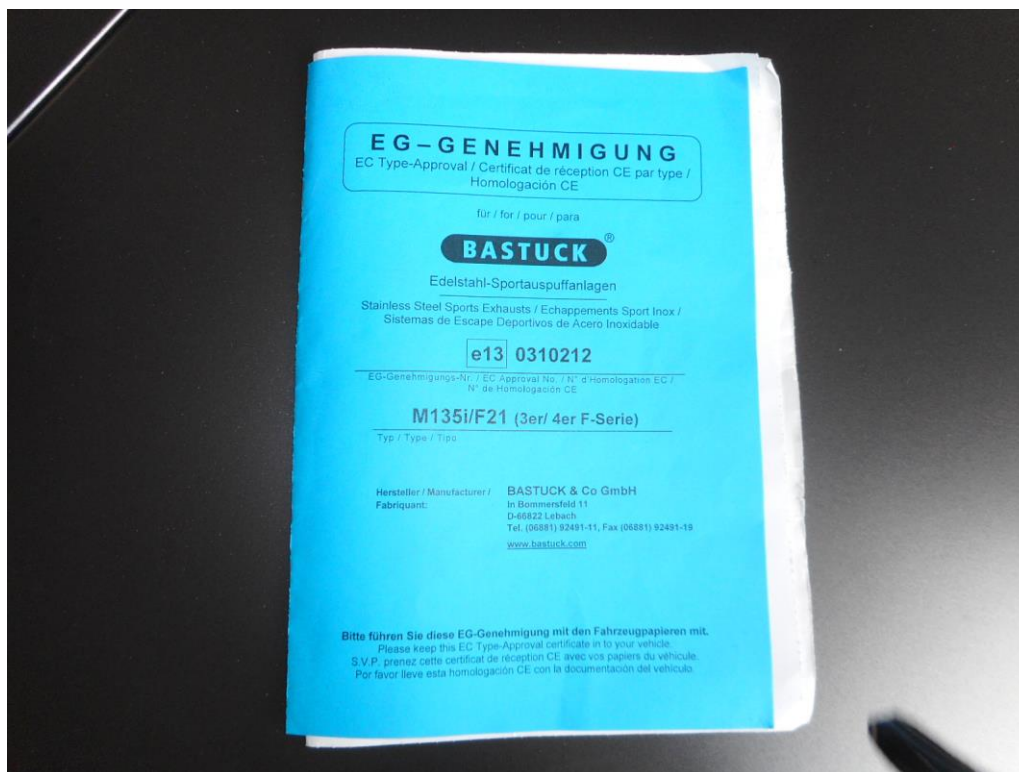
Photo 26 shows an aftermarket exhaust system certification booklet of the Insured Vehicle at the material time.

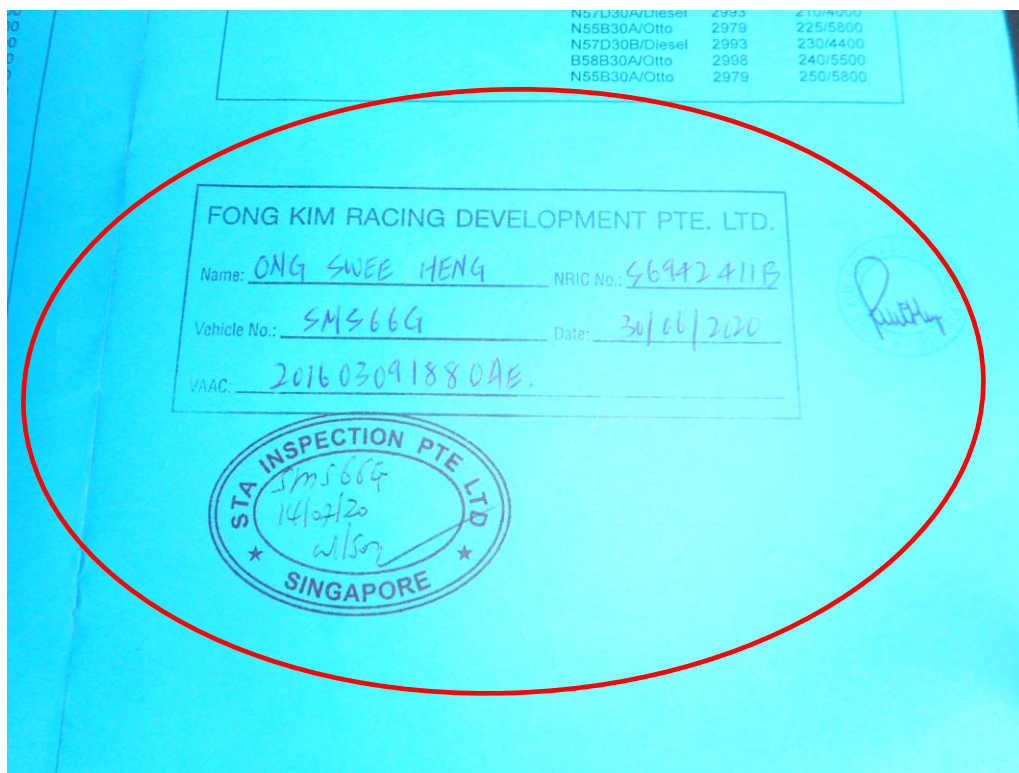
Photo 27 shows an aftermarket exhaust system certification booklet with the previous owner's number plate and the stamp of approval from LTA inspection centre (circled) on the Insured Vehicle at the material time.

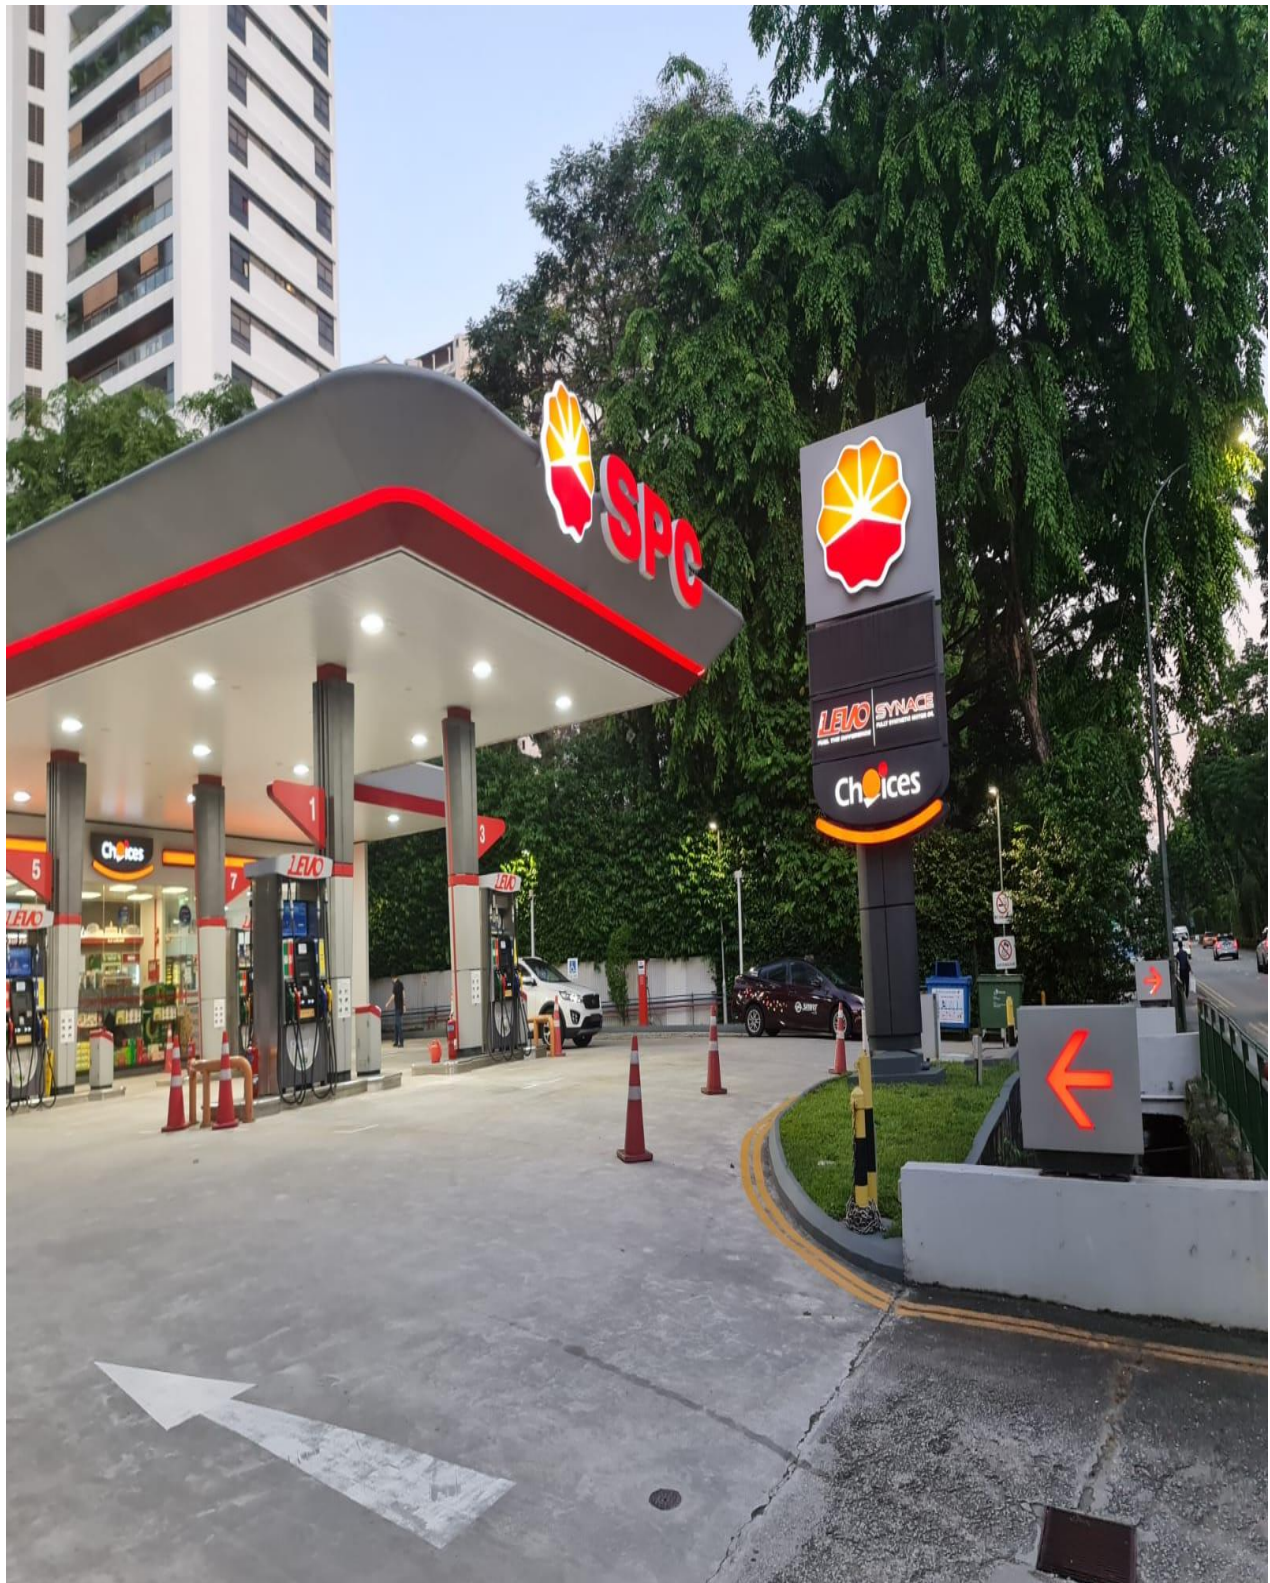
Photo 34 shows the petrol kiosk that Mr Harrison had drove in and stopped the Insured Vehicle at. In general, the information that could be gathered from this photograph had corresponded to the events that were related to us by Mr Harrison, location when the fire broke out.

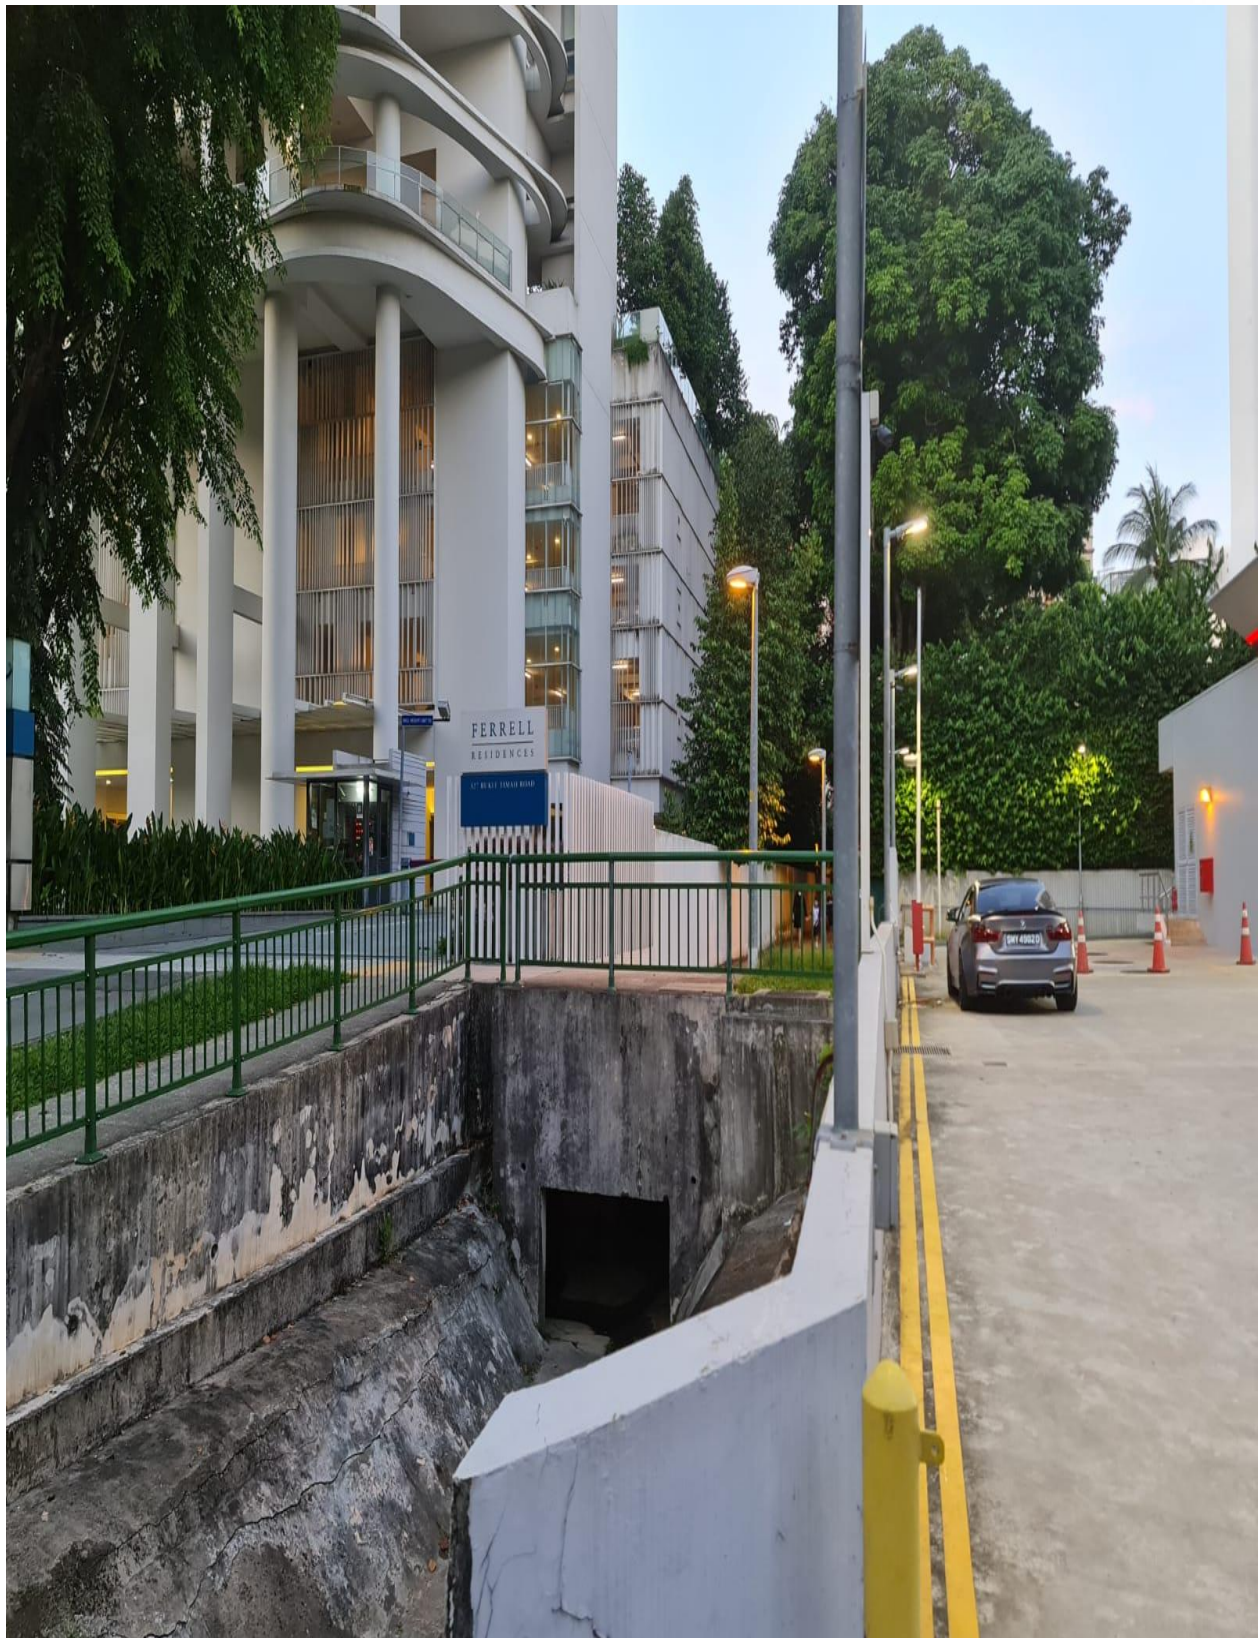
Photo 35 shows the petrol kiosk that Mr Harrison had drove in and stopped the Insured Vehicle at. In general, the information that could be gathered from this photograph had corresponded to the events that were related to us by Mr Harrison, location when the fire broke out.
