## REFERENCES

| Third party vehicle | : SLZ8831L | Date of Accident | : 30/11/2020 |

| Model / Make | : Mazda 3 | Pre-accident damage | : NIL |

## DESCRIPTION OF DAMAGE

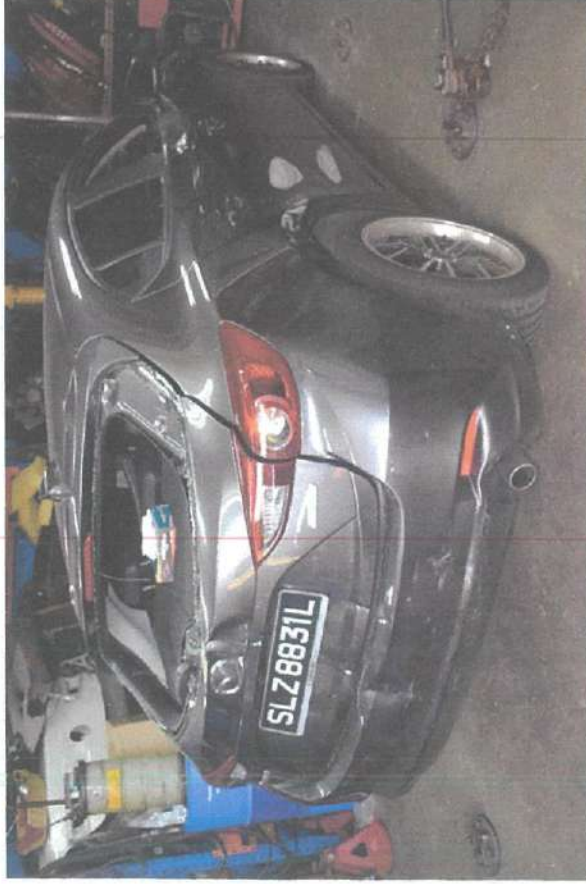
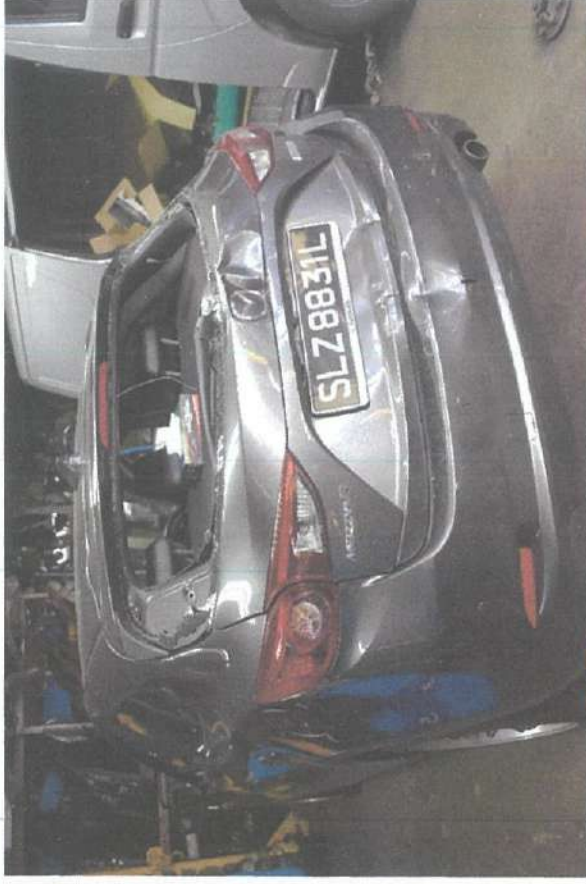
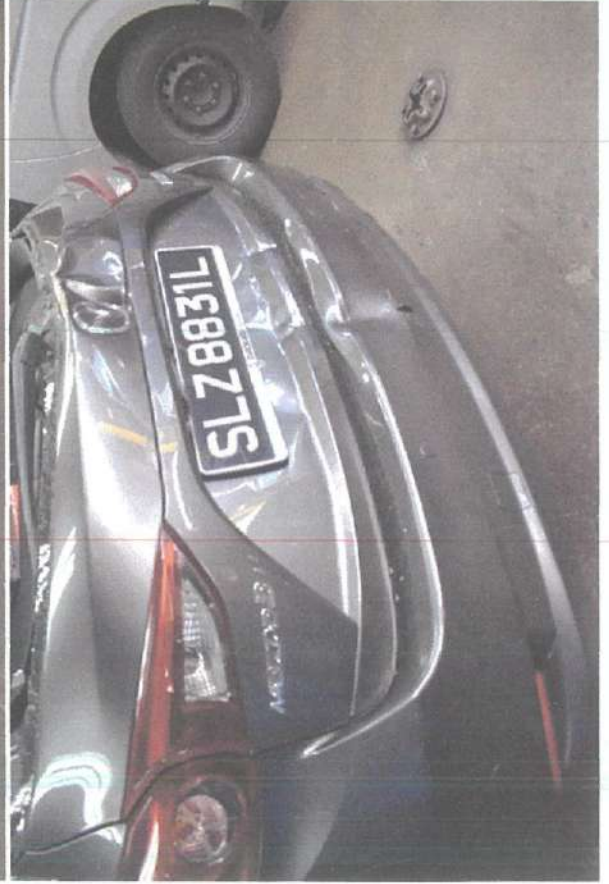
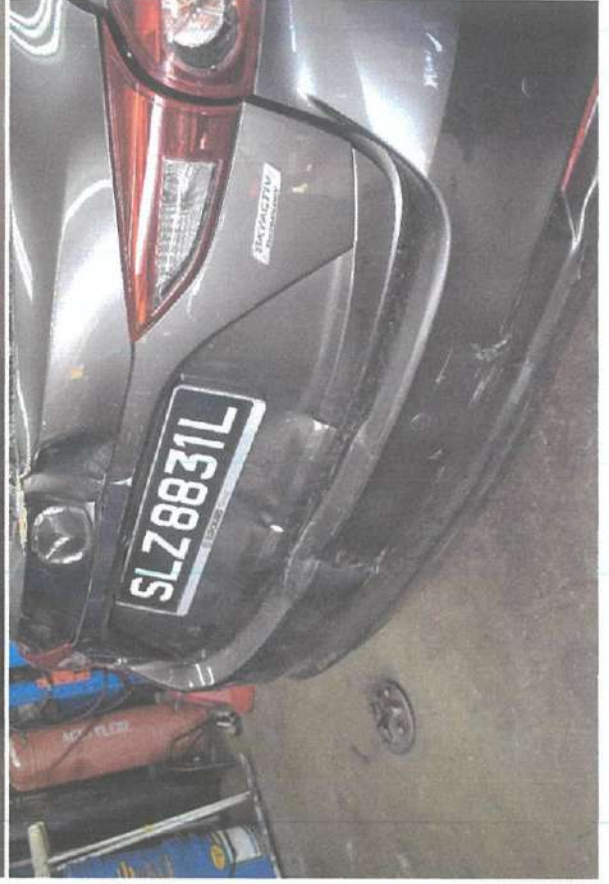
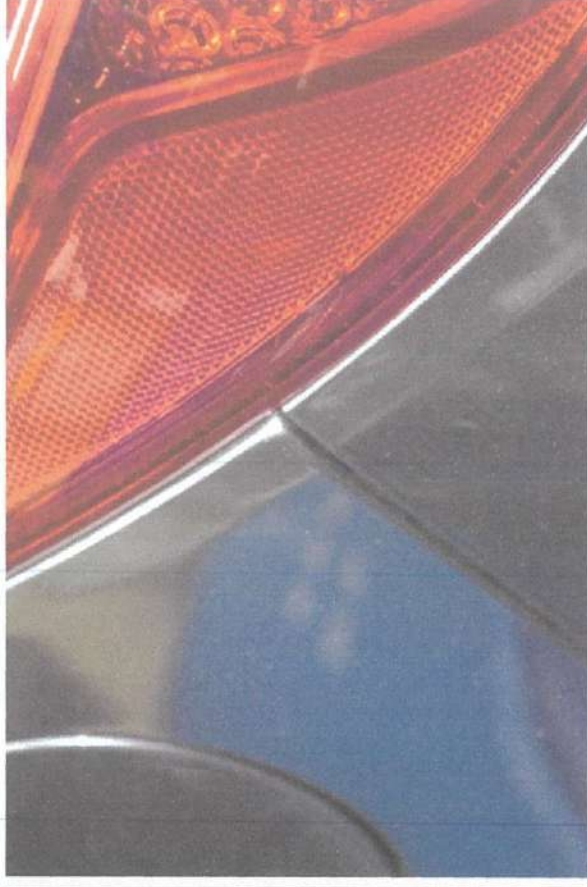
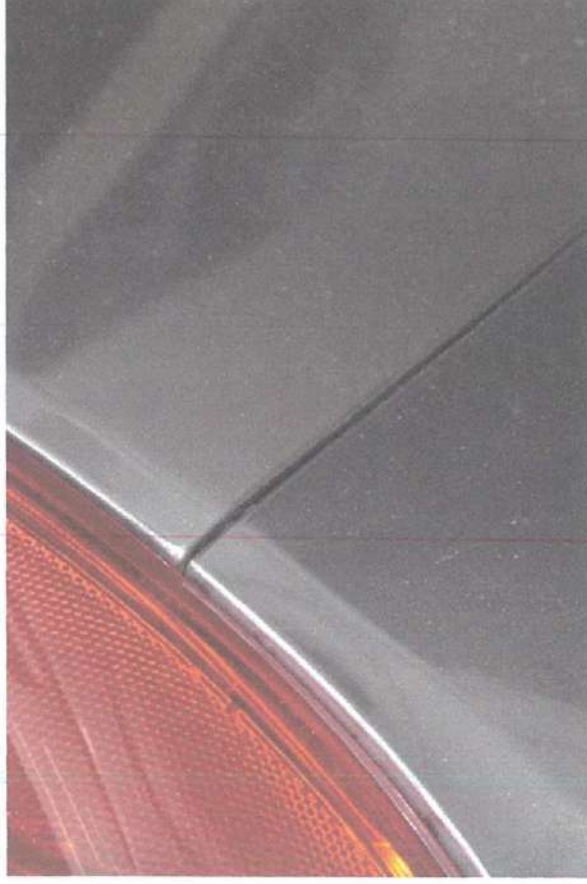
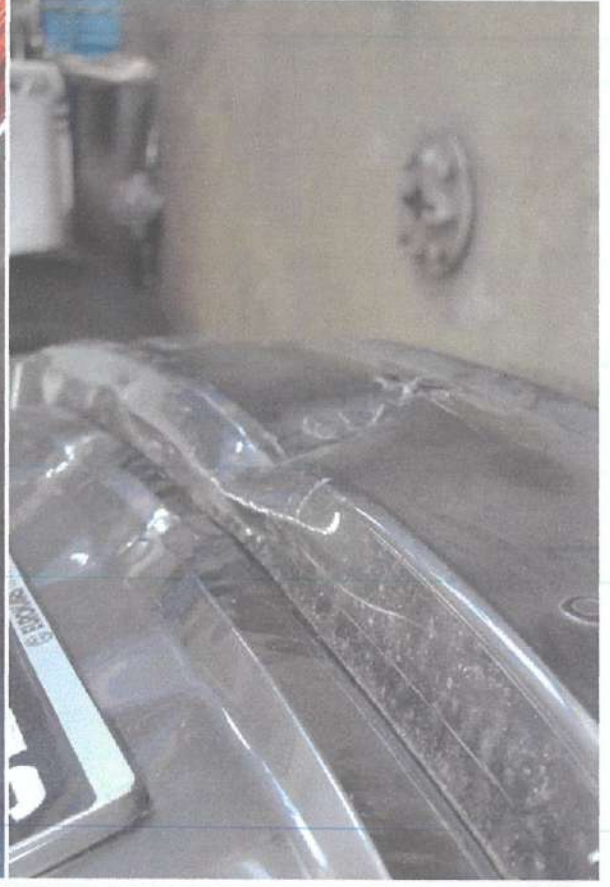
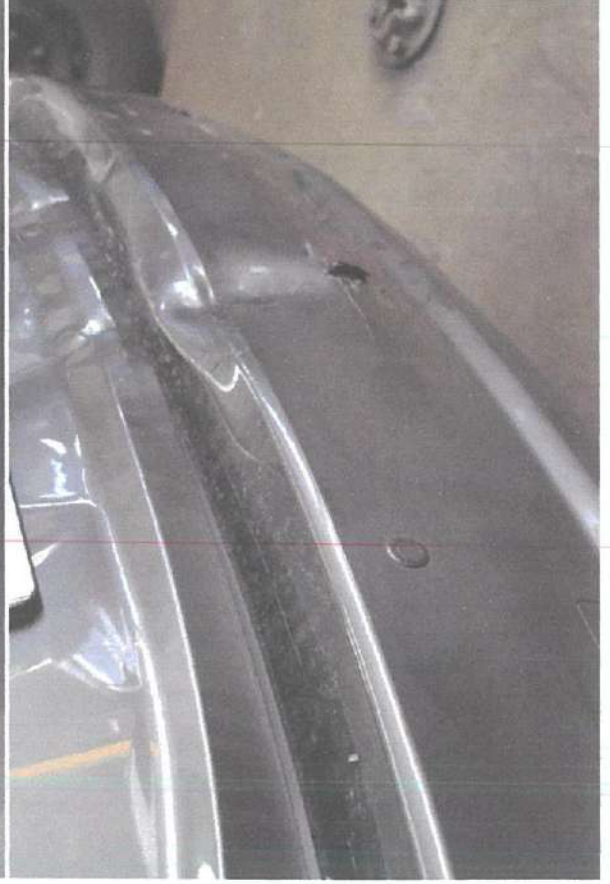
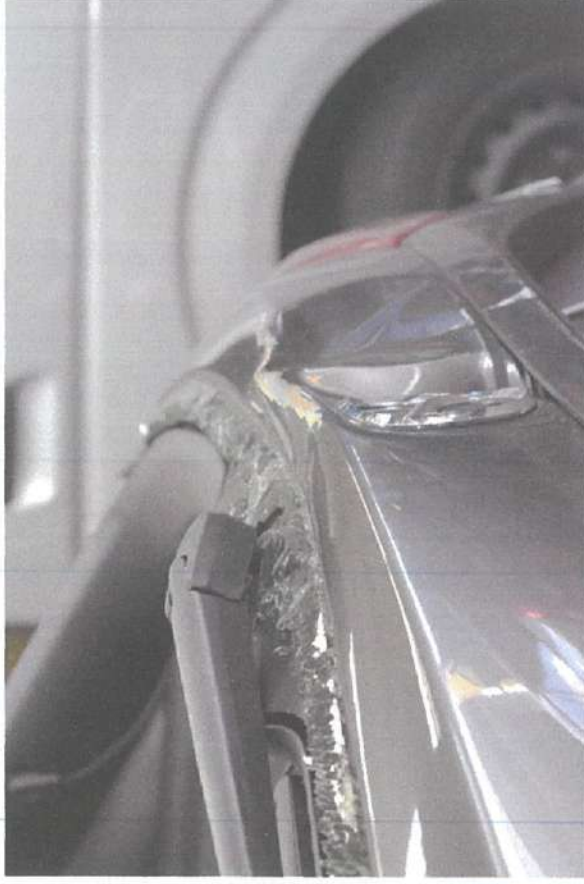
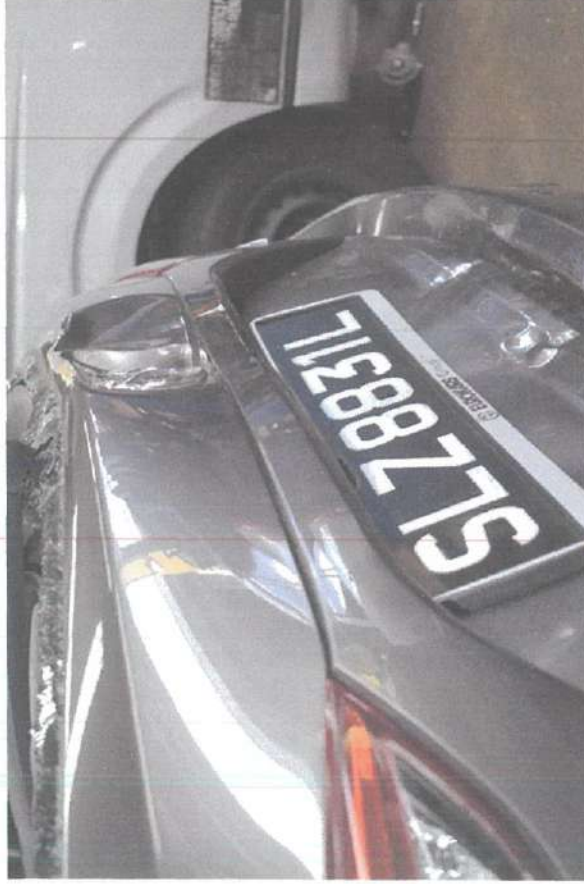
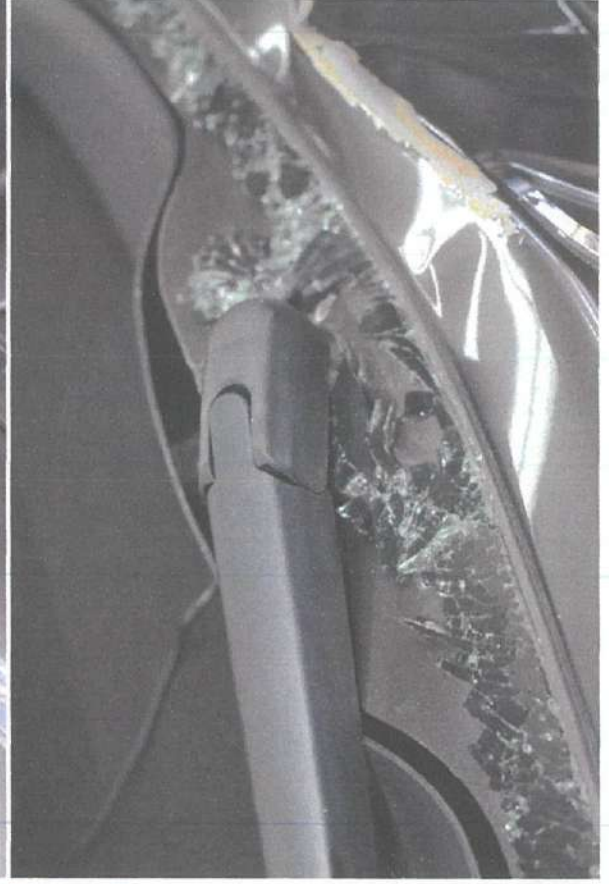
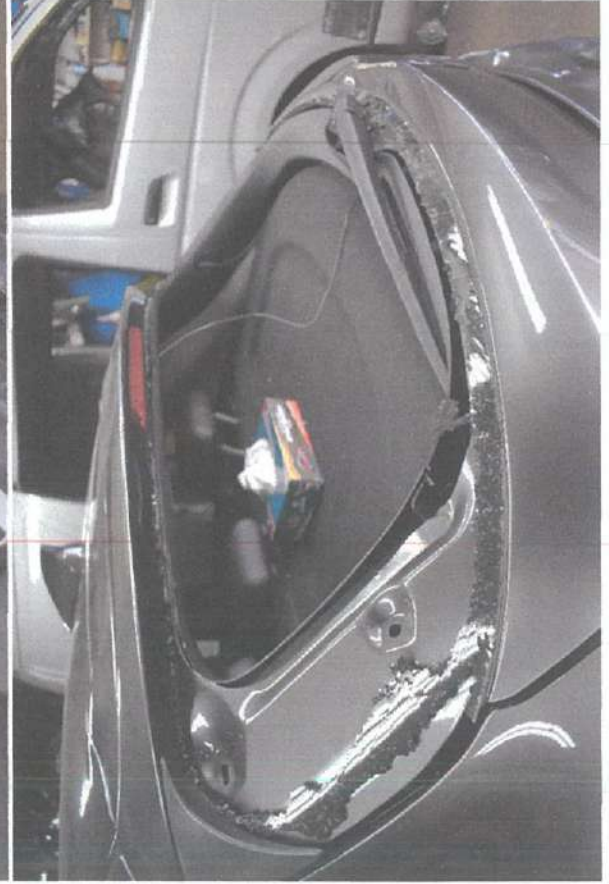
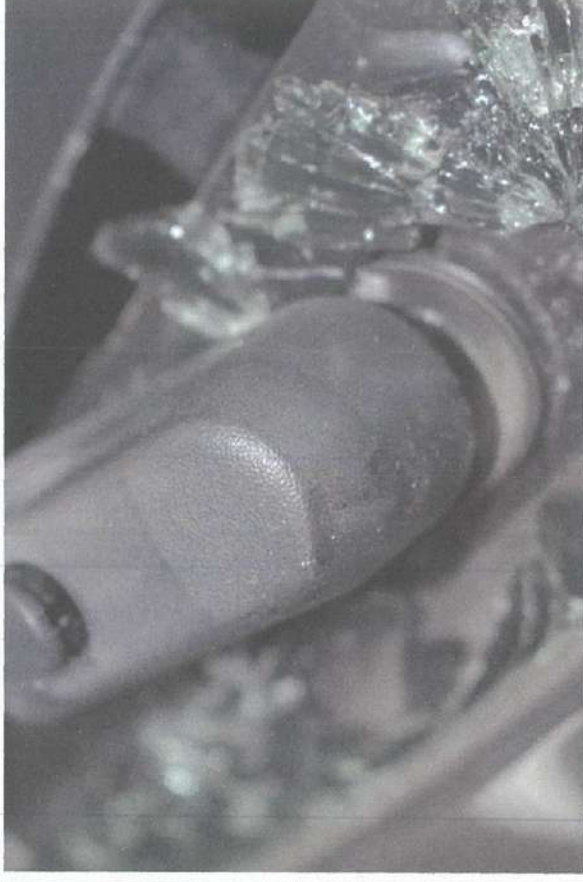
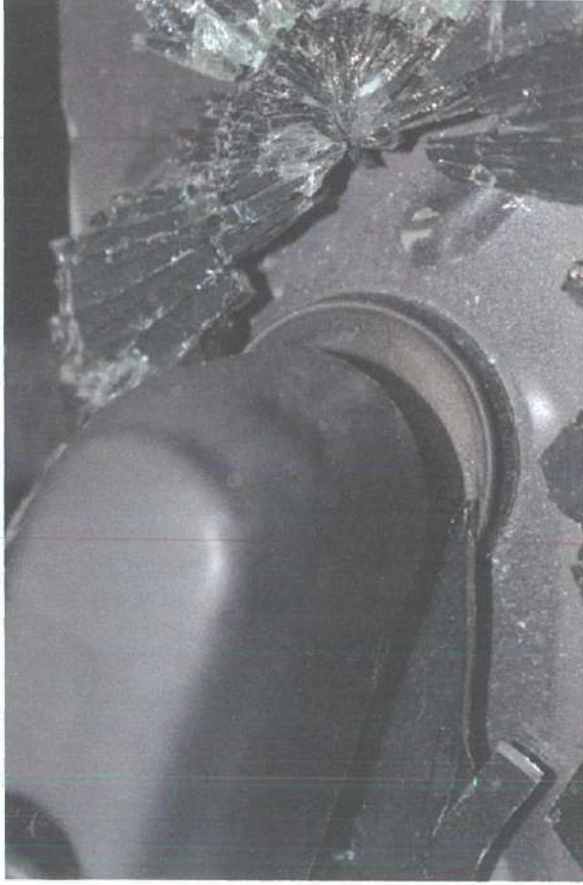
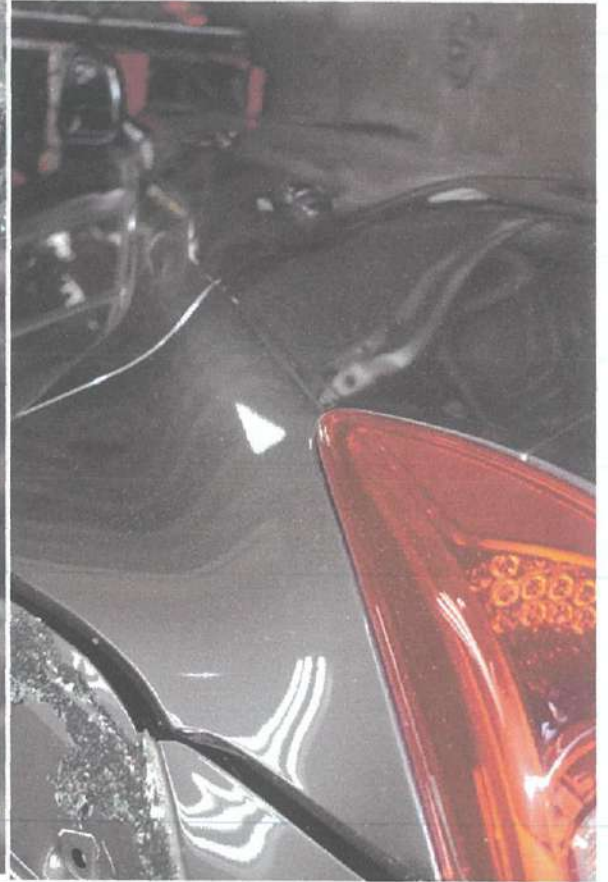
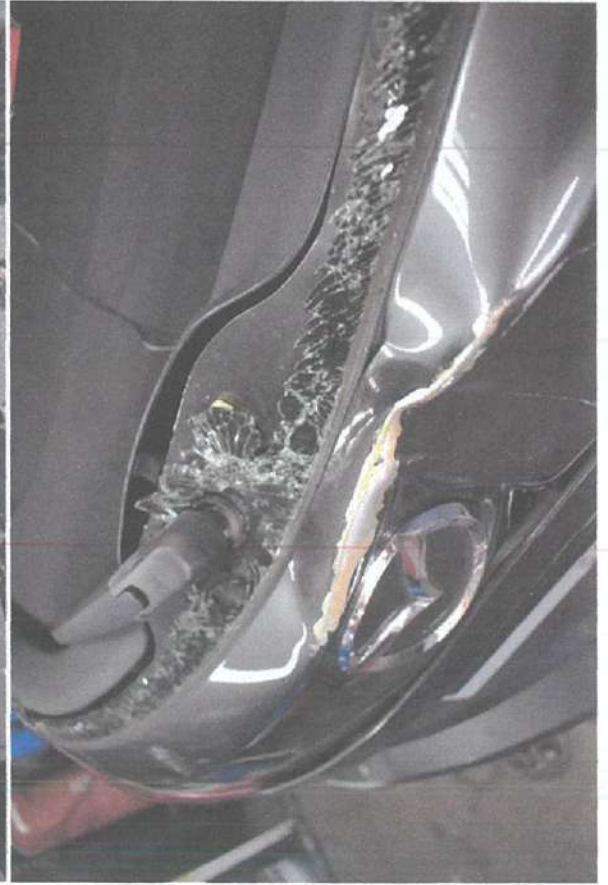
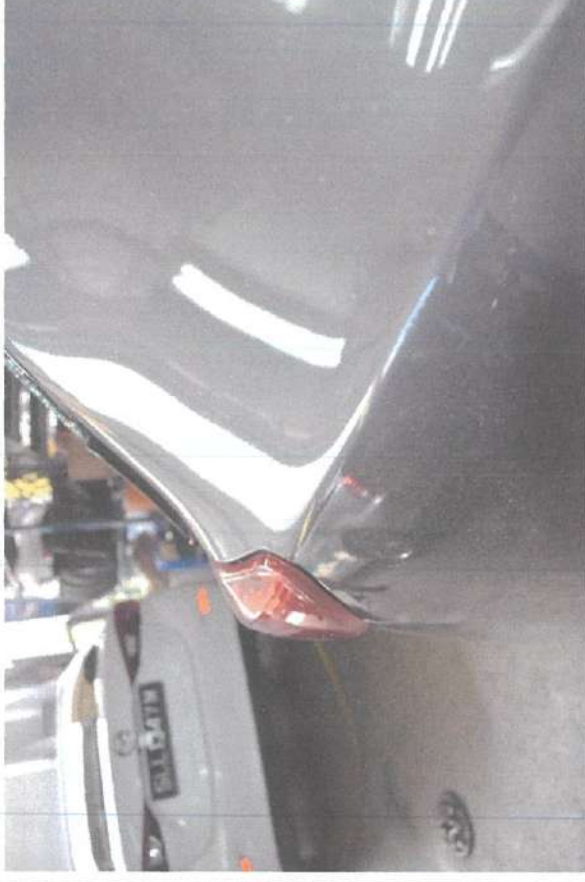
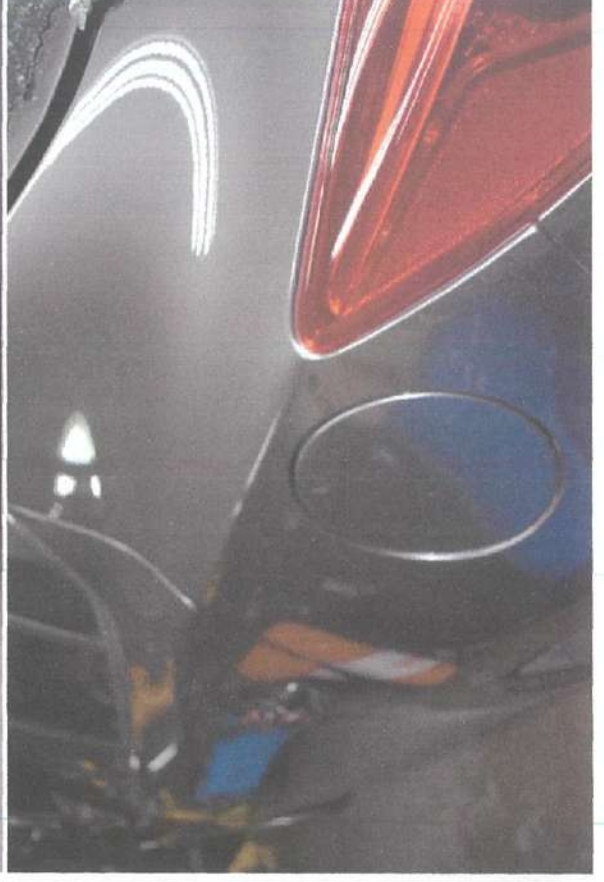
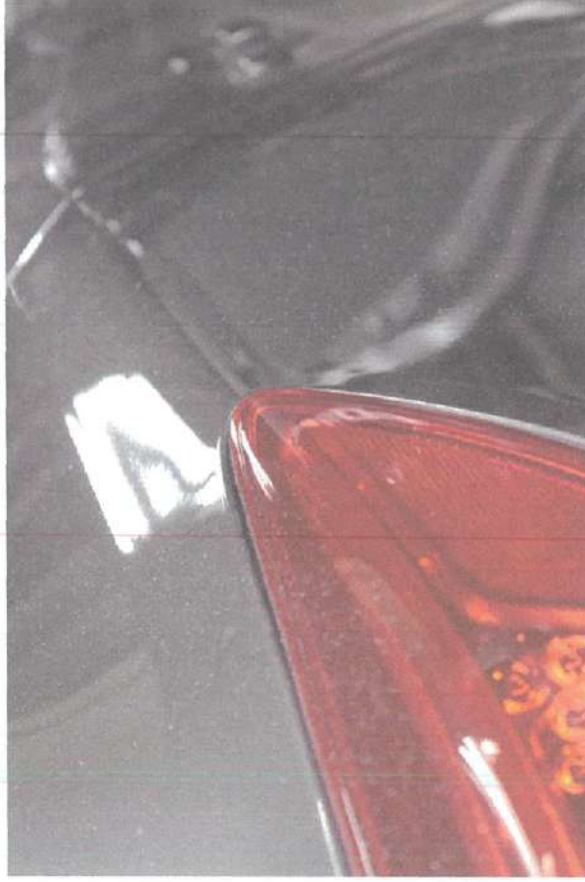
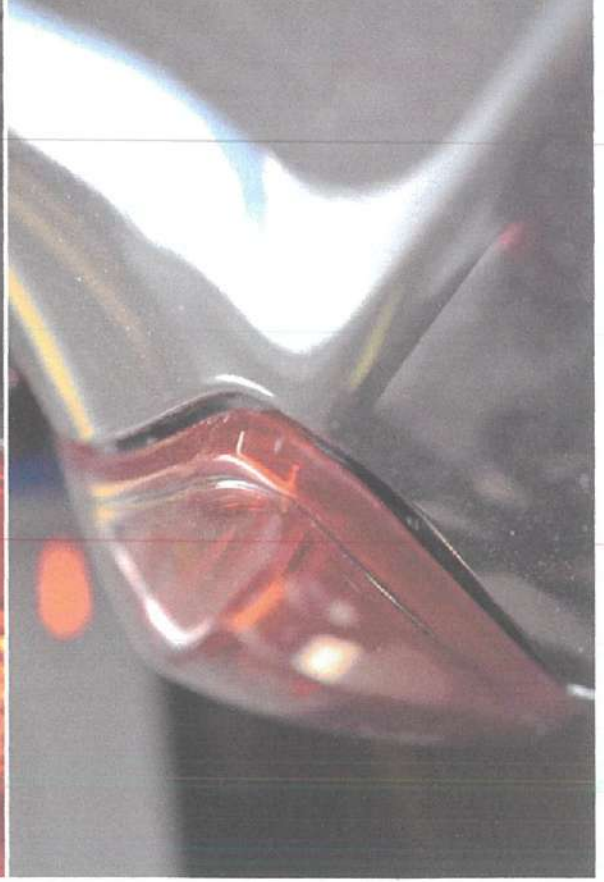
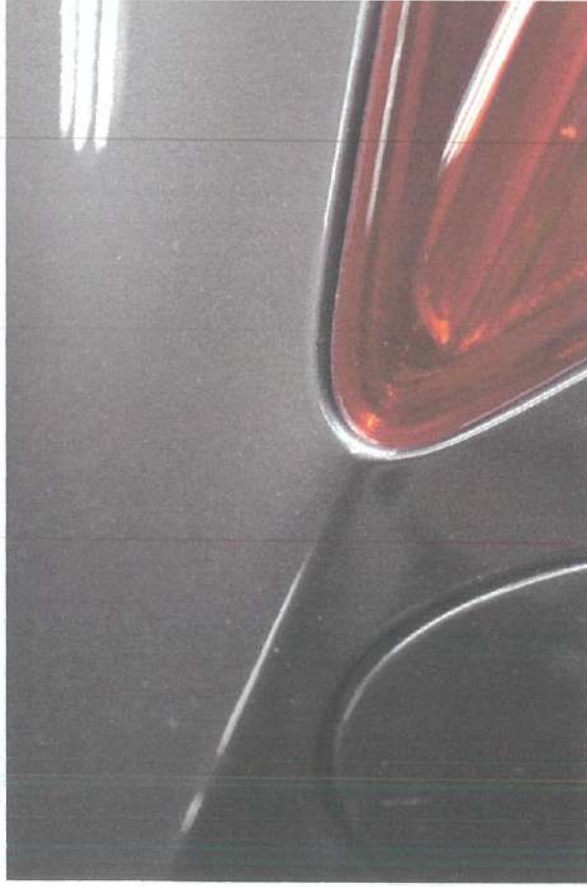
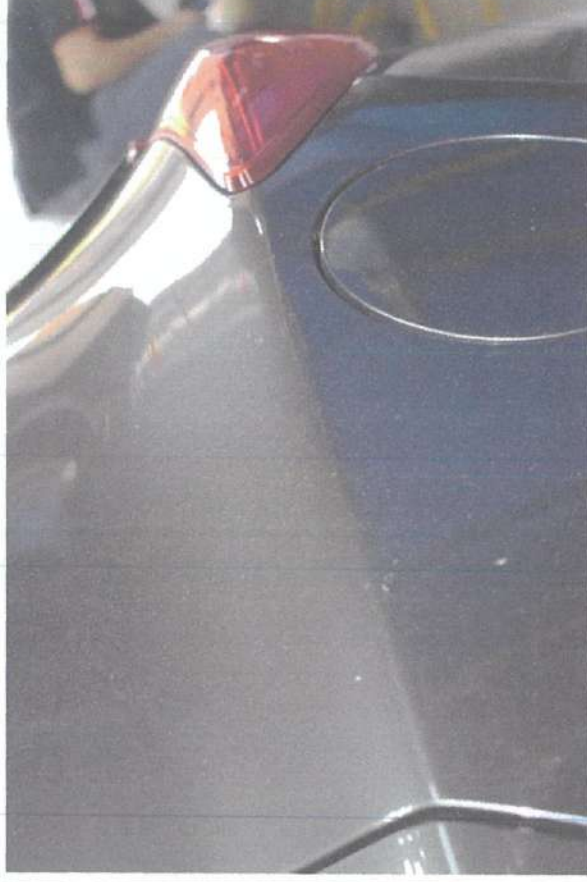
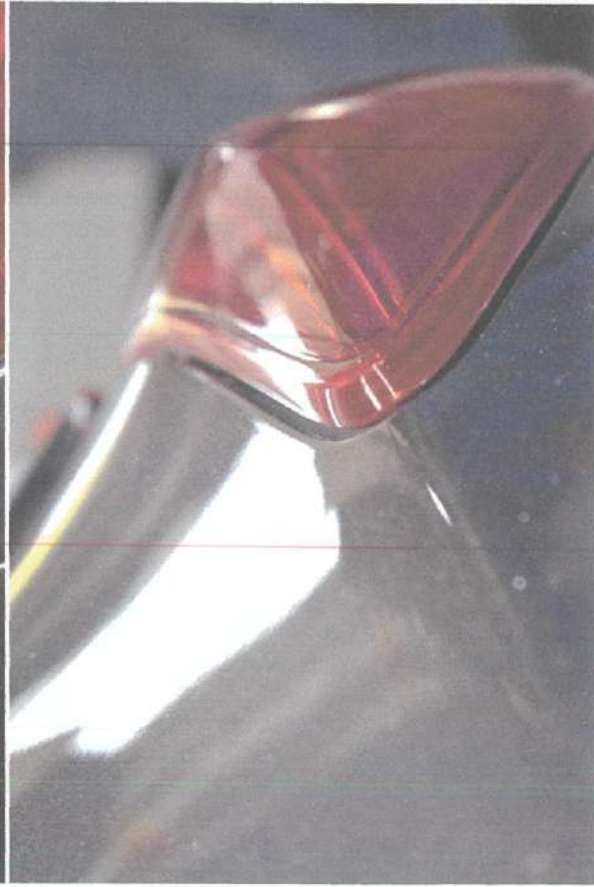
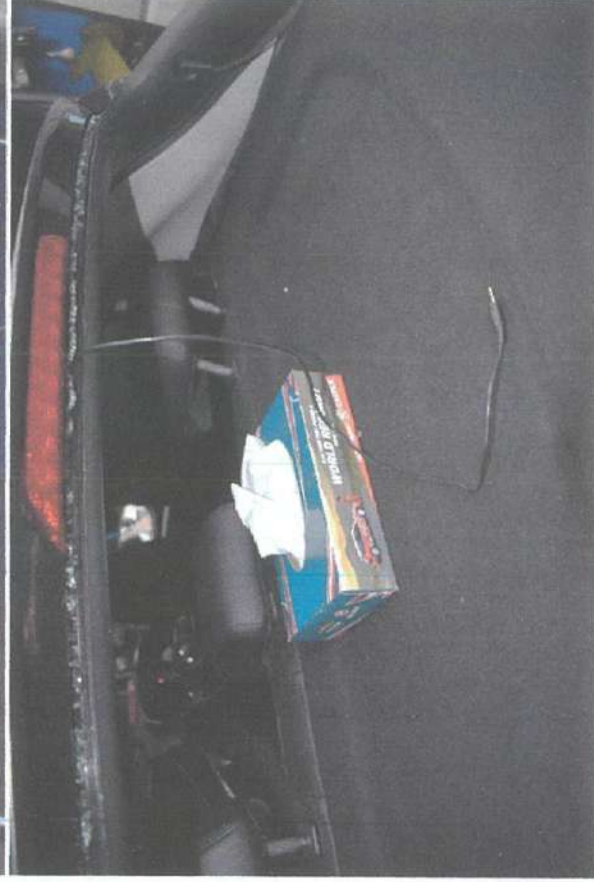
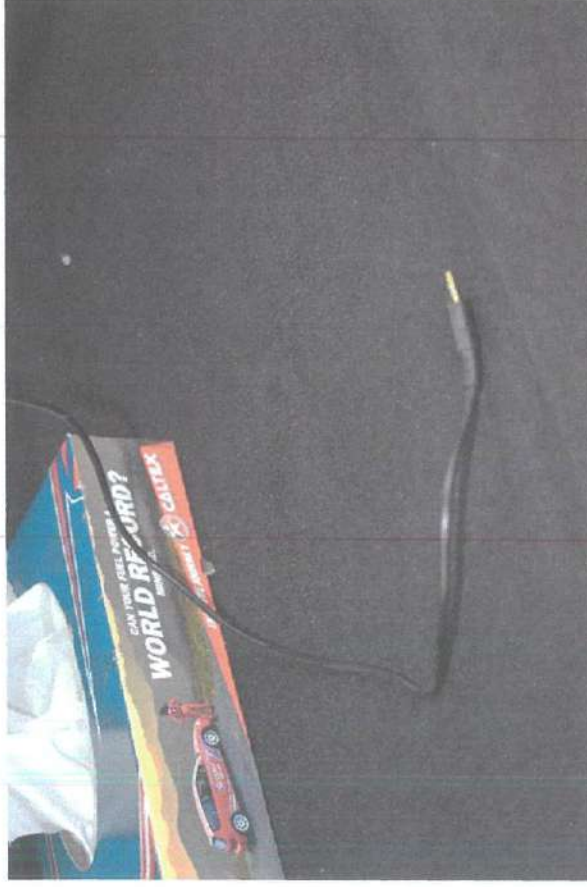
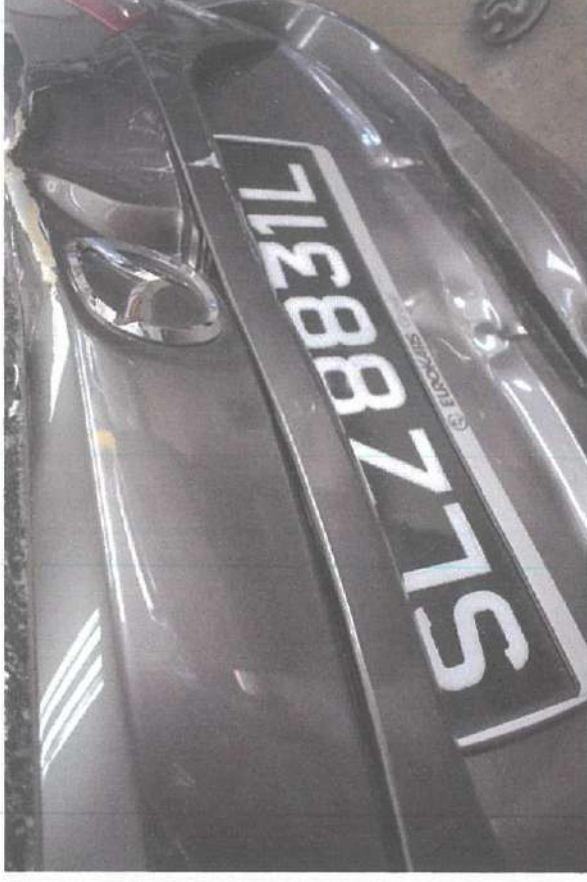
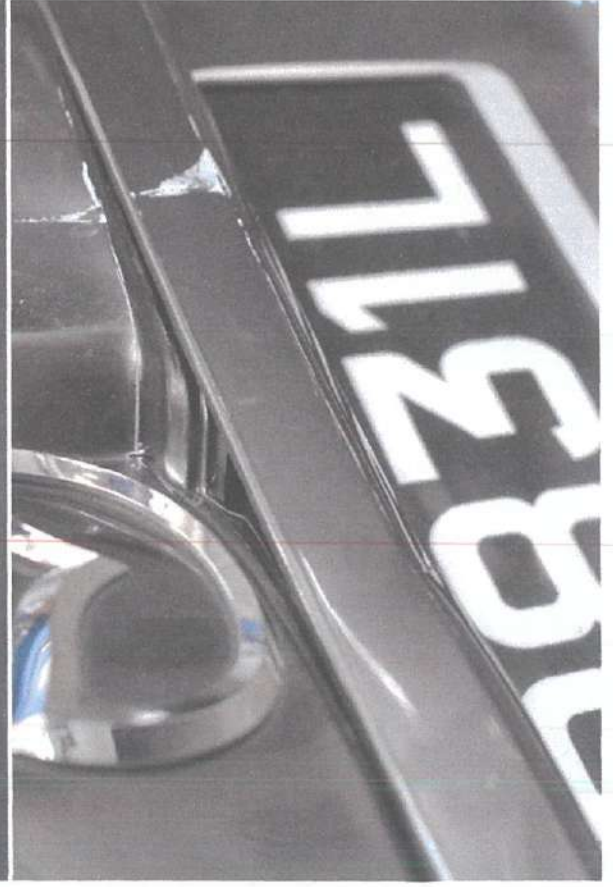
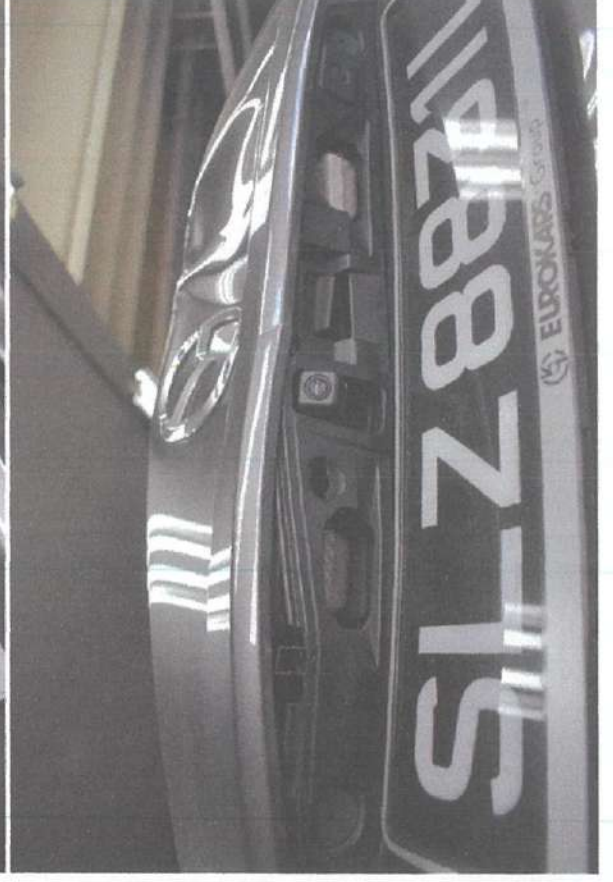
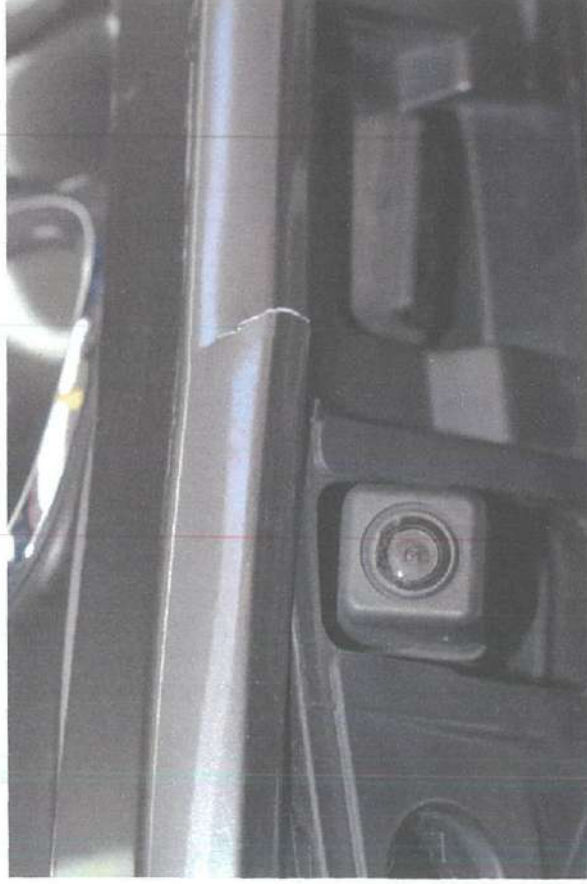
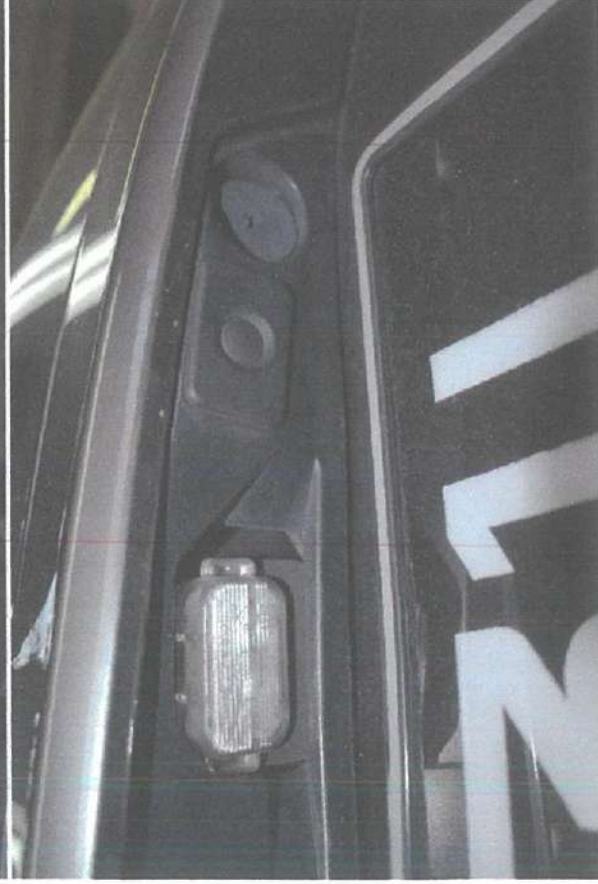
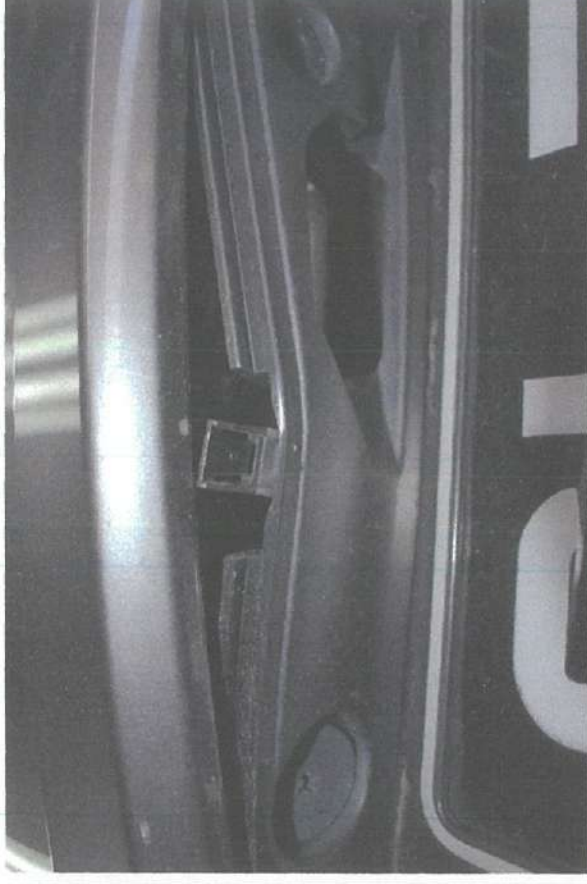
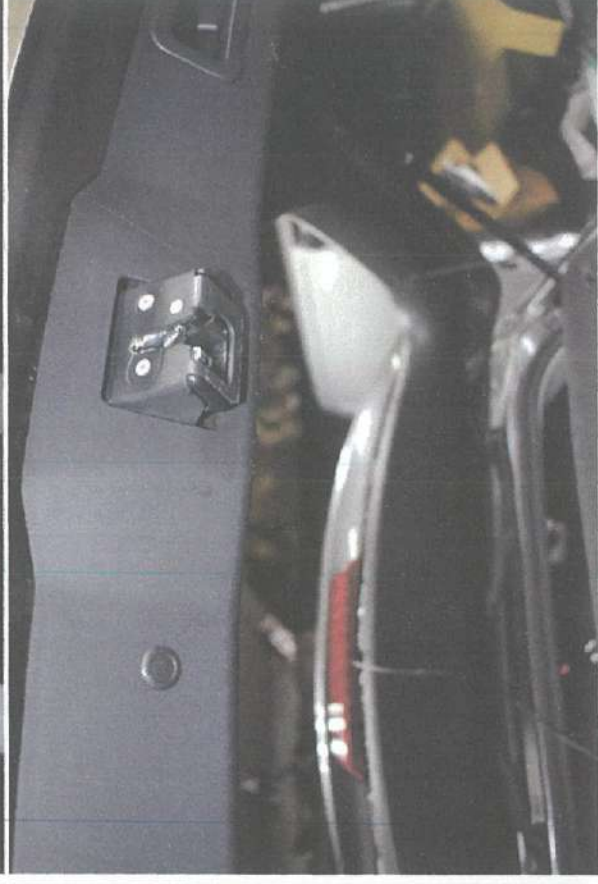
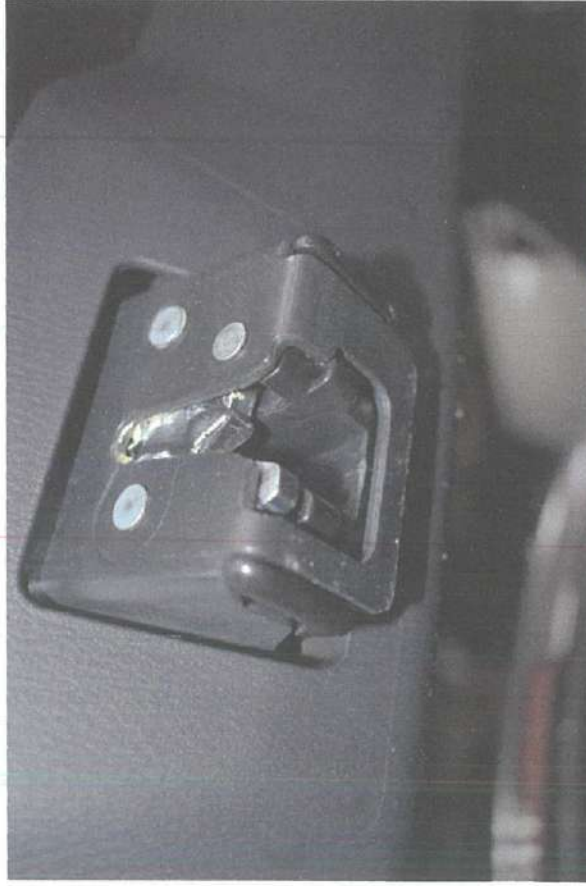
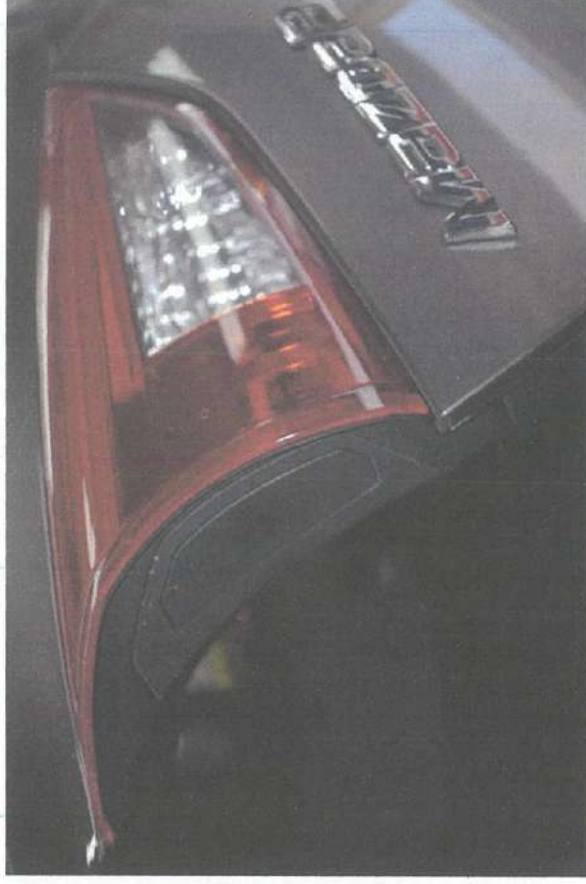
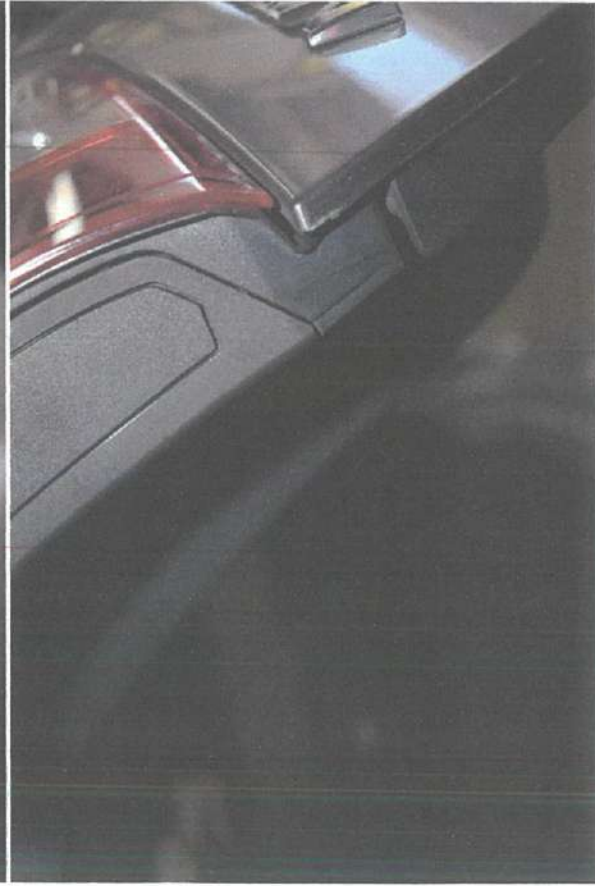
At the time of inspection, this vehicle sustained damages to the **Rear portion**.

Rear bumper, tailgate, rear end panel dented. Rear windscreen glass shattered, Taillamp, tailgate reflector base crack etc.

The workshop has agreed to undertake the repair on a Lump Sum Basis, and/or use of ex-stock/reconditioned parts whichever is possible (having taken into consideration to repair instead of replacements).

Under normal circumstances, the repair period would be about **11** working days.
