VEHICLE APPRAISAL REPORT

Registration No.	: SMS 4222X	Chassis Frame No.	: ZWR800421090
Make / Model	: Toyota Noah Hybrid 7-Seater 1.8X CVT	Engine No. (Logcard)	: 2ZR2F79252
Year of Manufacture/Reg	: 2019	Odometer Reading	: 83,551 KM
Colour	: Black		
Class / Type	: MPV

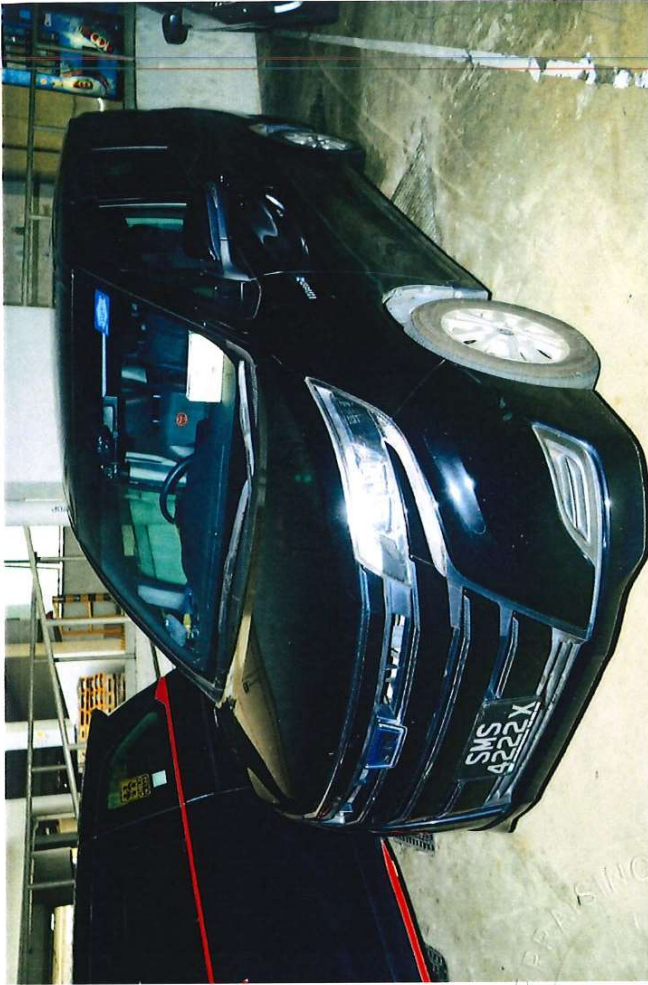
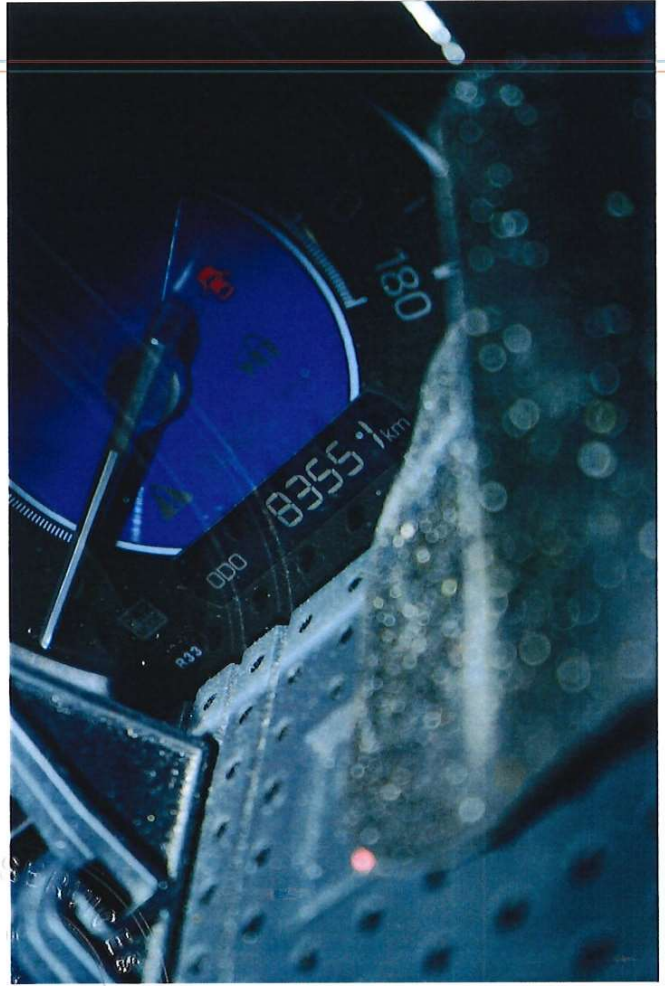
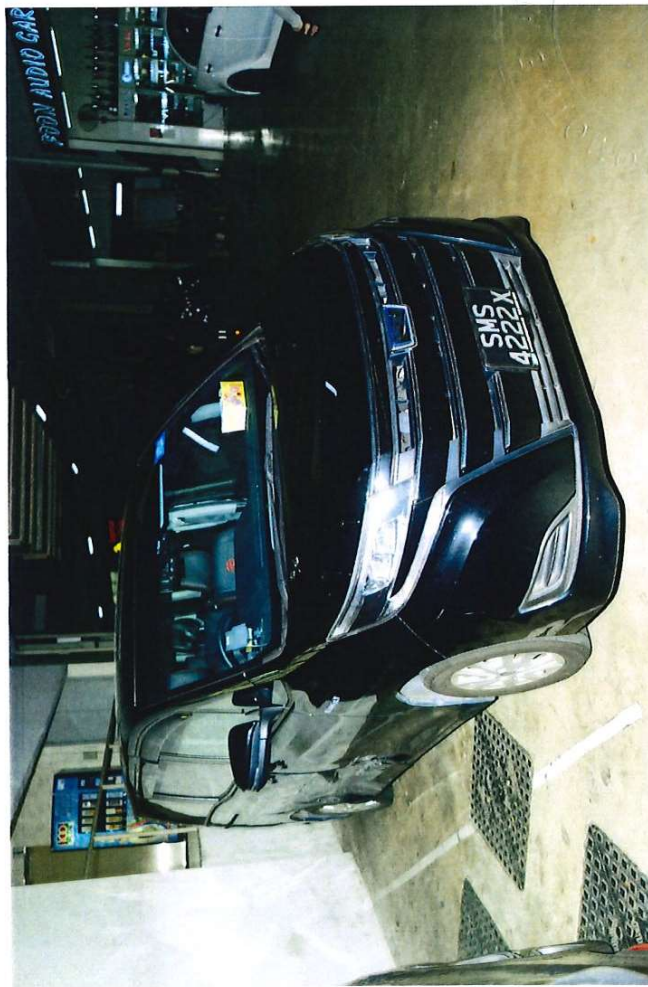
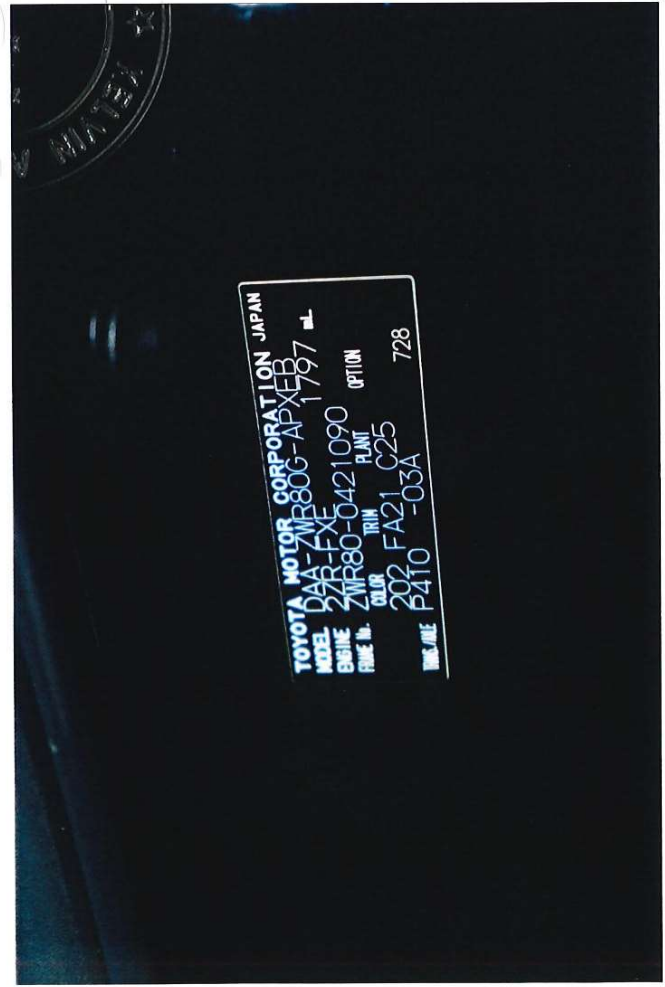
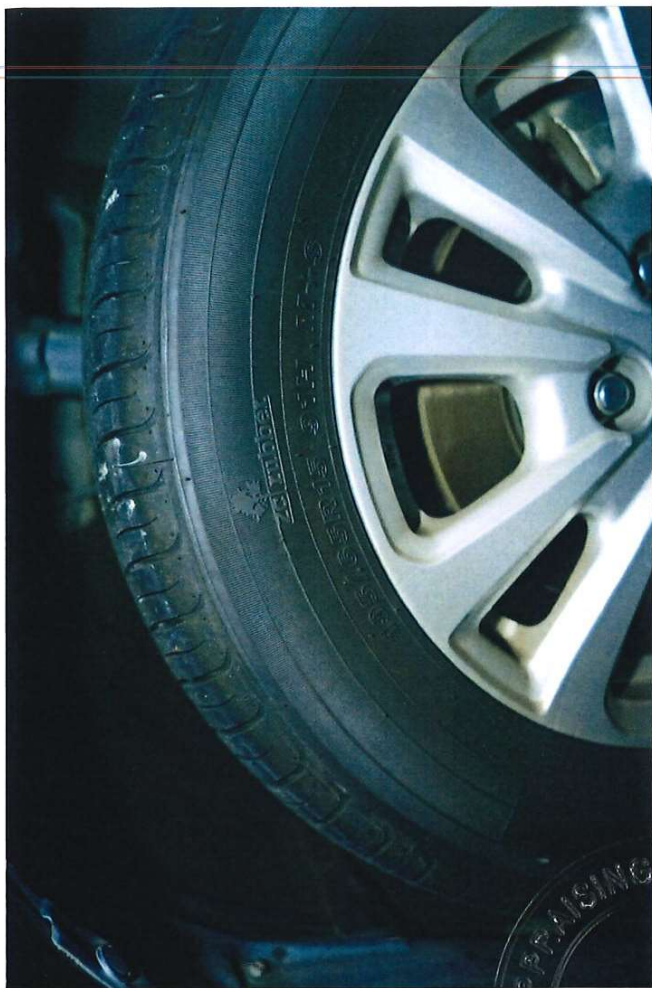
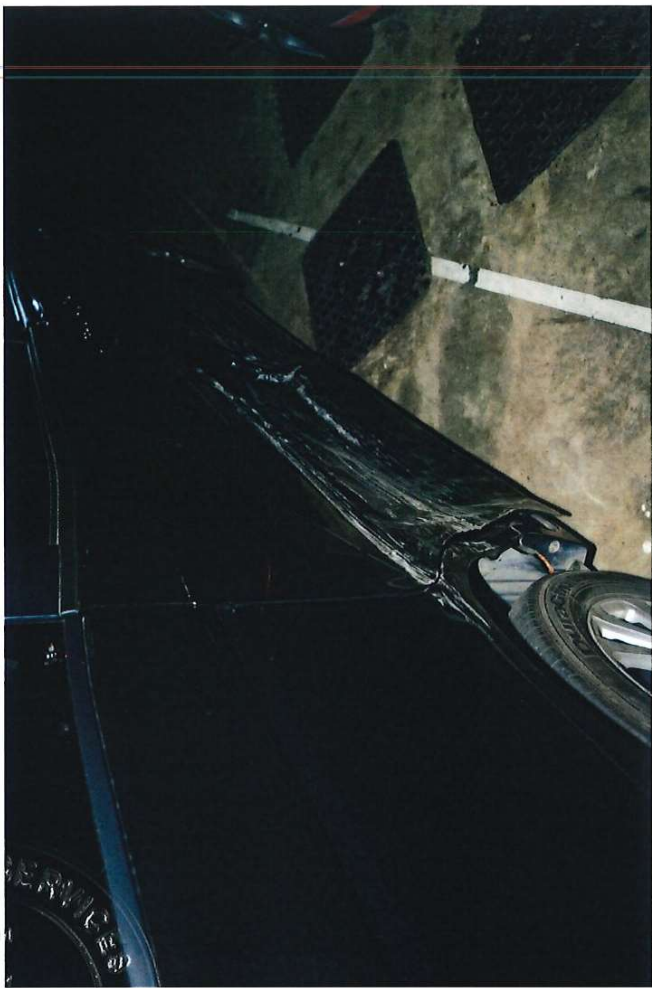
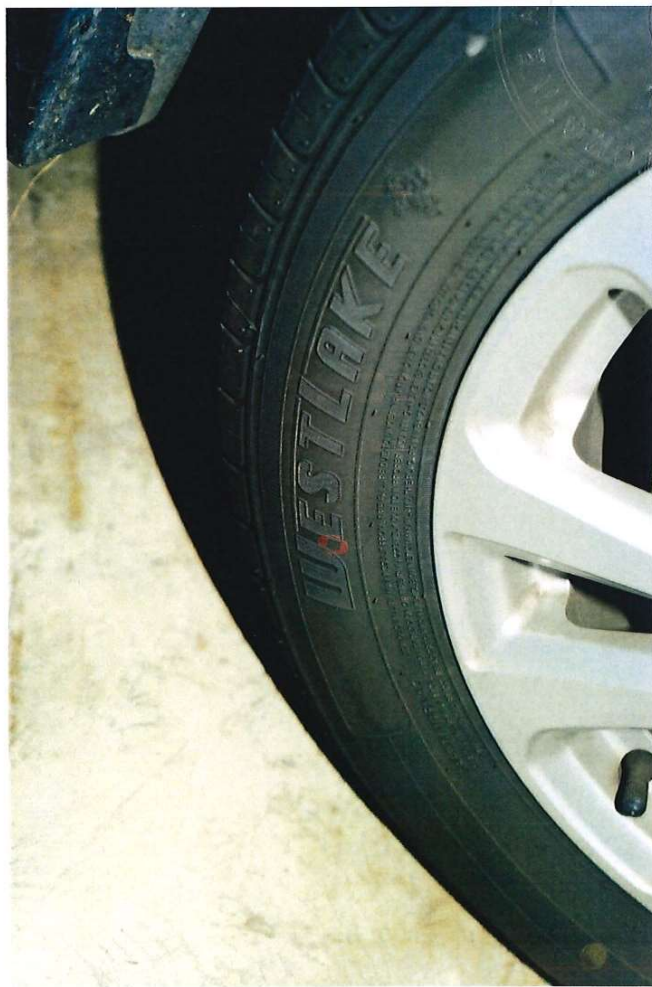
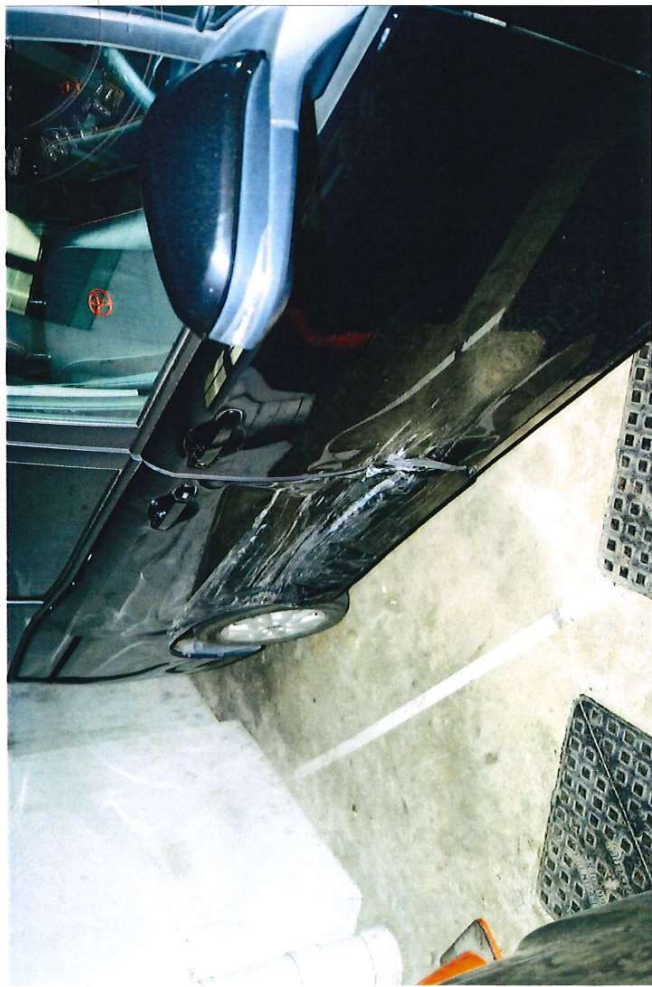
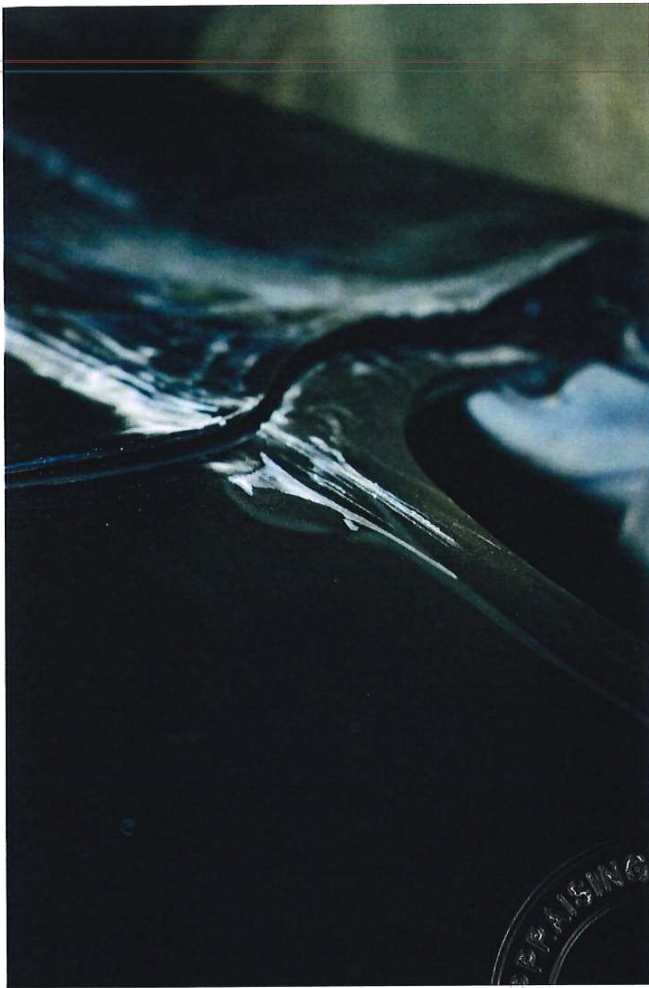
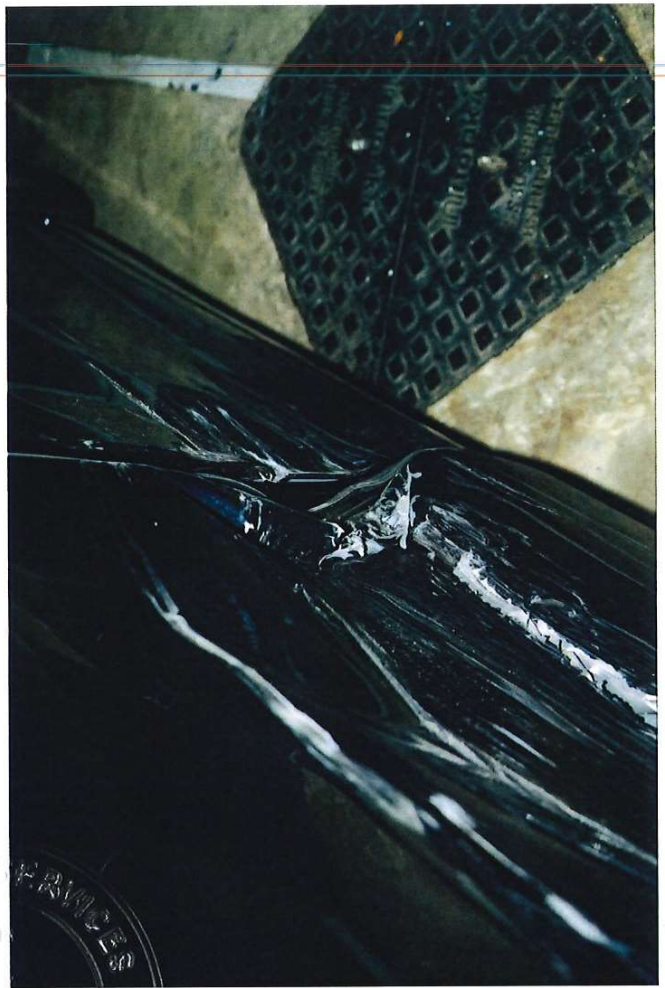
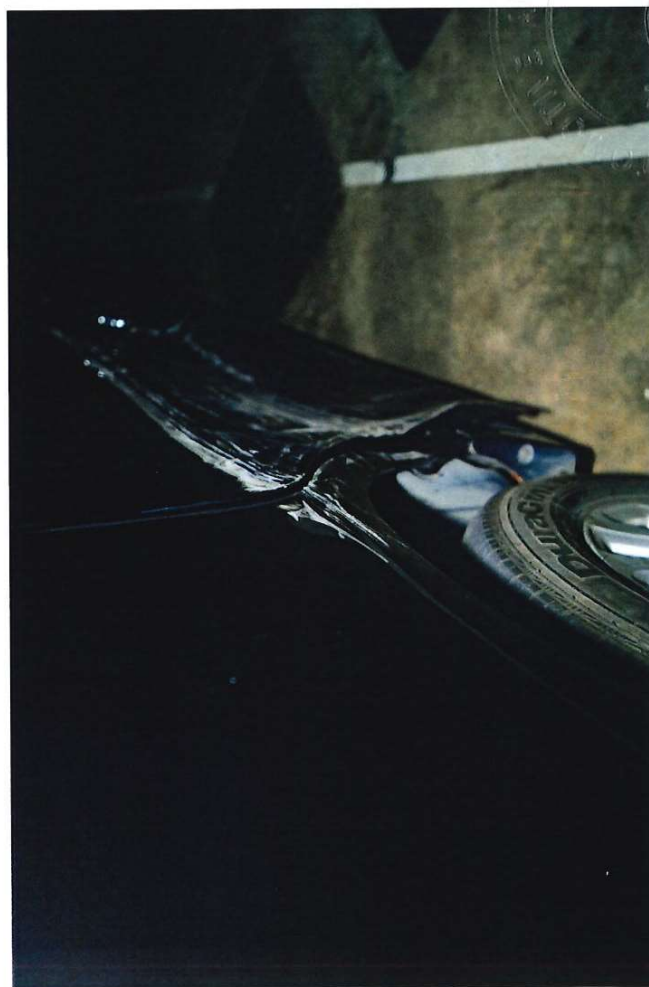
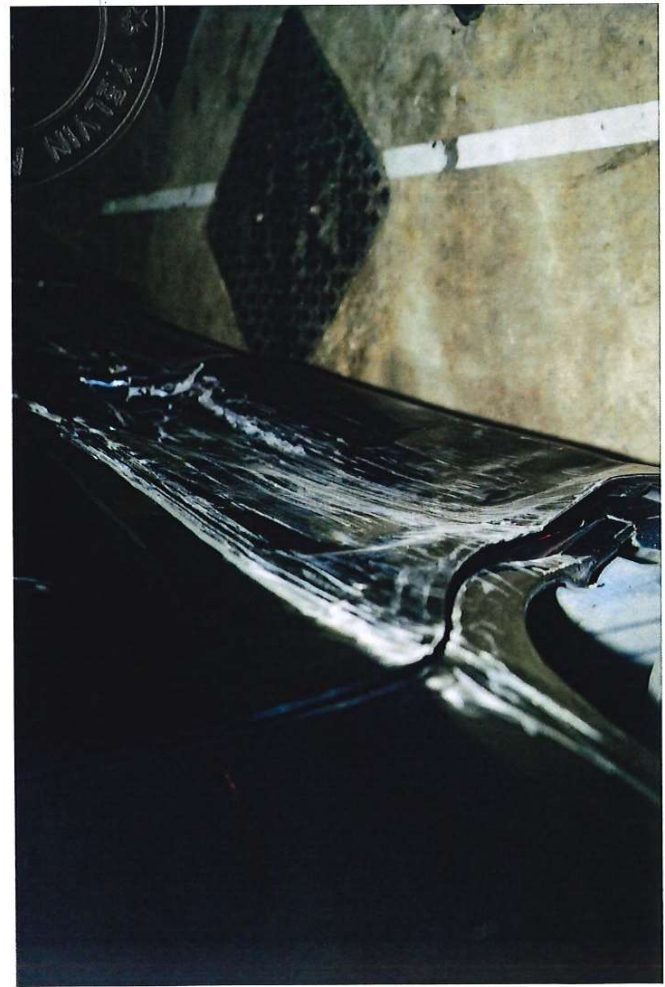
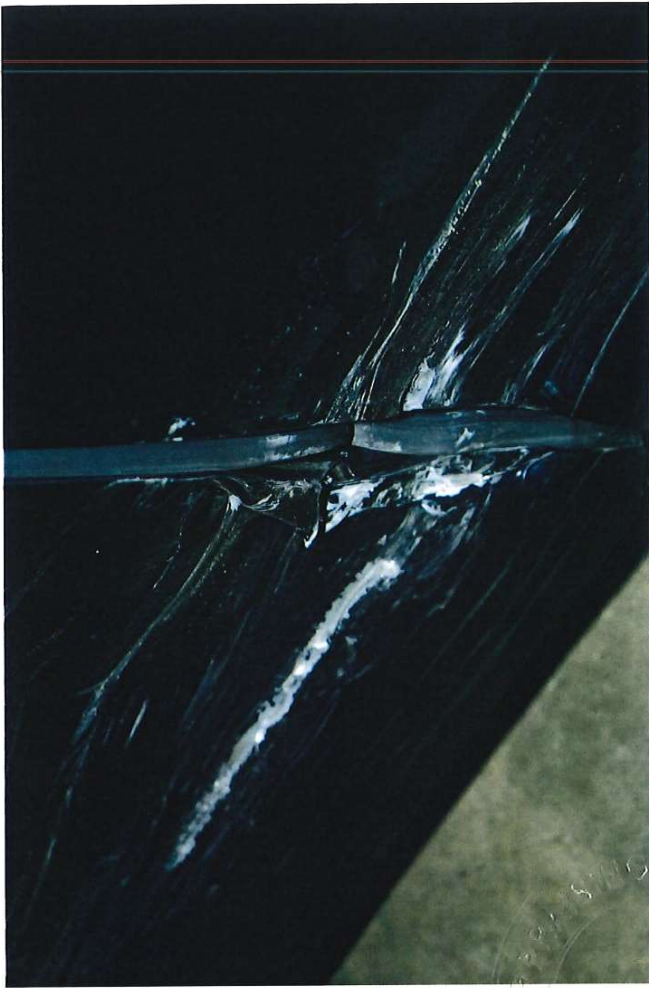
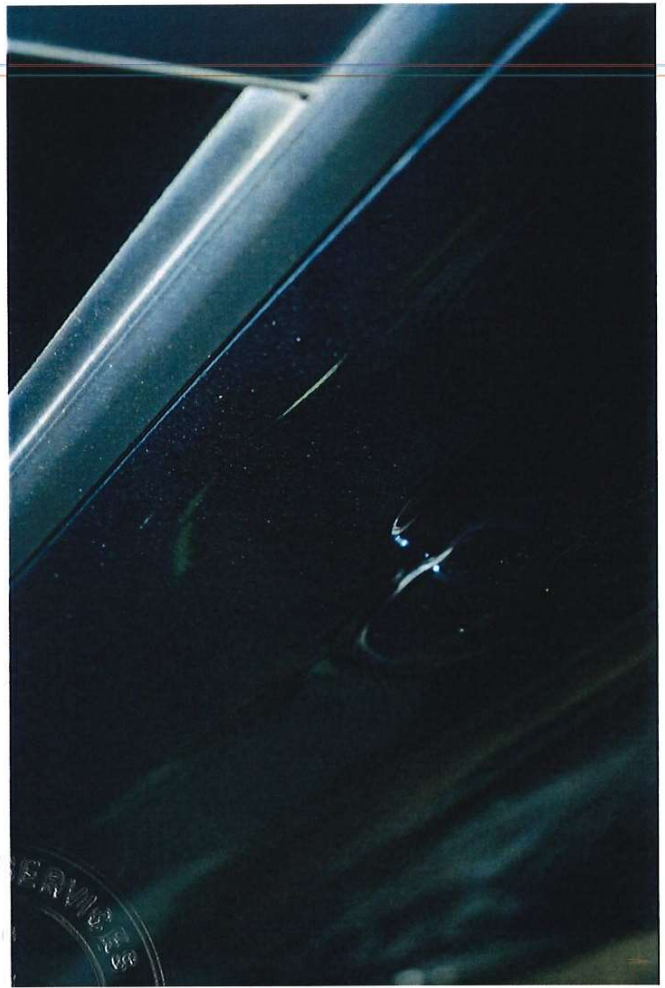
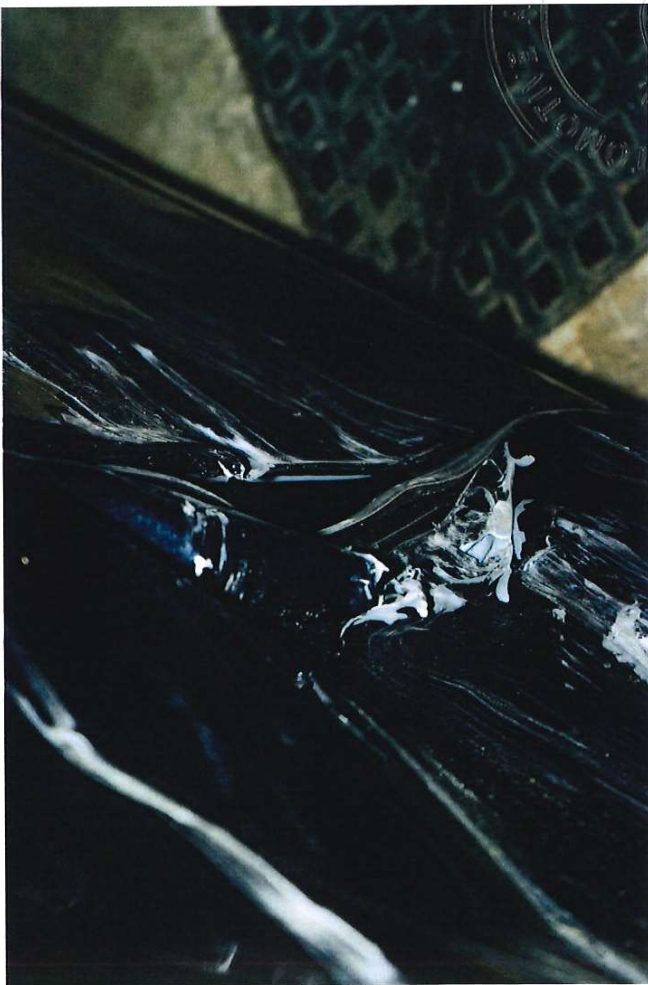
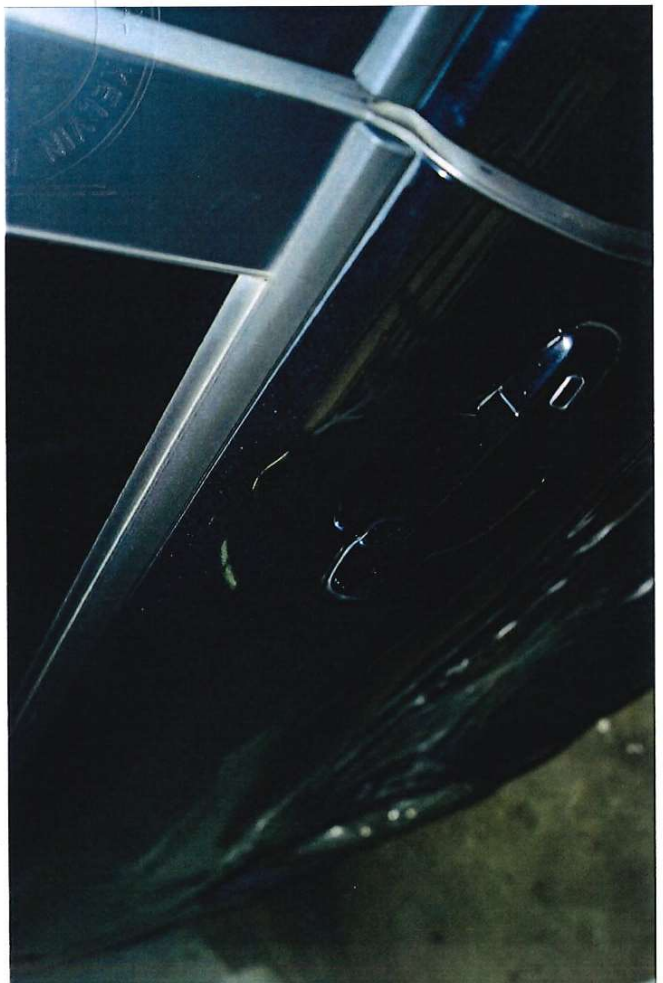
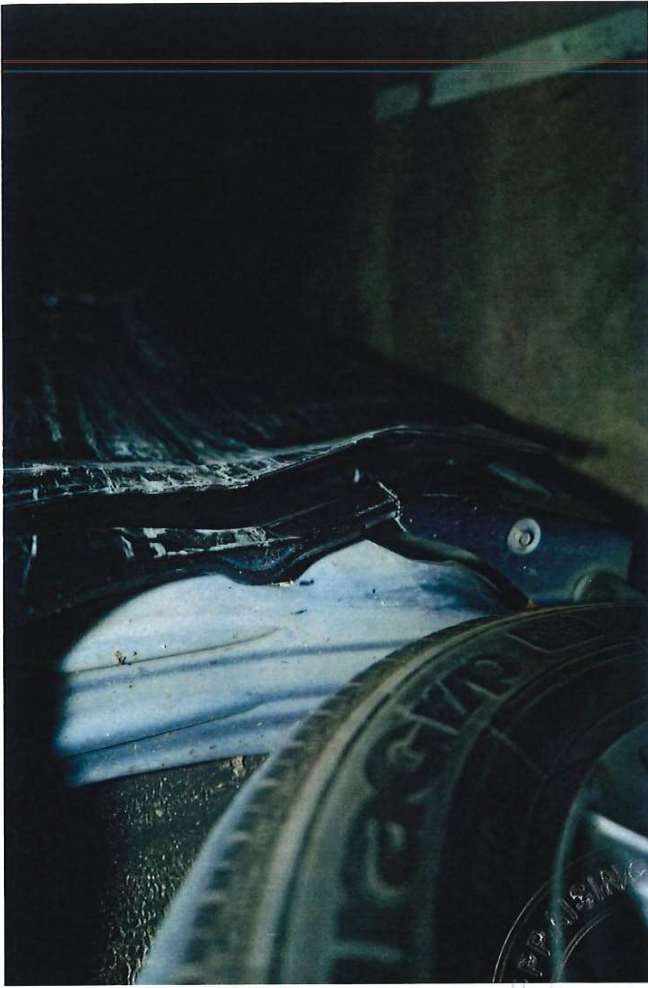
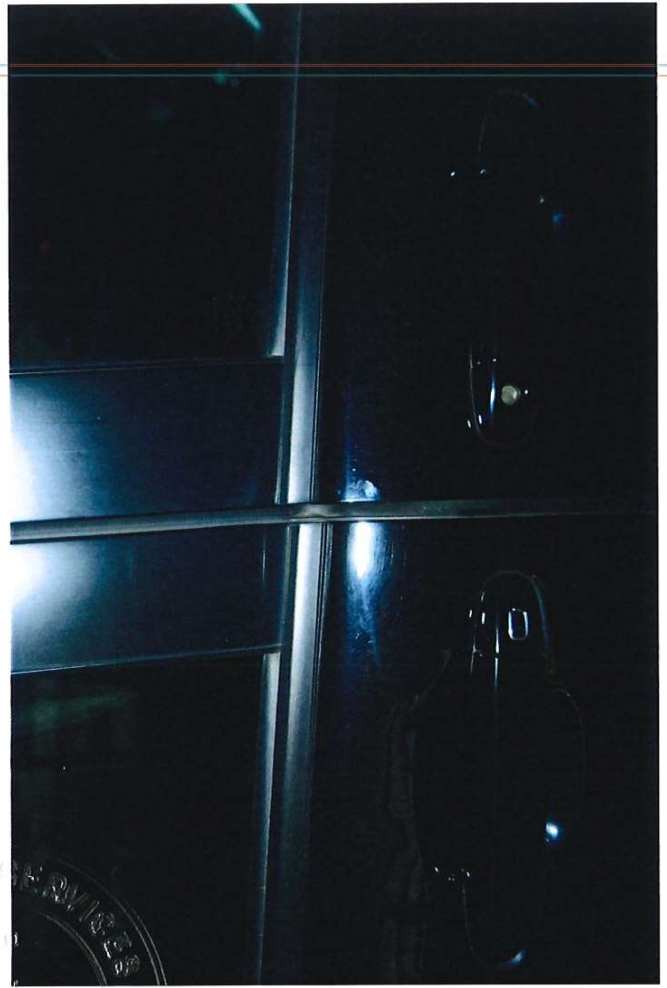
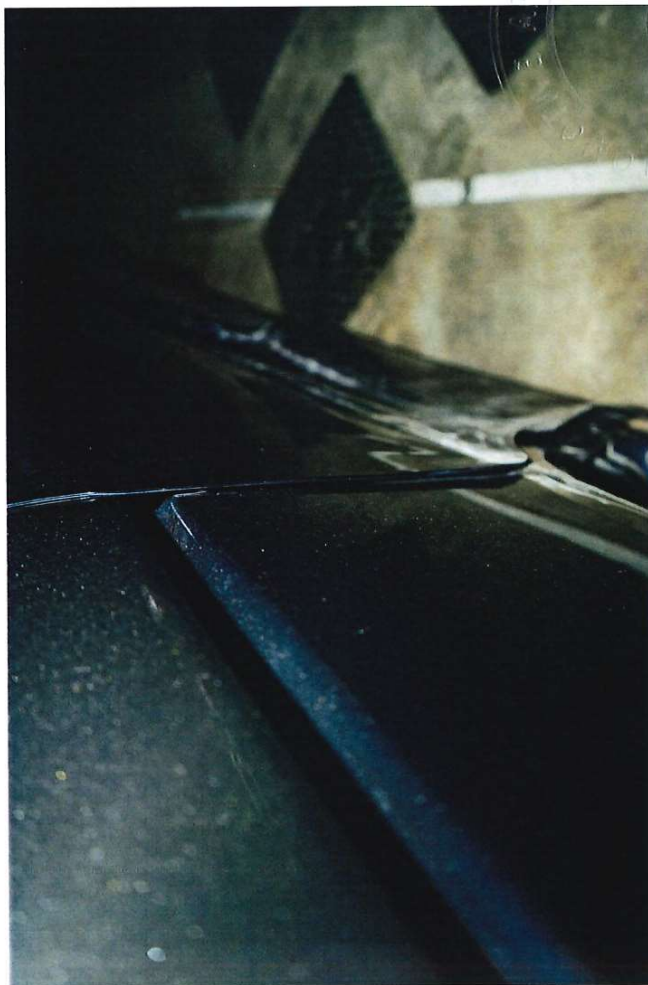
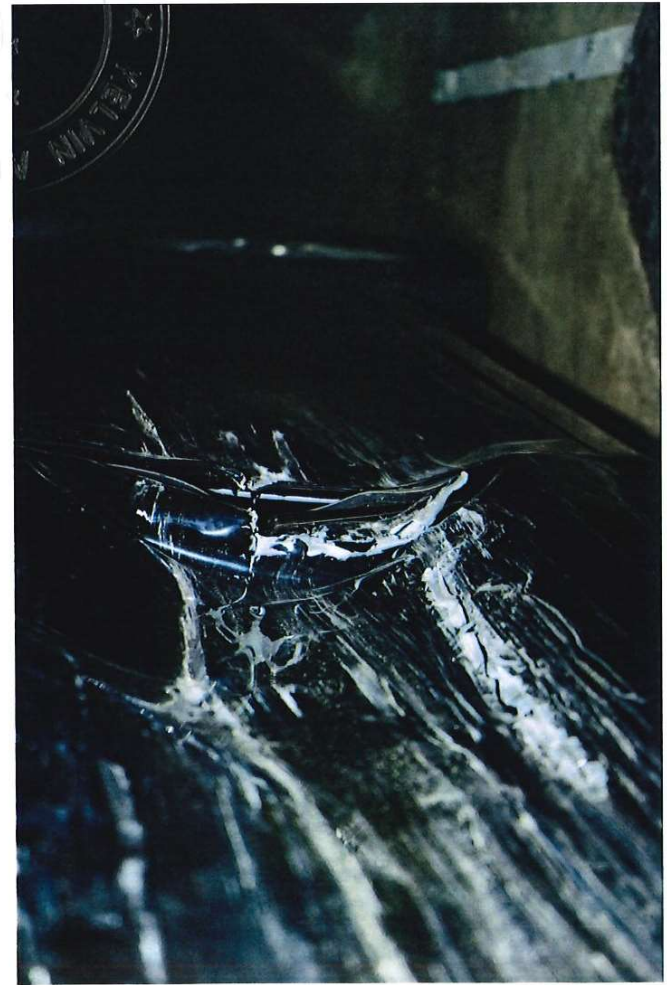
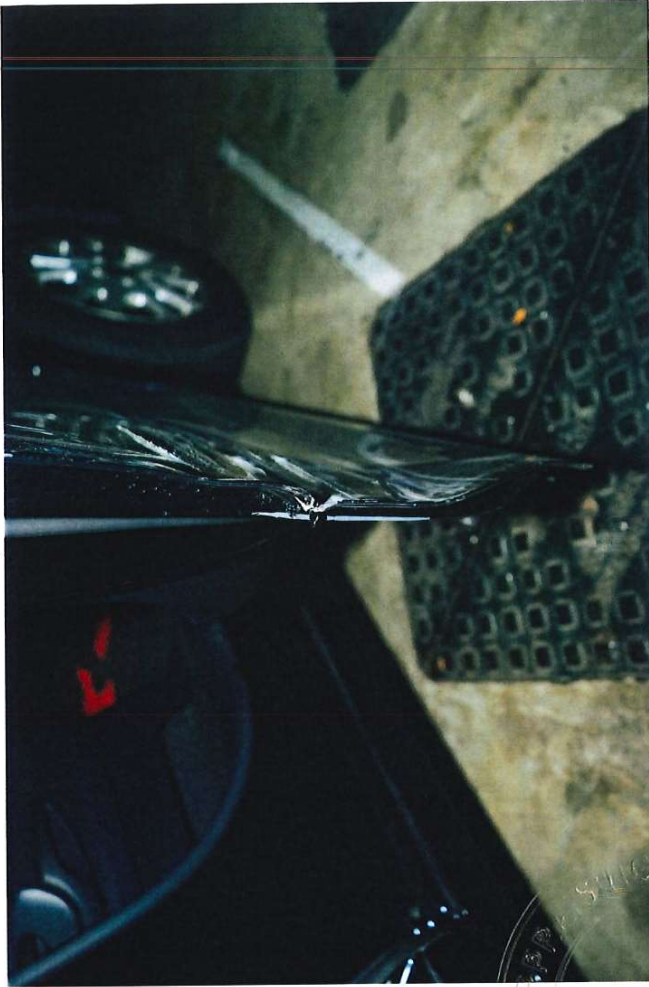
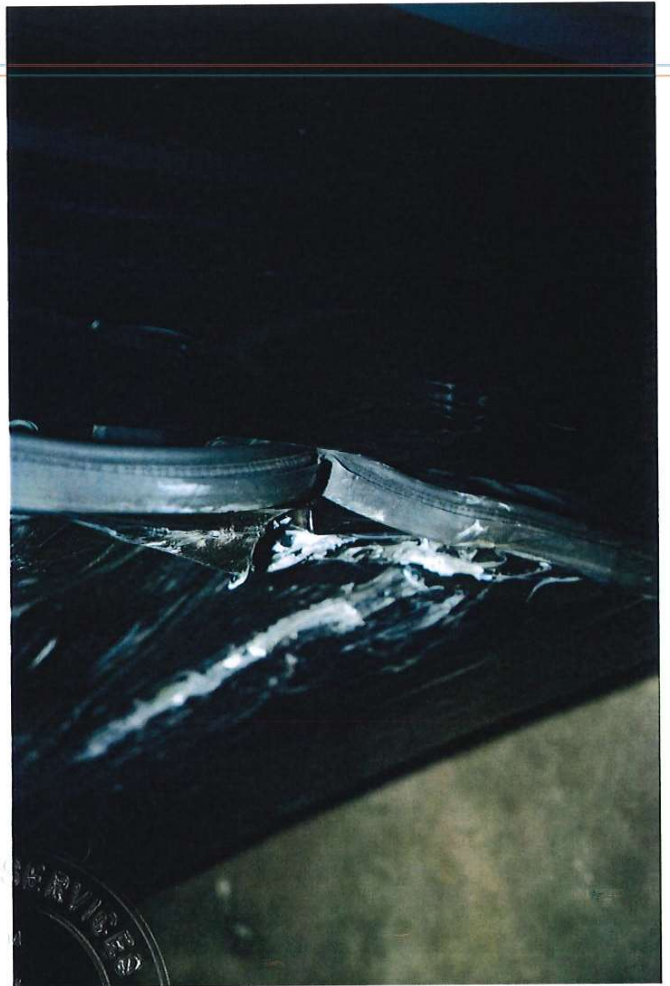
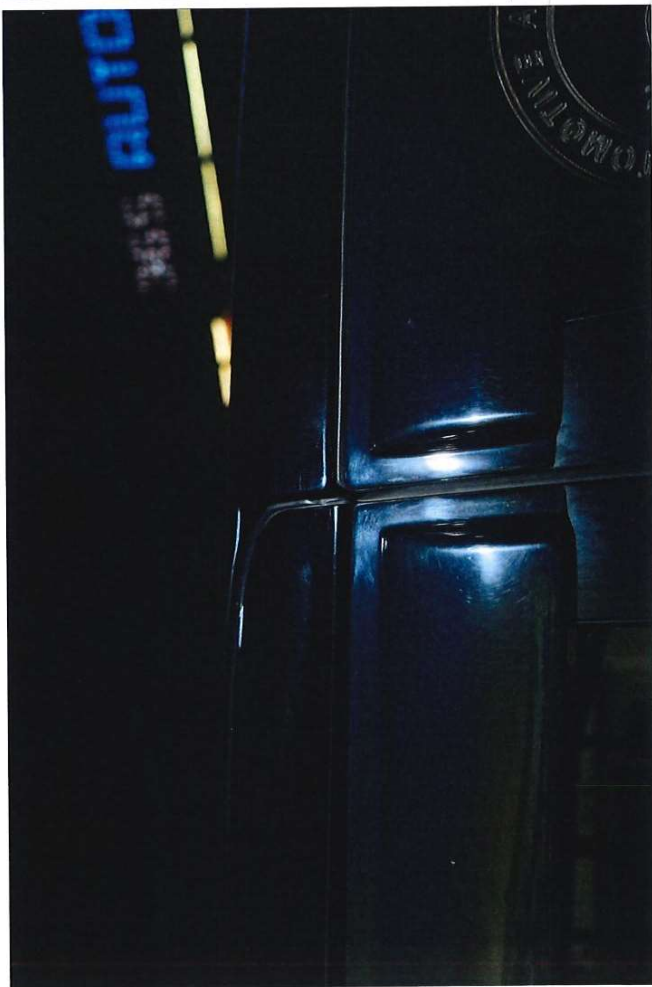
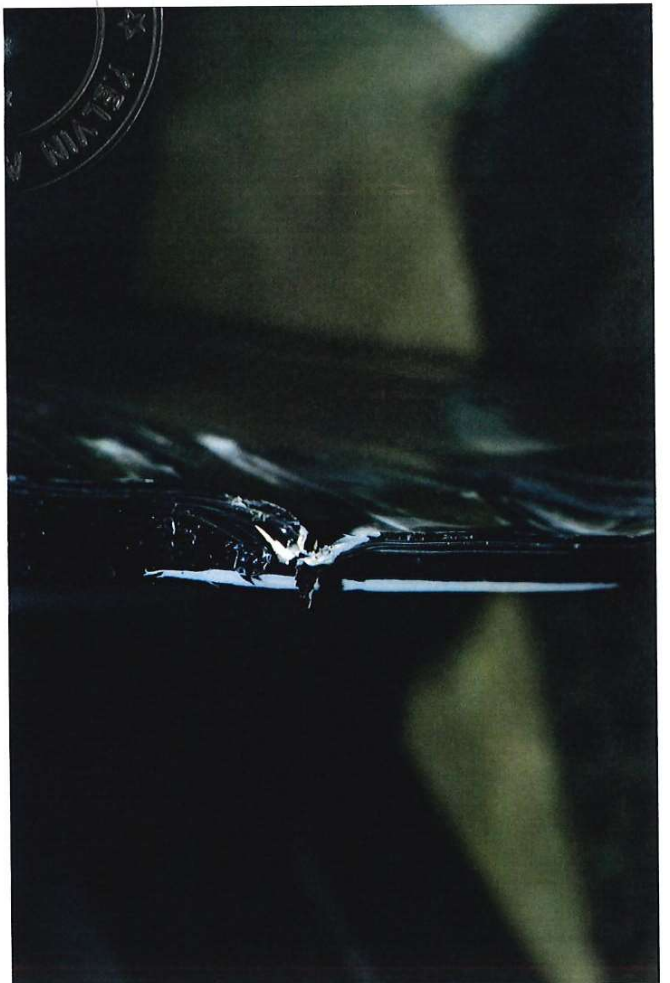
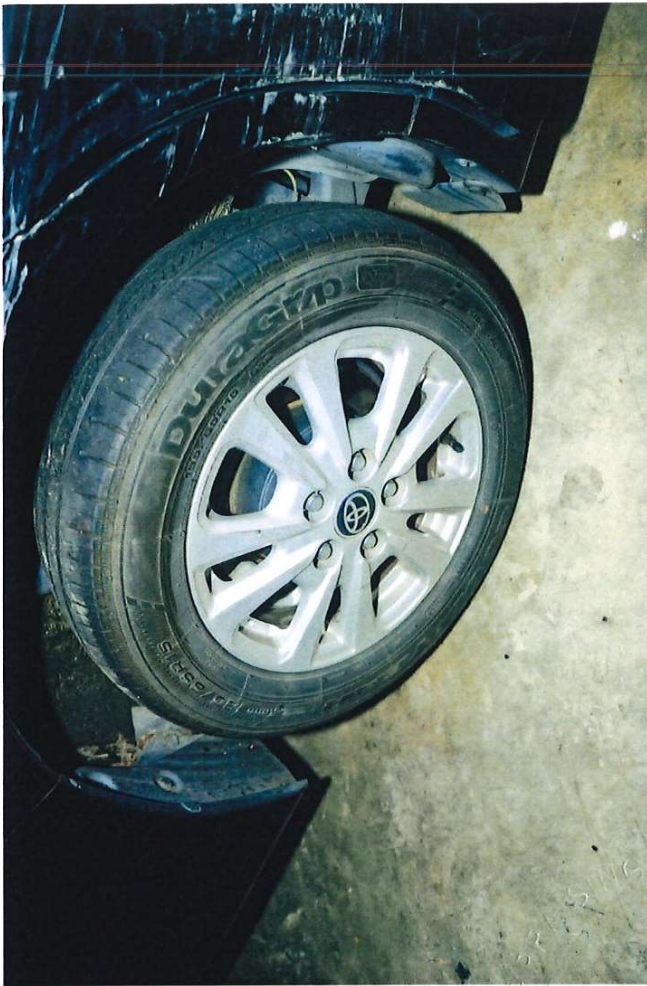
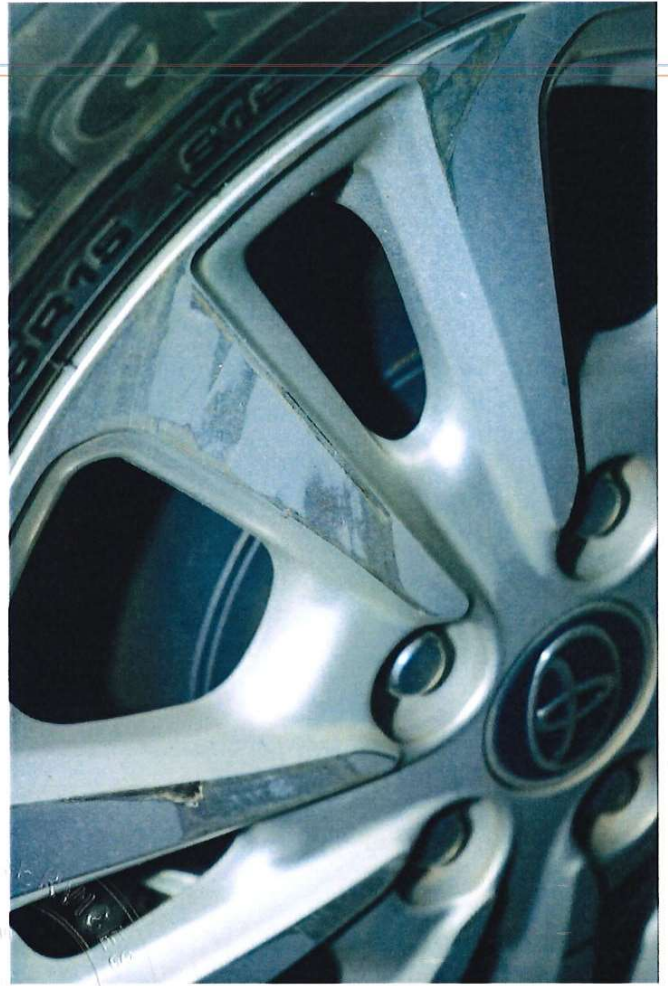
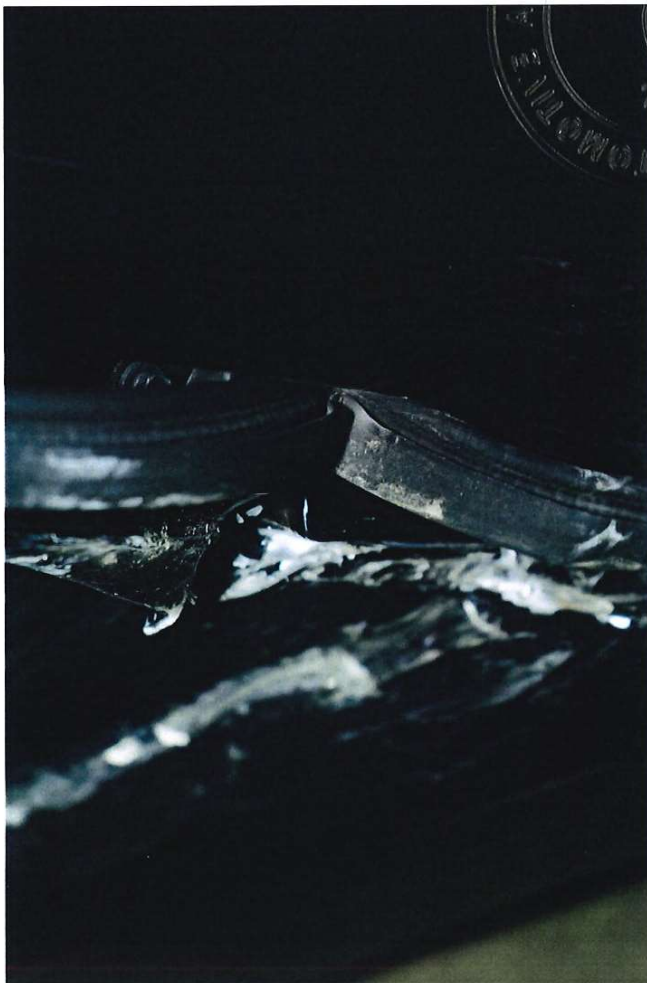
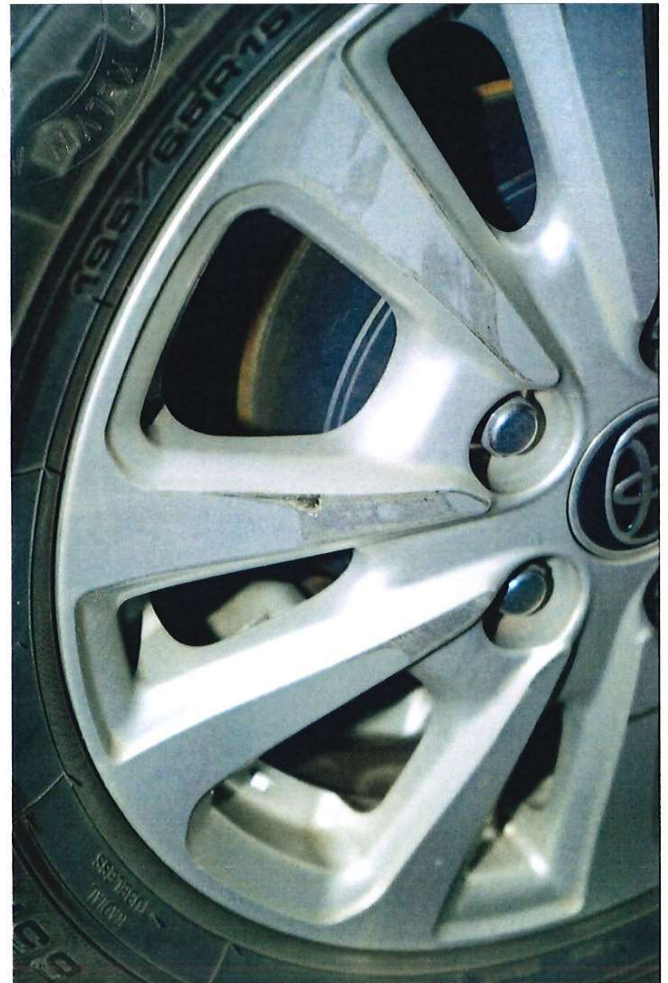
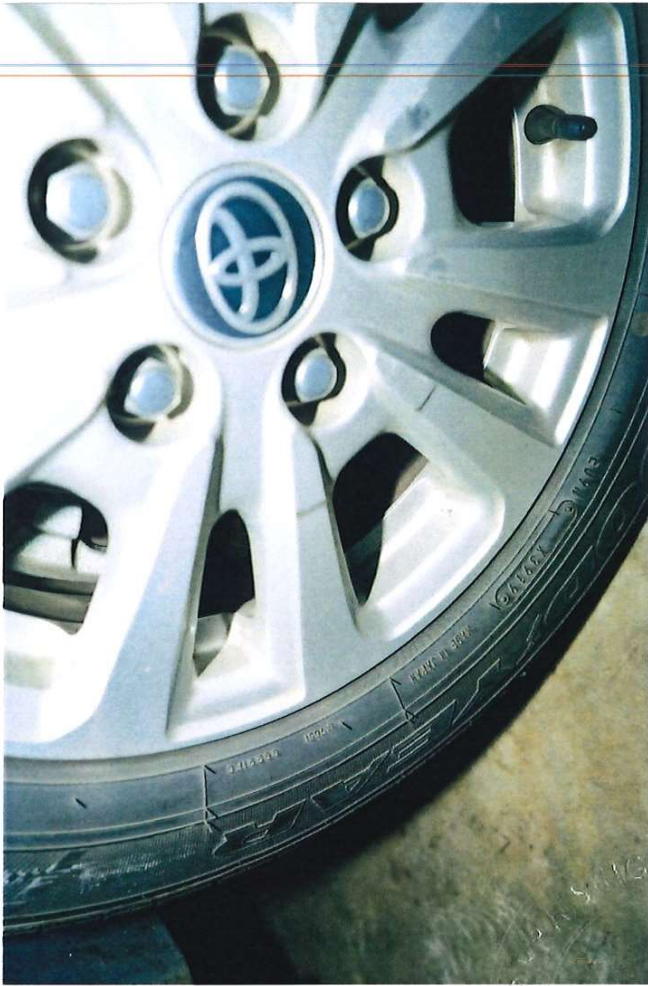
Damages sustained were consistent with the subject vehicle being involved in a collision with another vehicle and the impact was delivered **Diagonally to the RH Side from rear to front; right to left;** portion of the vehicle.

The general area of damages is at the **RH Side portion**
(Please refer to the parts list and photographs as attached for more information)
