AUTOMOBILE INSPECTION REPORT

Our Reference No. : PAS/WM/210310/TP

Registration No. : SJW 4018 J

: HONDA FIT 1.3G A Make/Model

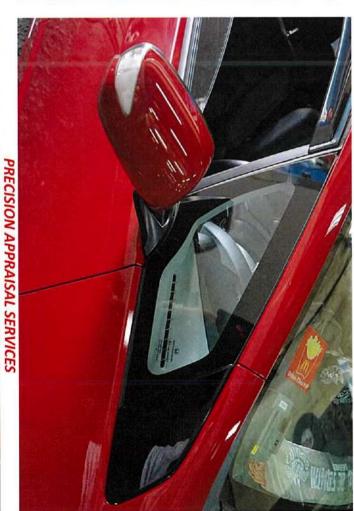
Parts damaged were: The front and rear ols door, ols centre door pillar and top rooftop panel, front ols door mirror, rear ols fender and wheel arch were dented
