## LKK Auto Consultants Pte Ltd

Vehicle No. SLA 4654P  
Insured Veh. SJN 2602H  
Claim No. SNM21D203863/C02  
Policy No. DMPCSNW00022782100  
Accident Date 12/07/2021  
Inspection Date 13/07/2021

## ADJUSTMENT ON REPAIR COST FOR VEHICLE NO. SLA 4654P

PHOTOGRAPHS FOR VEHICLE NO. SLA 4654P

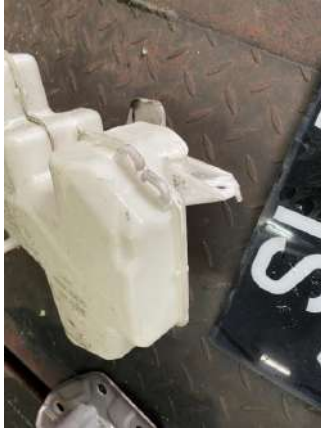
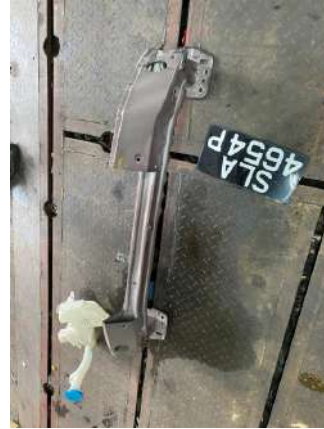
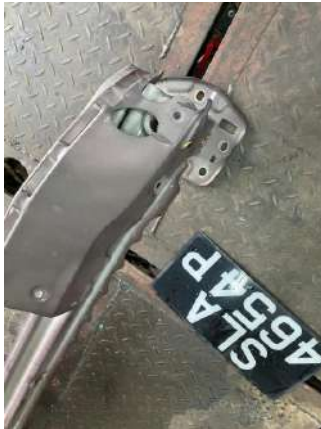
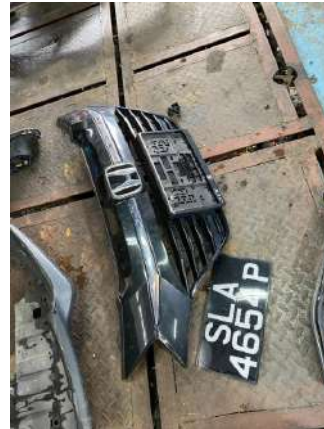
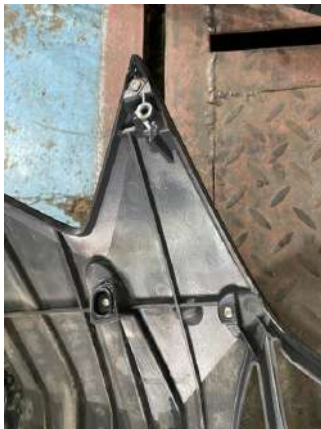
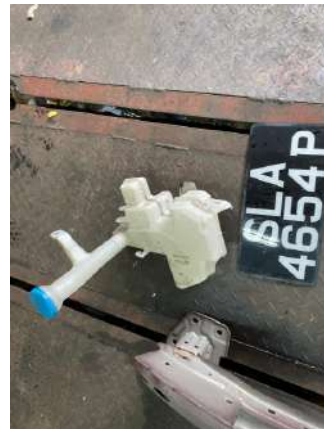
### PHOTOGRAPHS FOR VEHICLE NO. SLA 4654P

| Affiliated to Federation Internationale Des Experts En Automobile | | | | |
|---|---|---|---|---|
| | THE VEHICLE SUSTAINED DAMAGES AT THE O/S FRONT PORTION.<br><br>DAMAGES SEE DETAILS. | | | |

| Qty | Description of Parts | Condition | Estimate By Workshop (\$) | Our Adjusted (\$) |
|---|---|---|---|---|
| 1 | FRONT GRILLE OUTER | CRACKED | 203.40 | 203.40 |
| 1 | O/S HEAD LAMPS | CRACKED | 1,952.70 | 1,859.40 |
| 1 | O/S HEAD LAMPS BRACKET | CRACKED | 35.00 | 35.00 |
