Your Ref: TP/IP/14569/2021  
Our Ref : CI/TPD21007783/P

**Fatal Accident Investigation Team**

**MECHANICAL INSPECTION REPORT OF BUS PA 8825P**

1. I refer to your request on 19<sup>th</sup> July 2021 to conduct a physical inspection of a Bus bearing registration number PA 8825P (herein referred to as "**Bus**"), which was involved in a road traffic accident on 22<sup>nd</sup> March 2021
2. The objective of this inspection is to determine if there was any possible mechanical failure to the Bus that may have contributed to the accident.
3. Following the request, I had carried out a physical inspection of the Bus on 27<sup>th</sup> September 2021 at the premises of Traffic Police vehicle pound, 517 Airport Road Singapore 539942. I now set out below my observations and comments with respect to this inspection.

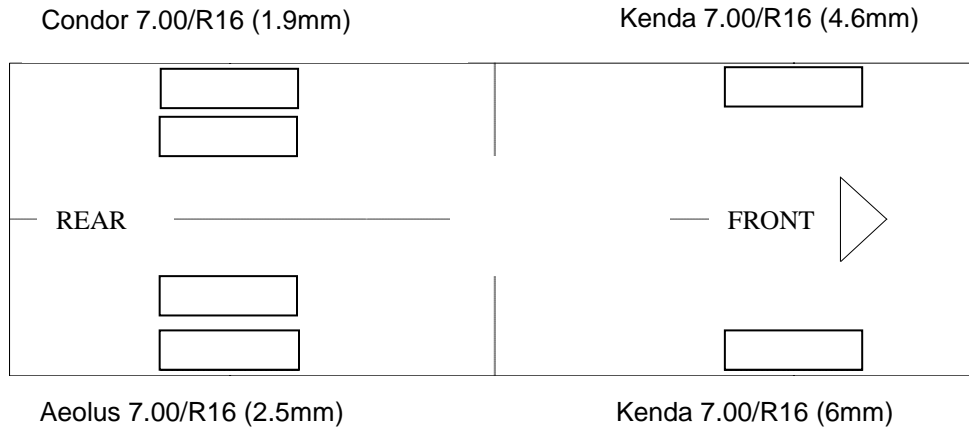
6. The 6 tyres of the Bus were observed to be in serviceable condition and sufficiently inflated for vehicular operation. I did not find any tear, cut or burst mark(s) on the outer and the inner sidewalls as well as across the tread of the 4 tyres. The tyre brand, tyre size and remaining tread depth of the 4 tyres of the Bus were recorded as follows:-
