Your Ref: TP/IP/26557/2021
Our Ref : CI/TPD21008010/N

Fatal Accident Investigation Team

**INSPECTION REPORT OF BICYCLE (BLACK) - TRAFFIC POLICE POUND
REPORT NO. 1873/21**

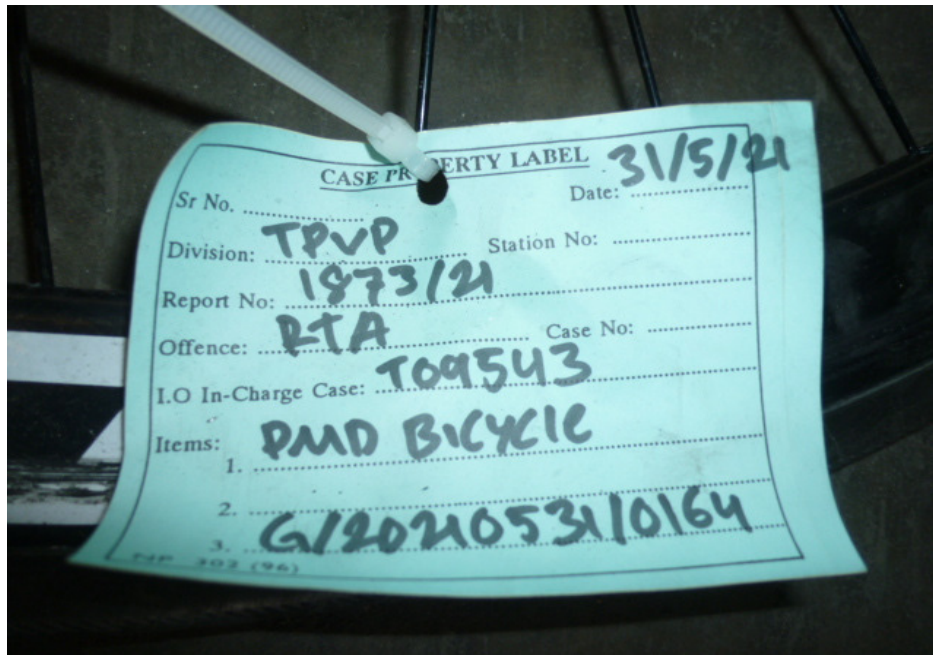
Photo 1 shows the identification of the Bicycle with reference to Traffic Police Pound Report No. 1873/21.
