Your Ref: TP/IP/29173/2021
Our Ref : CI/TPD21008011/N

Fatal Accident Investigation Team

**INSPECTION REPORT OF BICYCLE (ORANGE) - TRAFFIC POLICE POUND
REPORT NO. 2062/21**

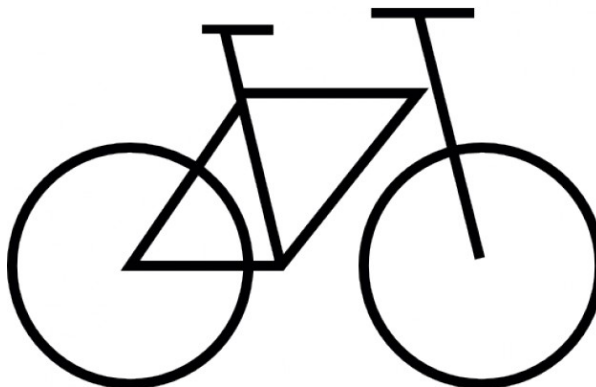
5. The condition of the Bicycle's front & rear tyres was observed to be in serviceable condition. The tread pattern of the 2 tyres was clearly visible. We did not observe any tear, burst mark(s) and/or punctured hole(s) on the sidewalls as well as across the tread of the 2 tyres. The 2 tyres were both observed to be sufficiently inflated for vehicular operation. The tyre brand, tyre size and remaining tread depth of the 2 tyres were recorded as follows:-
