# SINCERE

## VEHICLE DAMAGE INSPECTION REPORT

Our Ref: 113/TP/2021

Reg No:	GBG5142E	Make &	Toyota
Reg date:	28/8/2017	Model	Hiace
Colour:	Blue	Engine No:	1KD2700401
Type:	Van	Chassis No:	JTFHT02P300220258
Type of Claims:	Third Party	Odometer No:	146084km
		Engine Cap:	2982cc

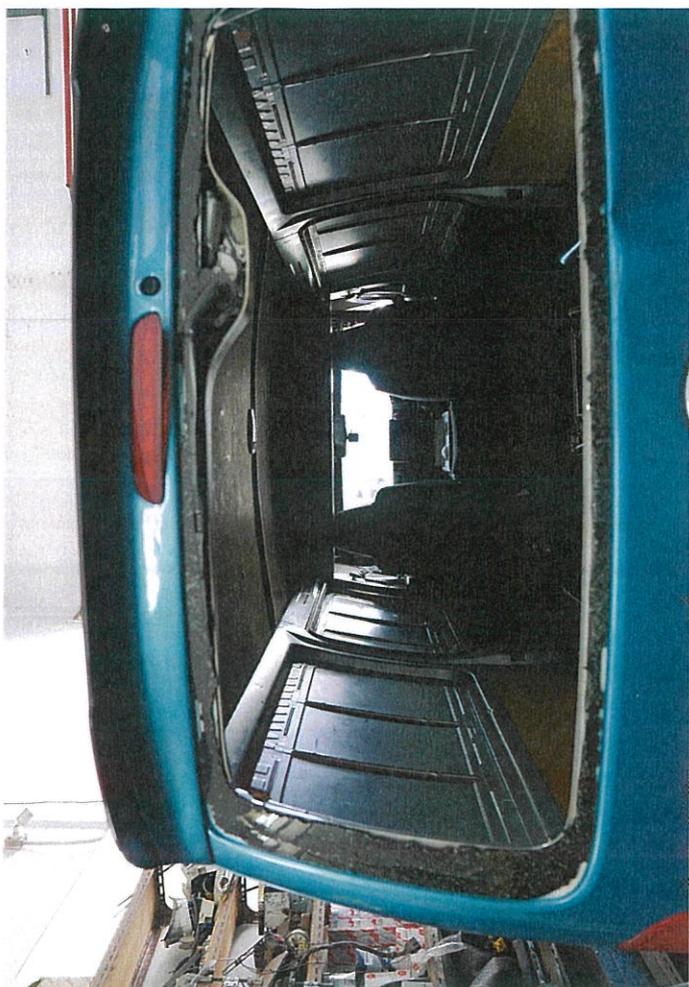
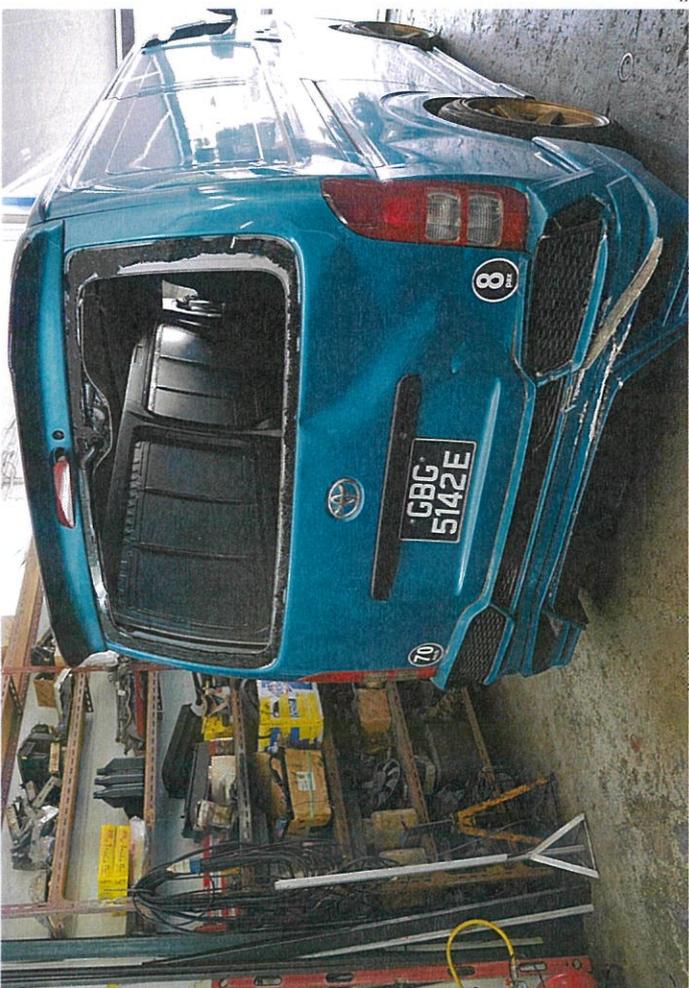
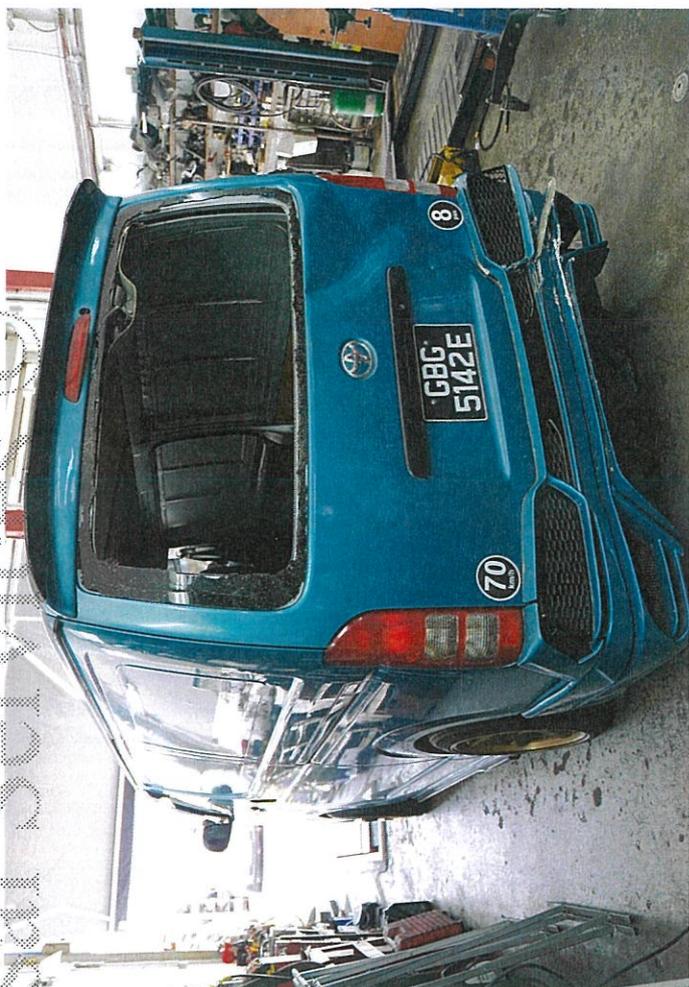
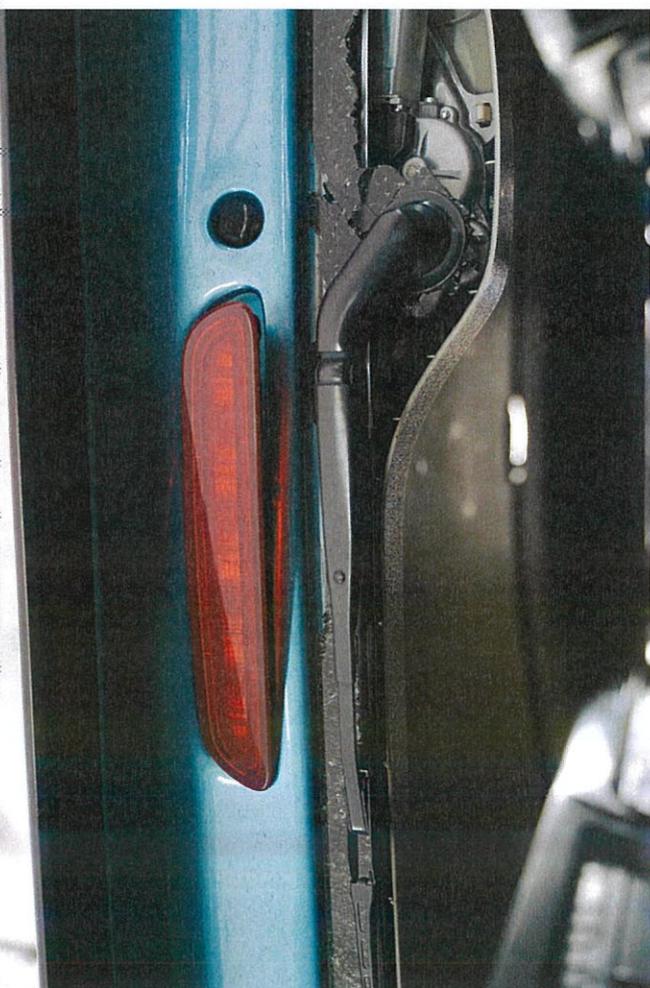
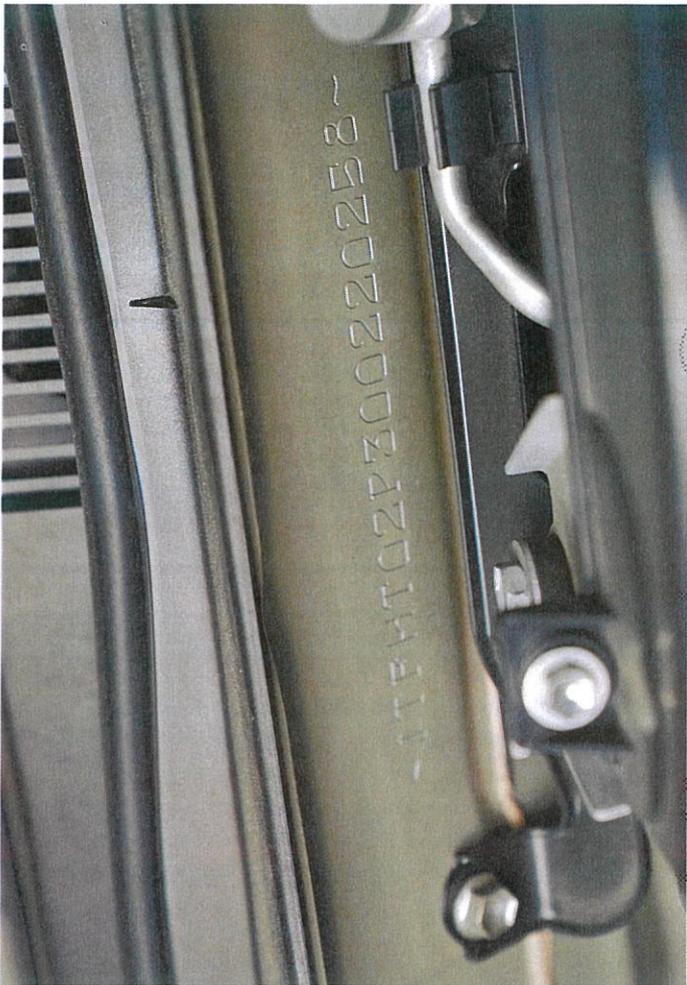
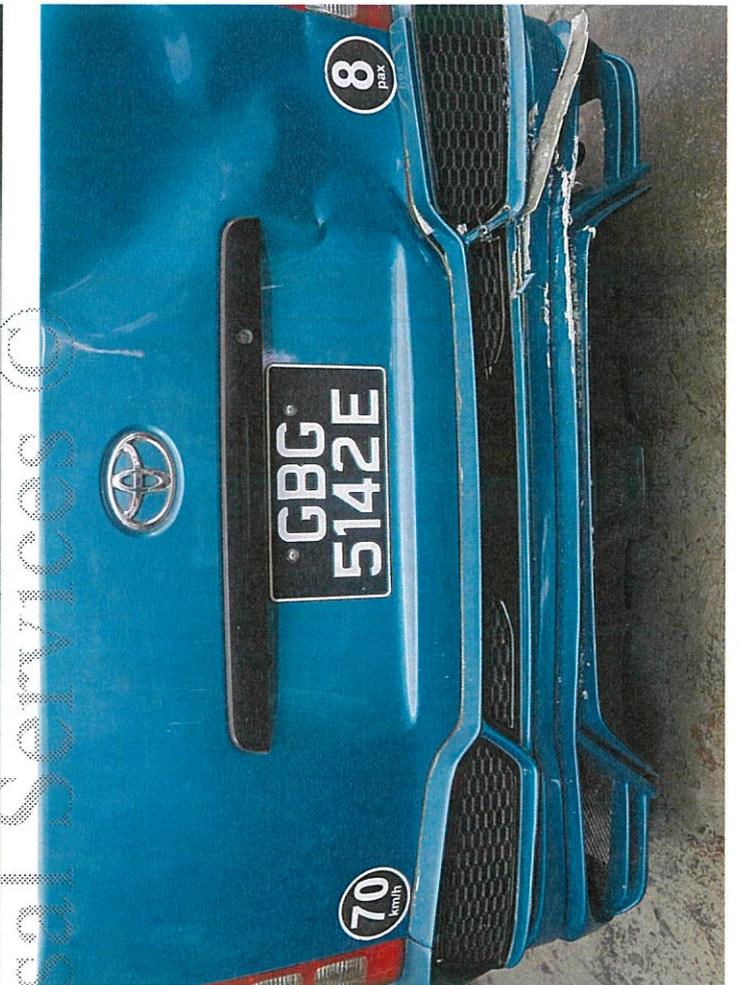
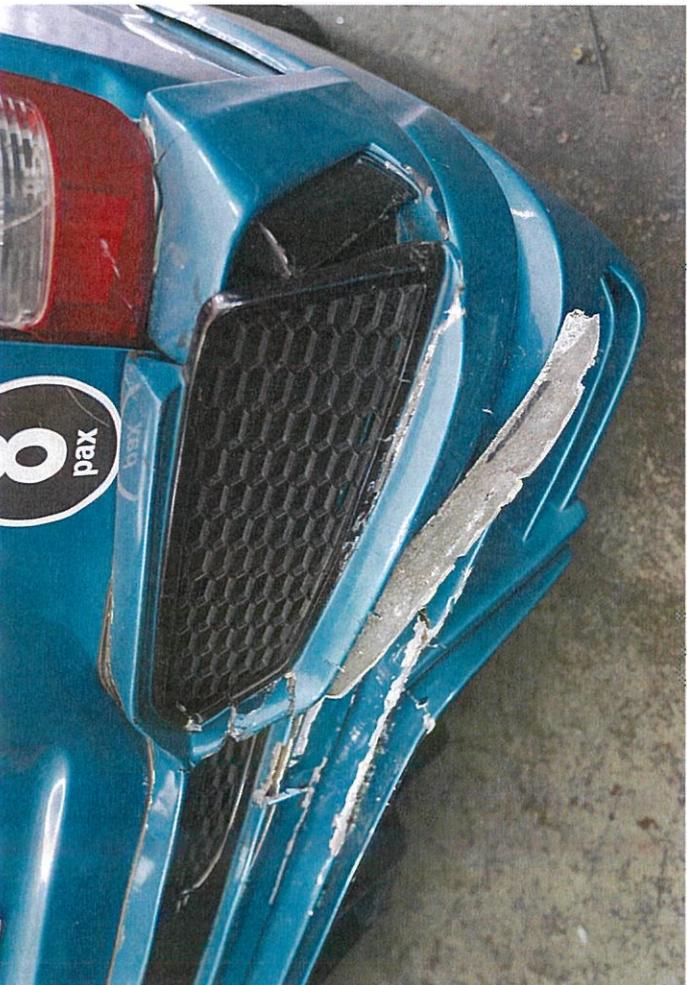
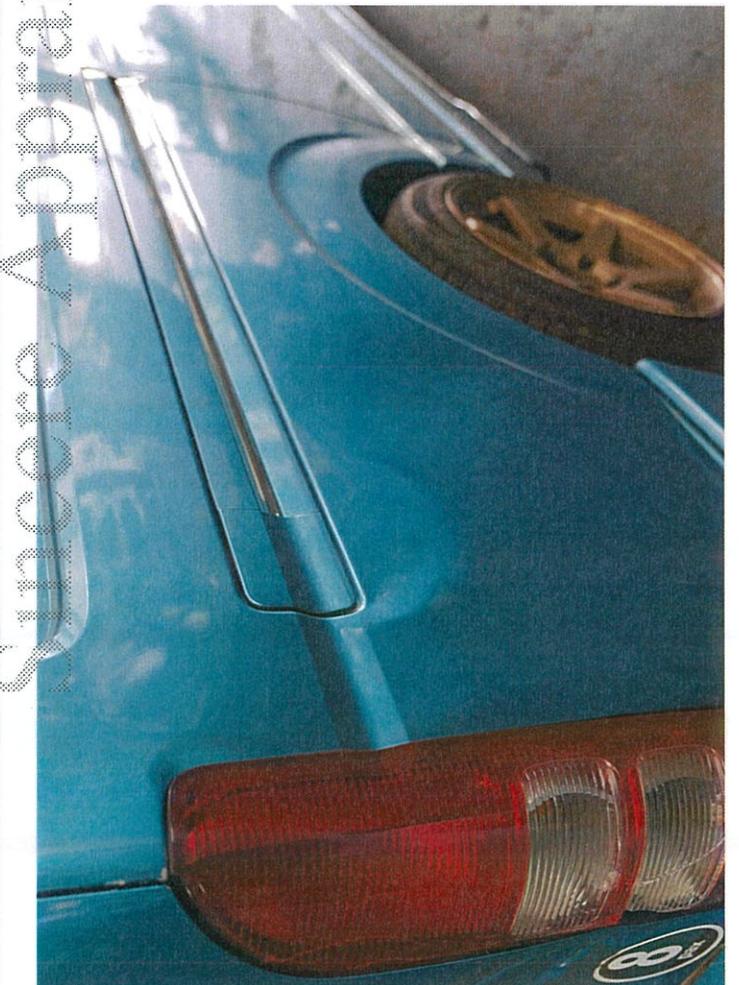
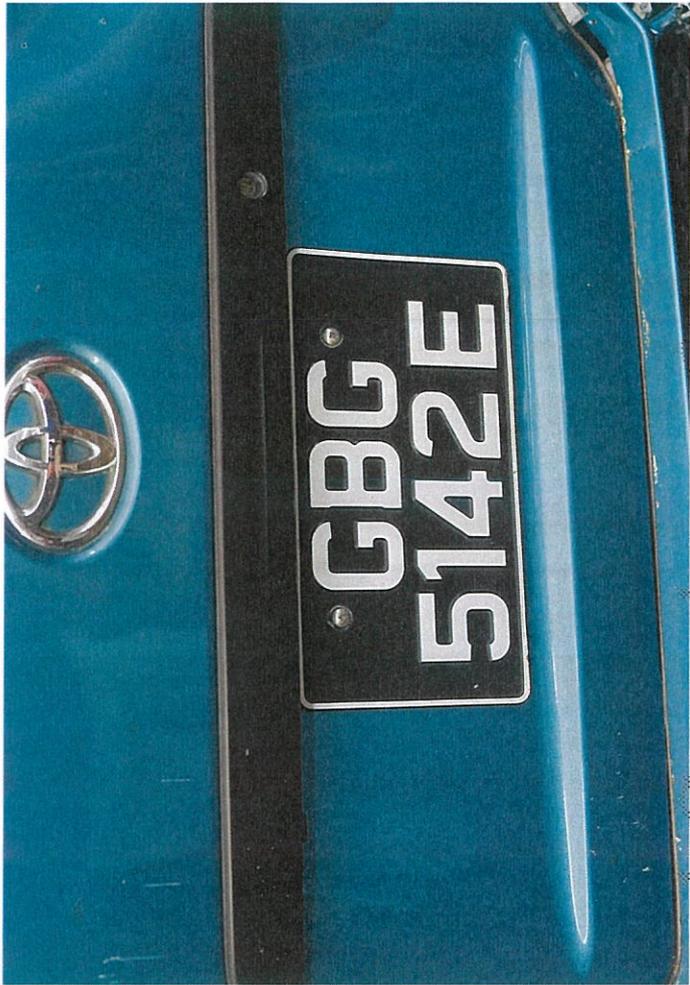
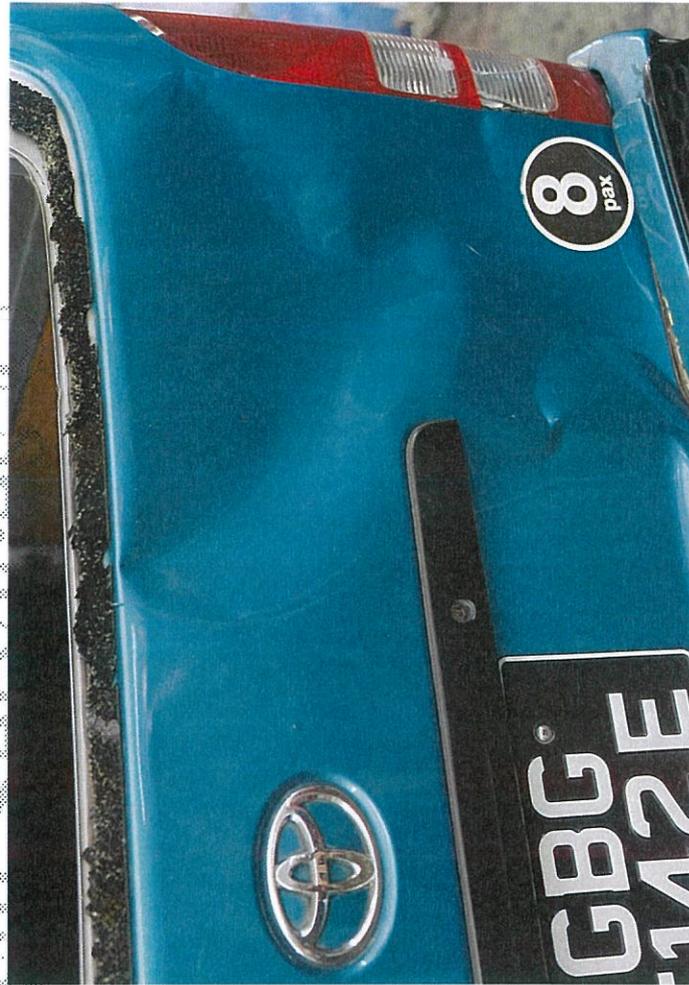
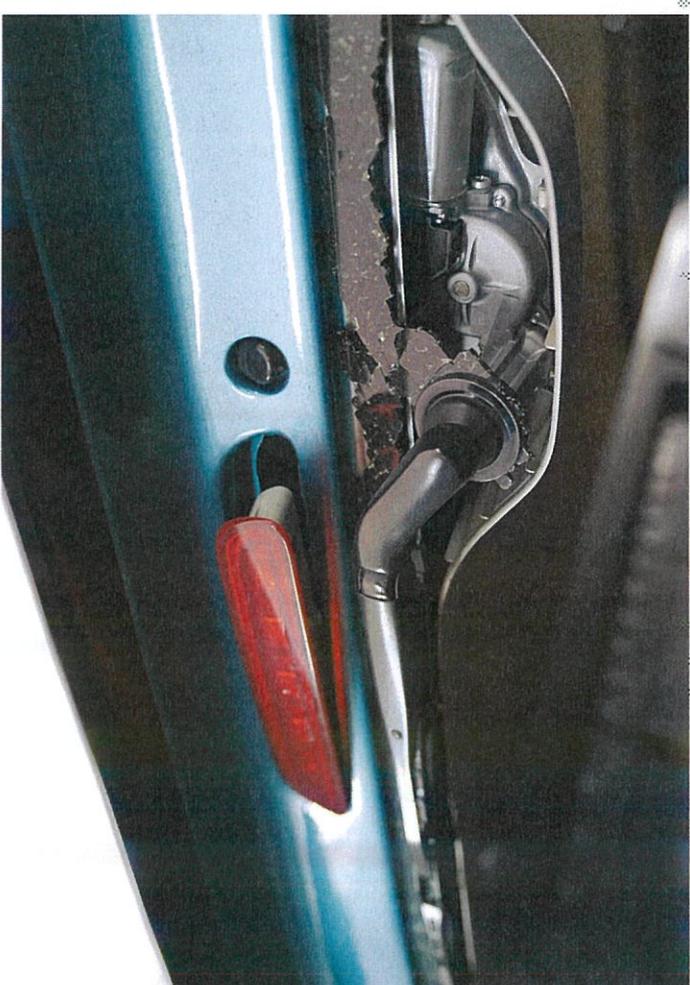
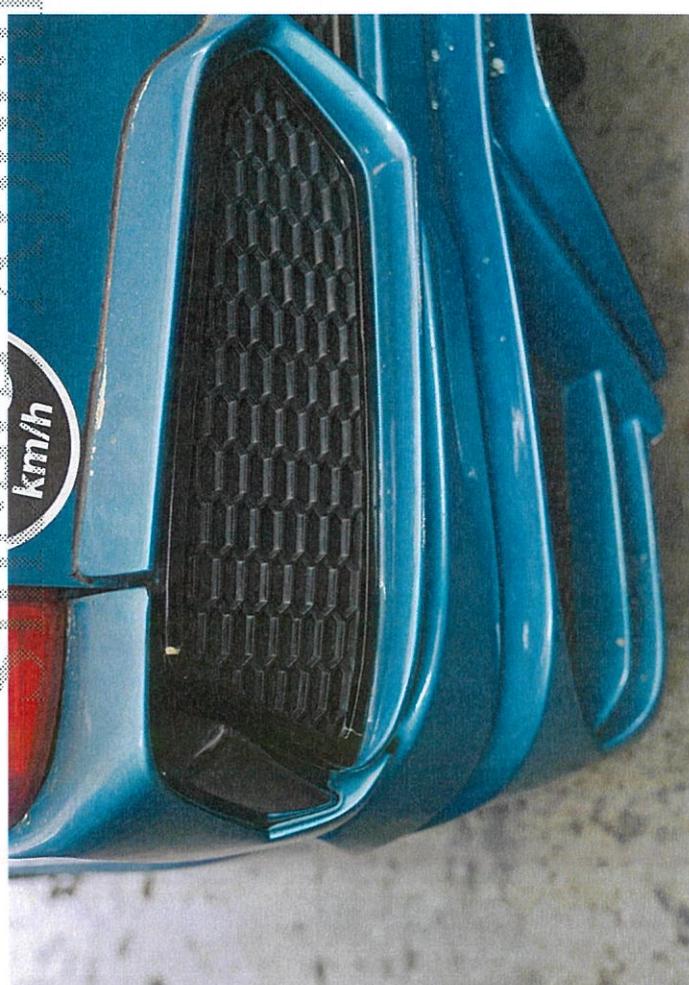
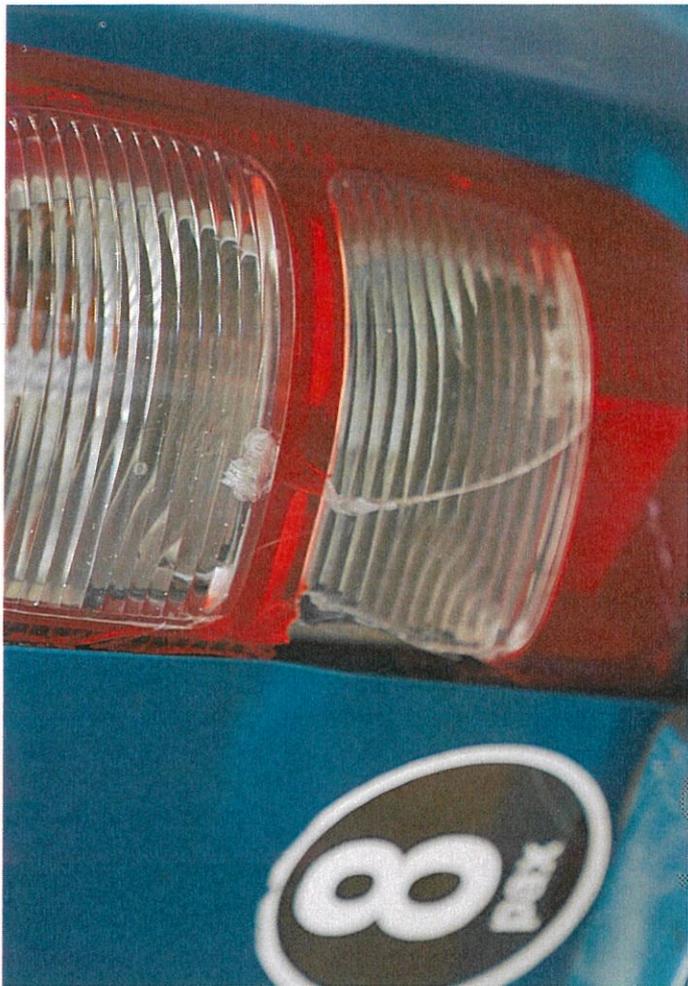
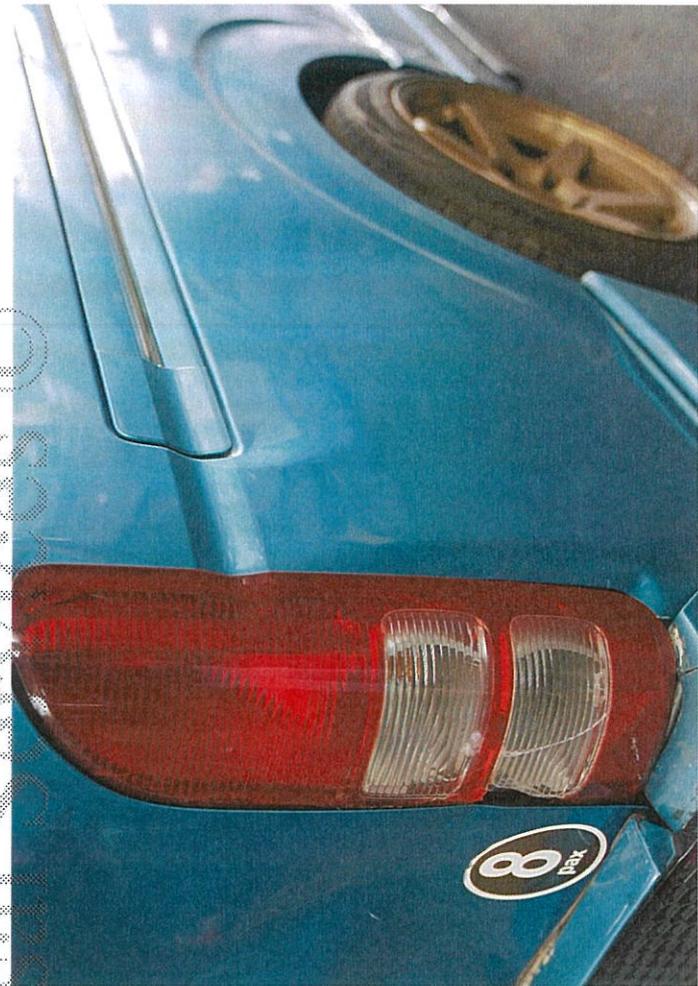
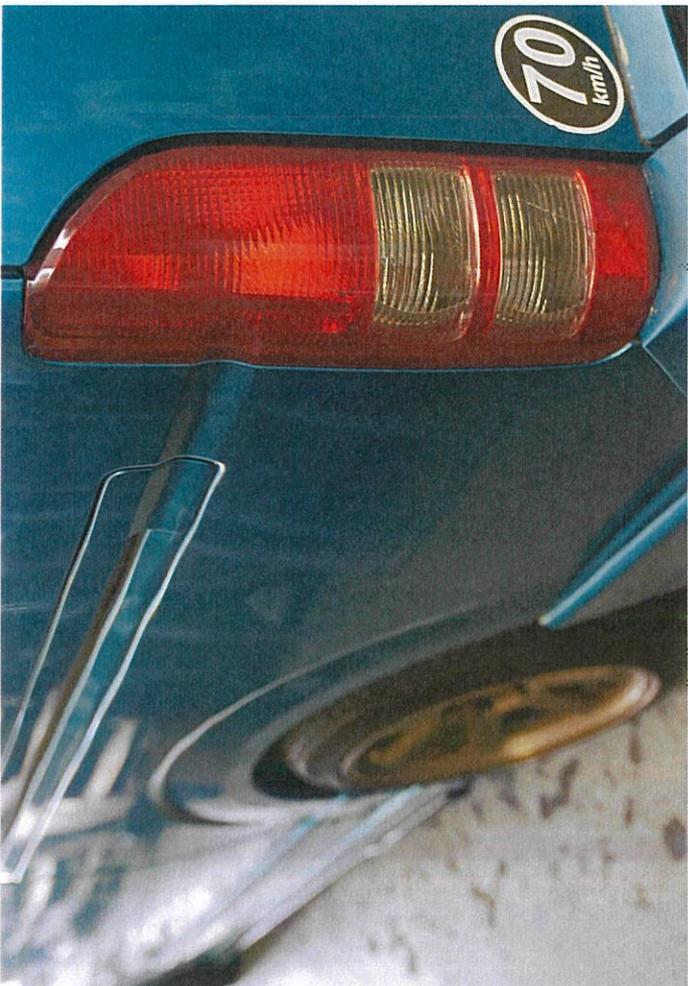
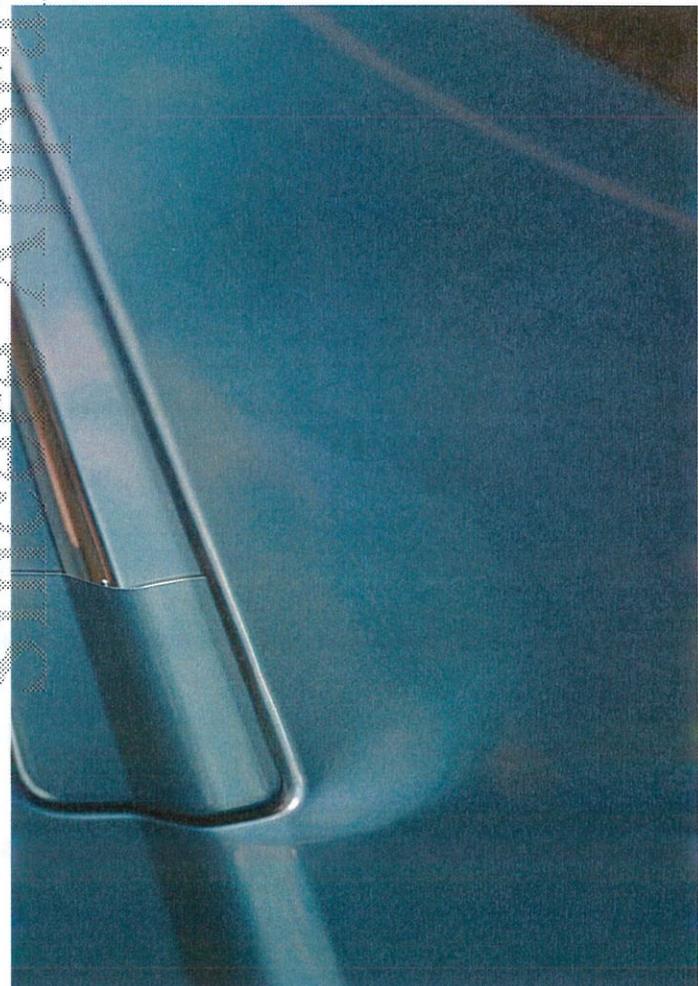
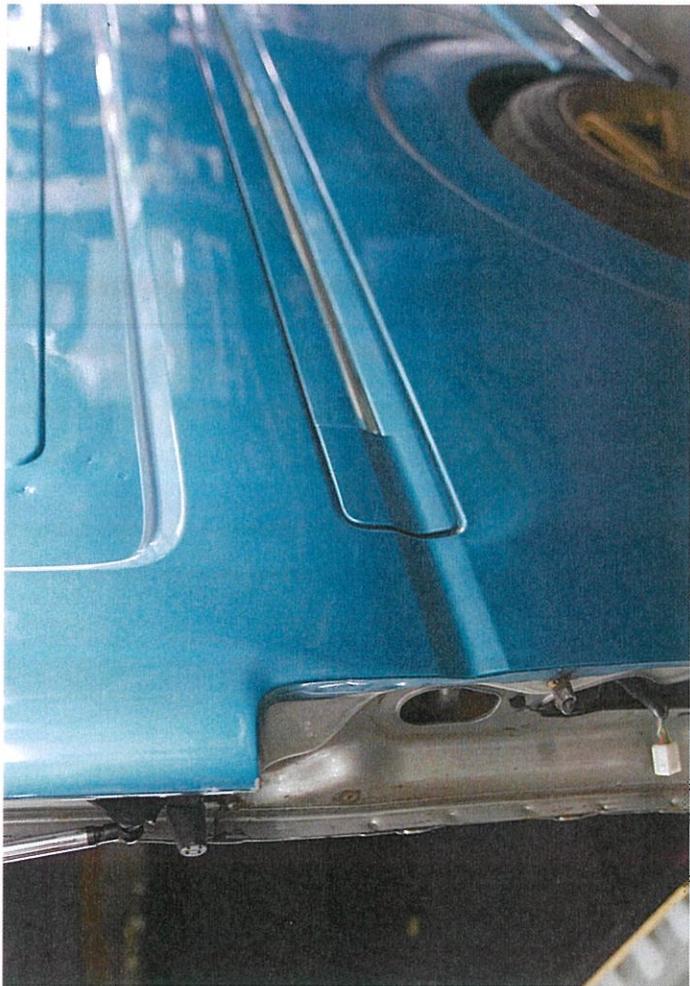
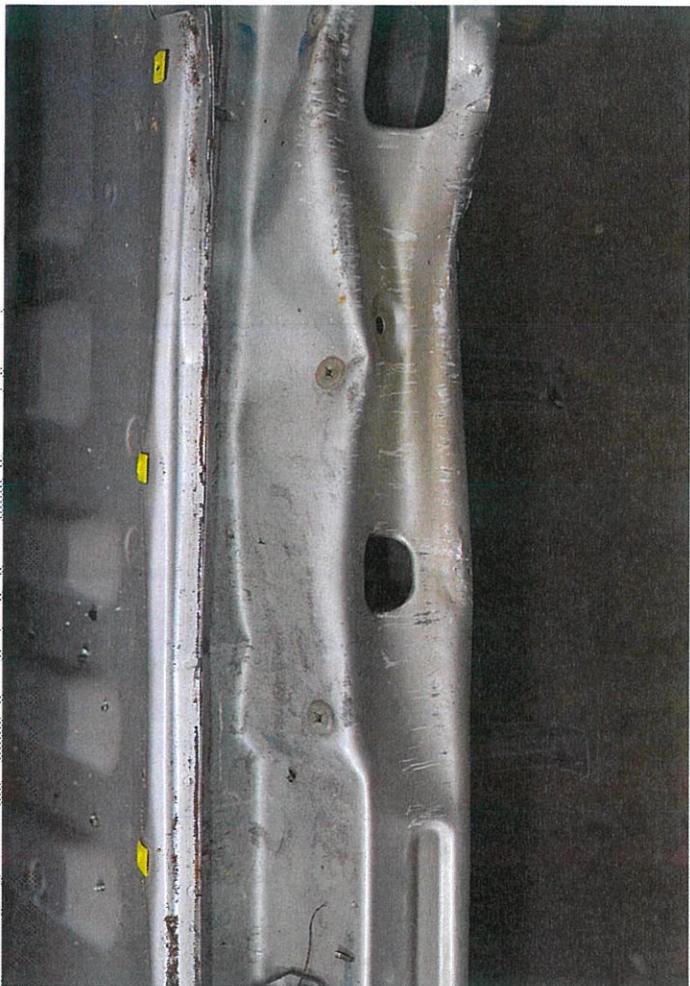
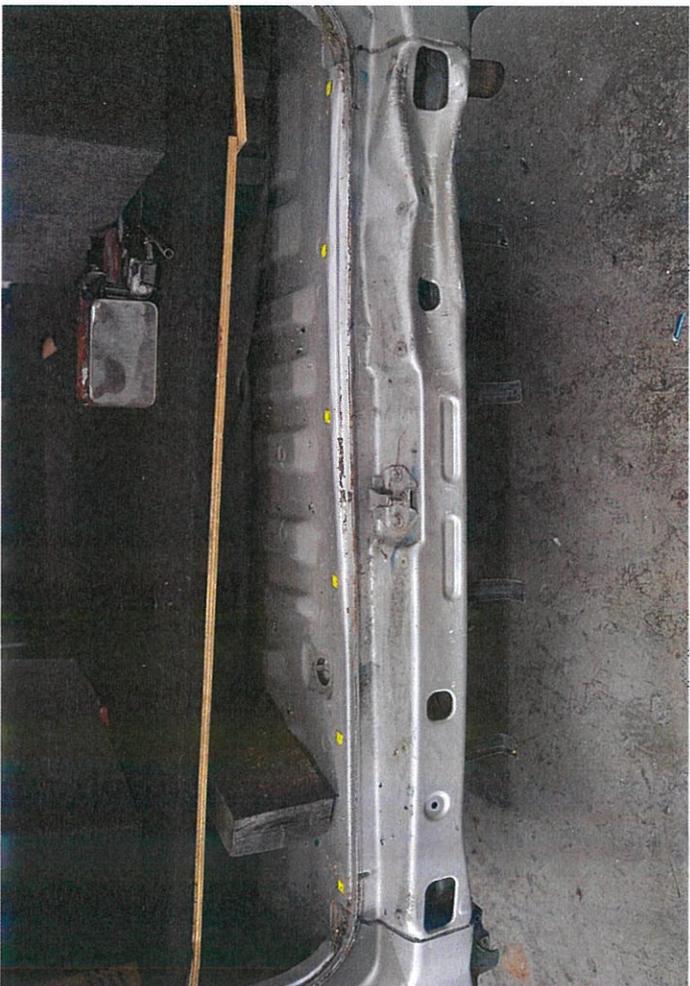
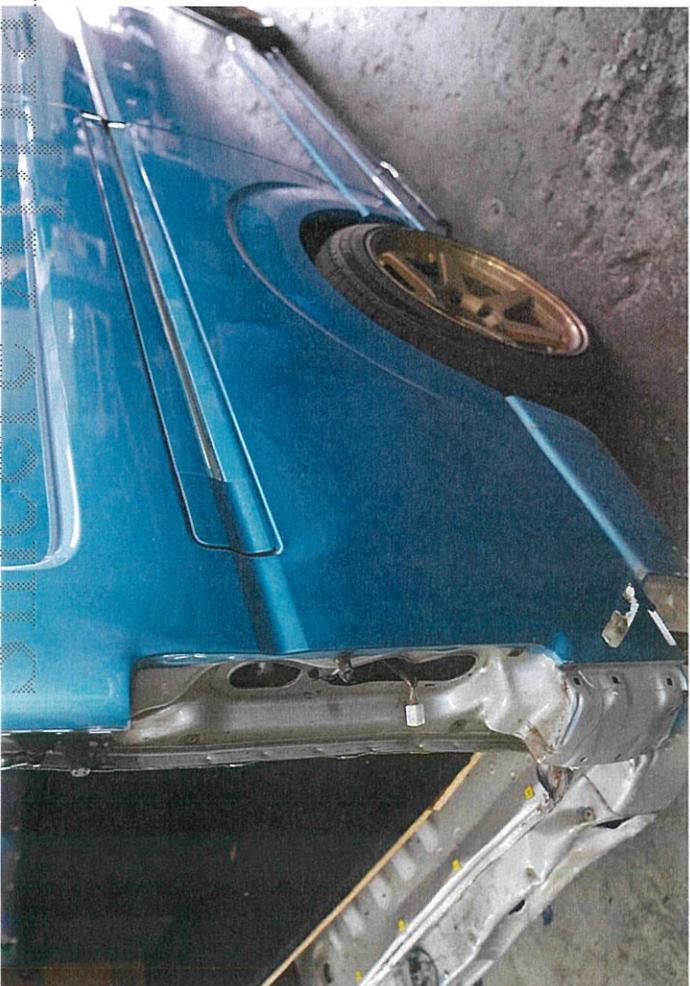
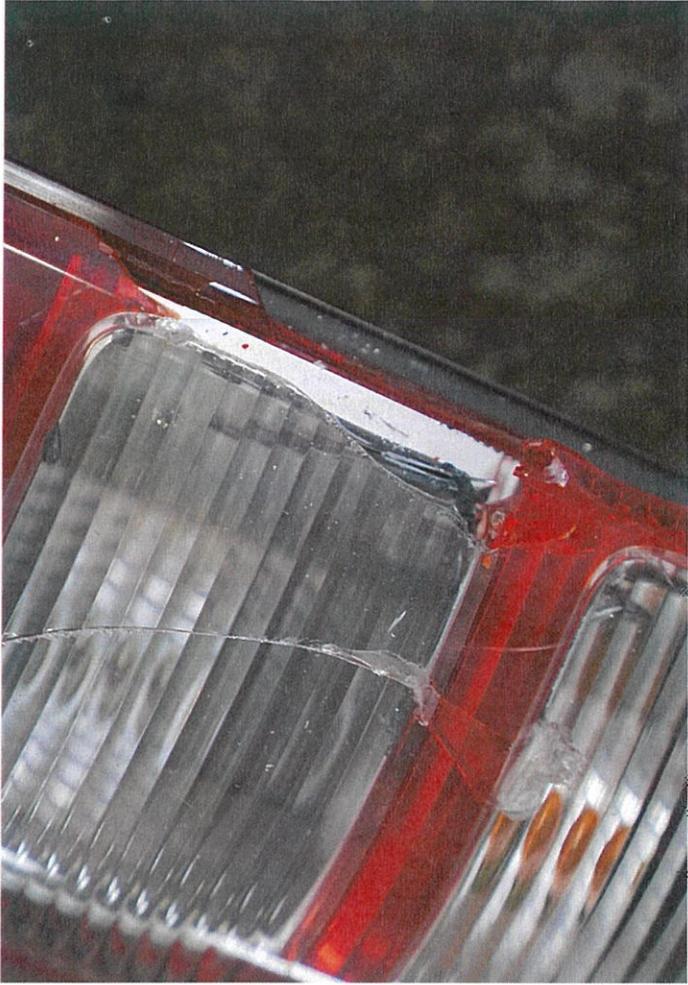
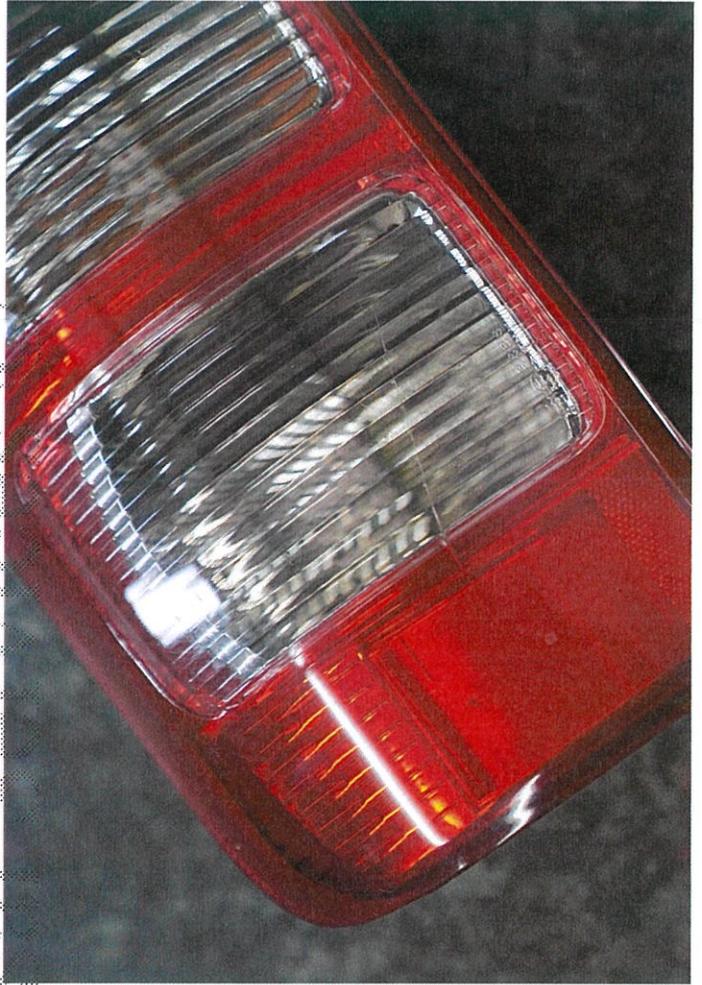
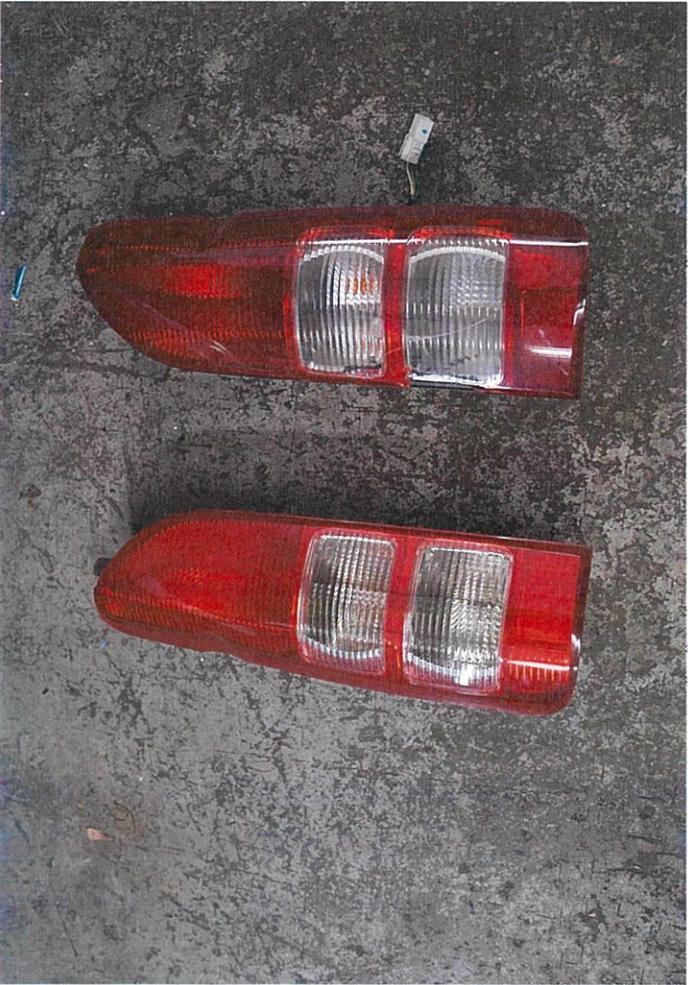
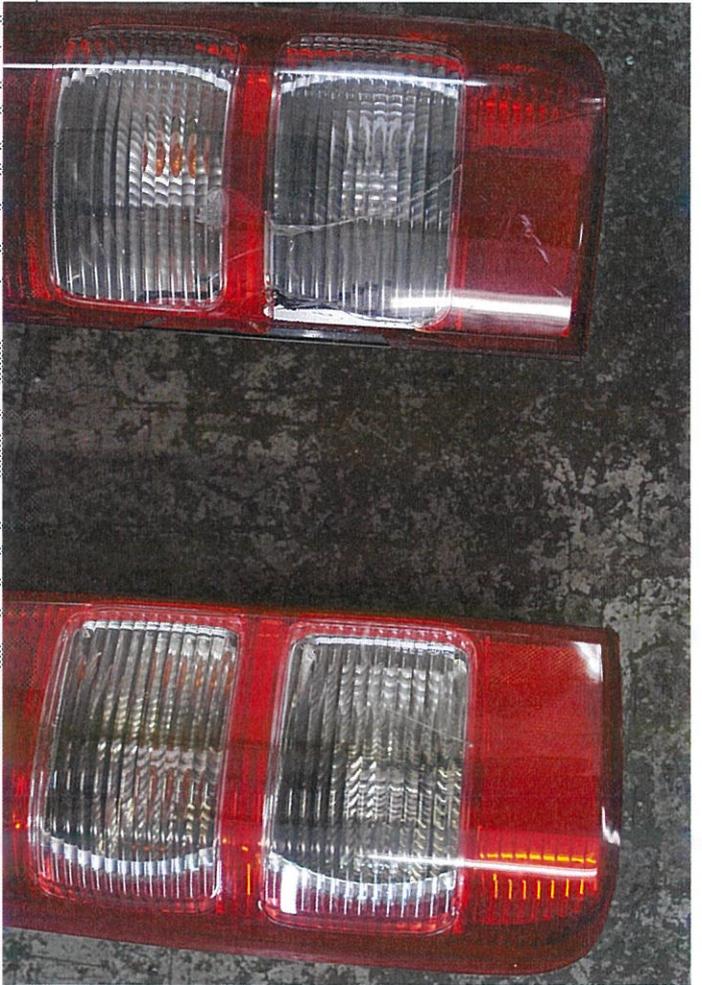
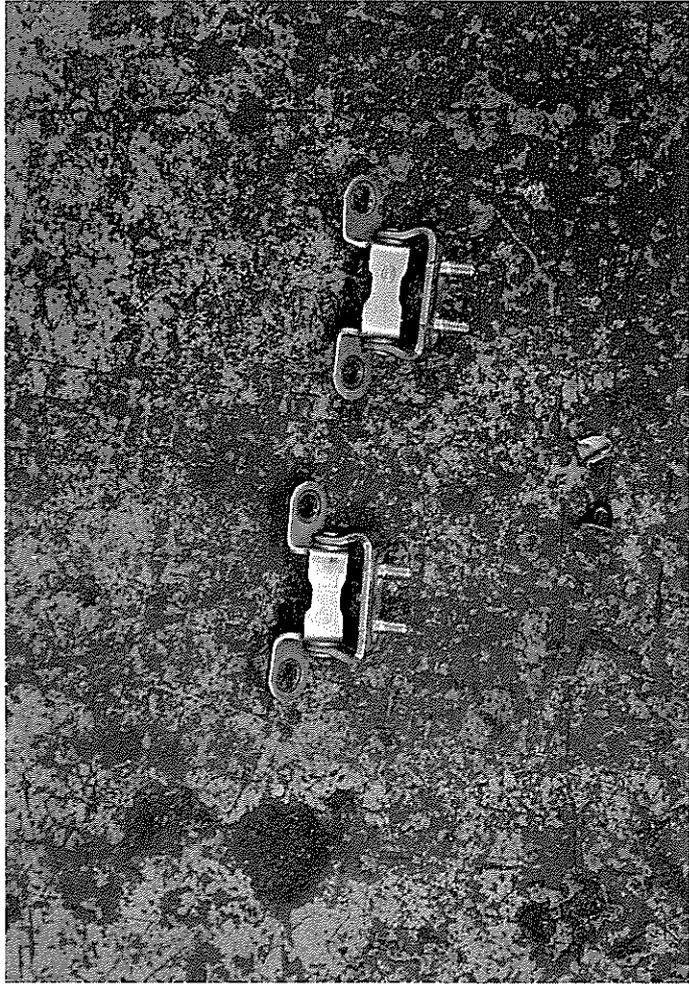
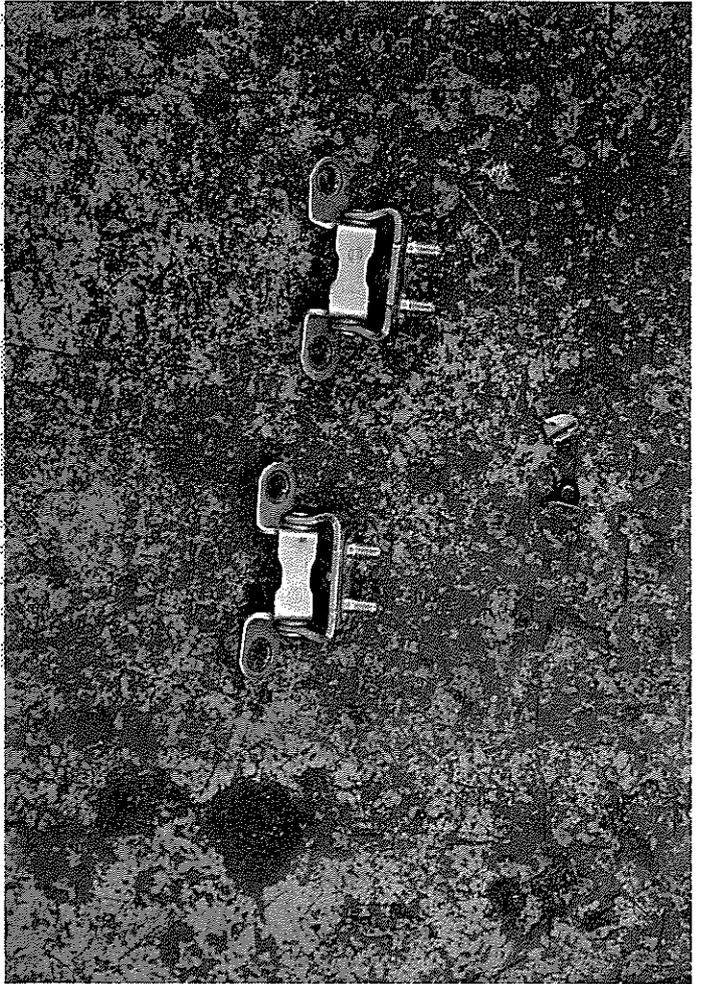
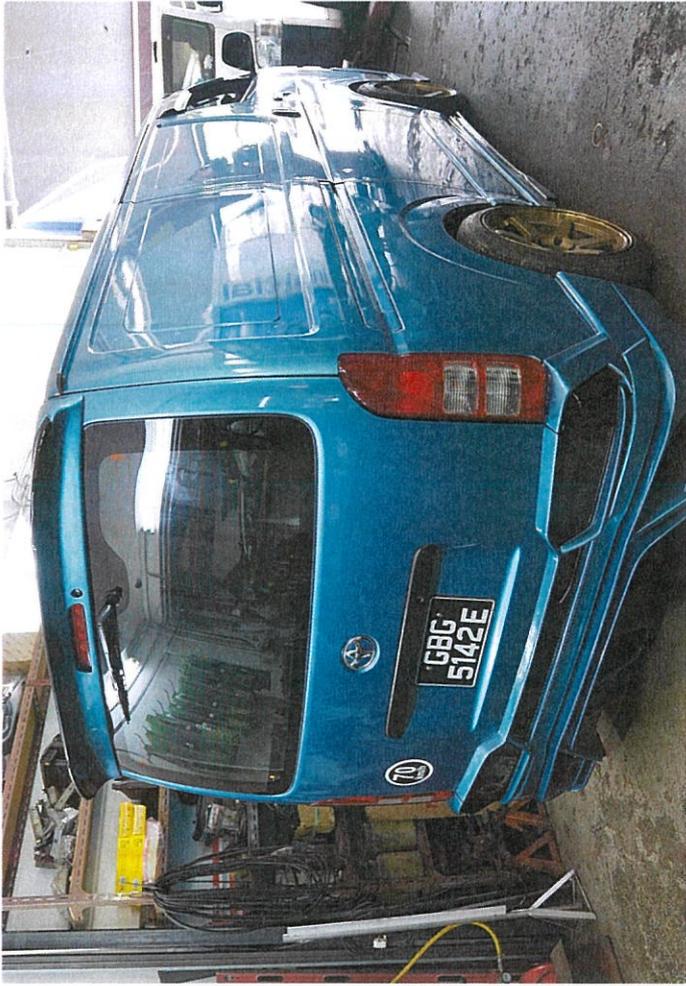
Our visual inspection of the vehicle revealed that the damages noted are at the rear portion.

We have inspected the actual damages found on the vehicle and recommend the replacement of parts and repairs accordingly. The estimated repair cost is \$14,525.50. The repairer has agreed to undertake the repairs at our adjusted lump sum amount of \$10,700.00.
