## LKK Auto Consultants Pte Ltd

## ADJUSTMENT ON REPAIR COST FOR VEHICLE NO. SHB 6188Y

PHOTOGRAPHS FOR VEHICLE NO. SHB 6188Y

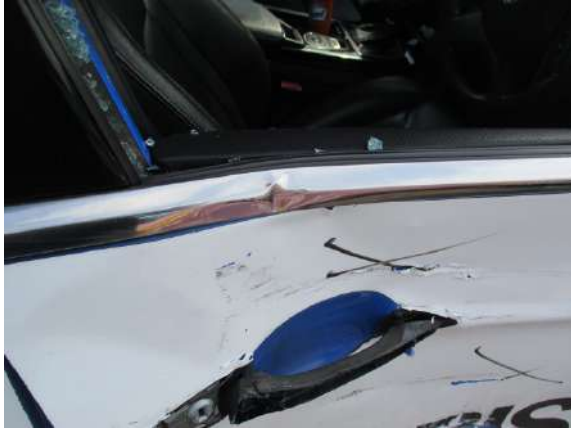
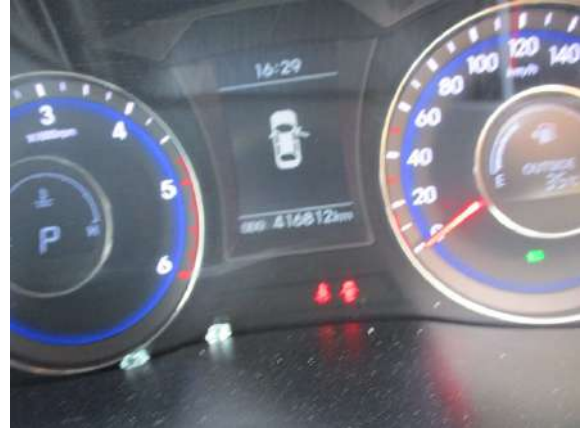
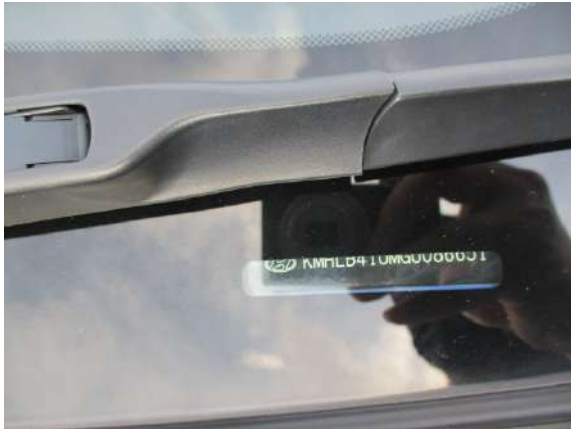
<b>4. Description of Damages</b>				
THE VEHICLE SUSTAINED DAMAGES AT THE O/S BODY. DAMAGES SEE DETAILS.				
<b>5. General Information</b>				
Accident Date	21/08/2021	Inspection Date	23/08/2021	
Survey held at	COMFORTDELGRO ENGINEERING PTE LTD 59 LOYANG DRIVE SINGAPORE 508969			
<b>5a. Remarks</b>				
A)THE INSPECTION WAS CONDUCTED ON A"WITHOUT PREJUDICE" BASIS. B)IN ACCORDANCE TO YOUR INSTRUCTIONS, WE HAVE NOT AUTHORISED REPAIRS.				
<b>5b. Estimate Days of Repair</b>				
ESTIMATED NORMAL PERIOD FOR REPAIR:			4 Working Days
