**MAKE/MODEL: HONDA CBR1000RR FIREBLADE
REGISTRATION NO: FBJ2330H**

VEHICLE APPRAISAL REPORT

The vehicle sustained damages on front & both sides.

ASSESSMENT FOR REPAIR : FBJ2330H

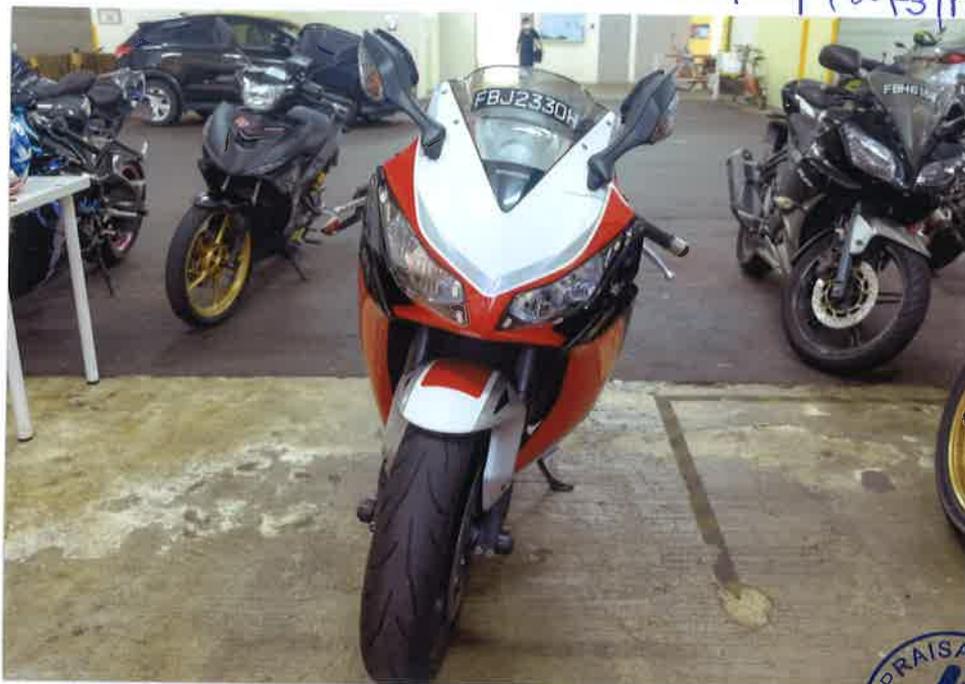
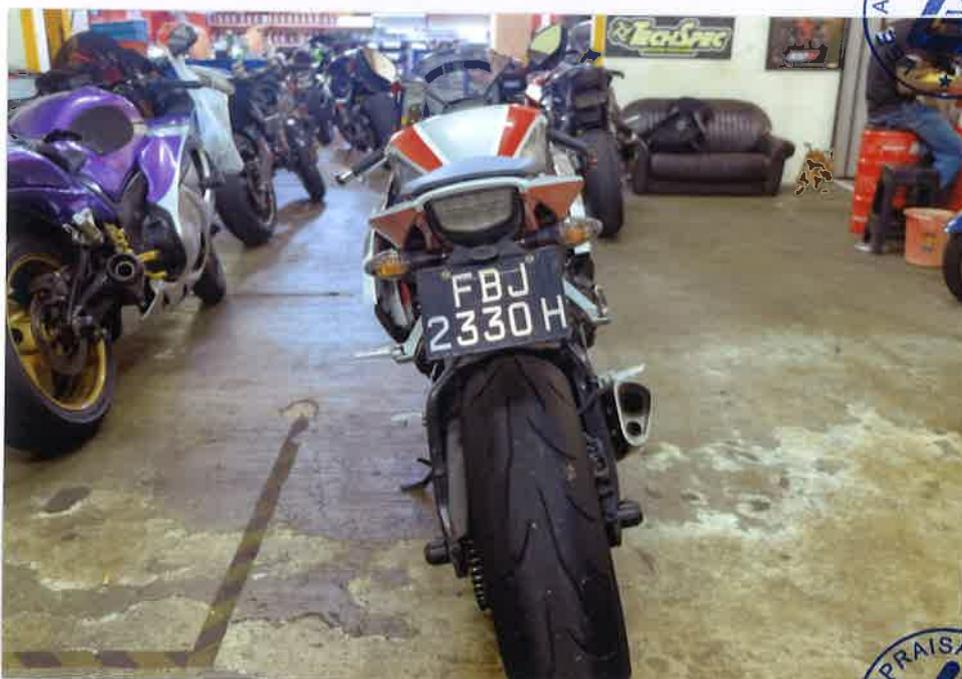
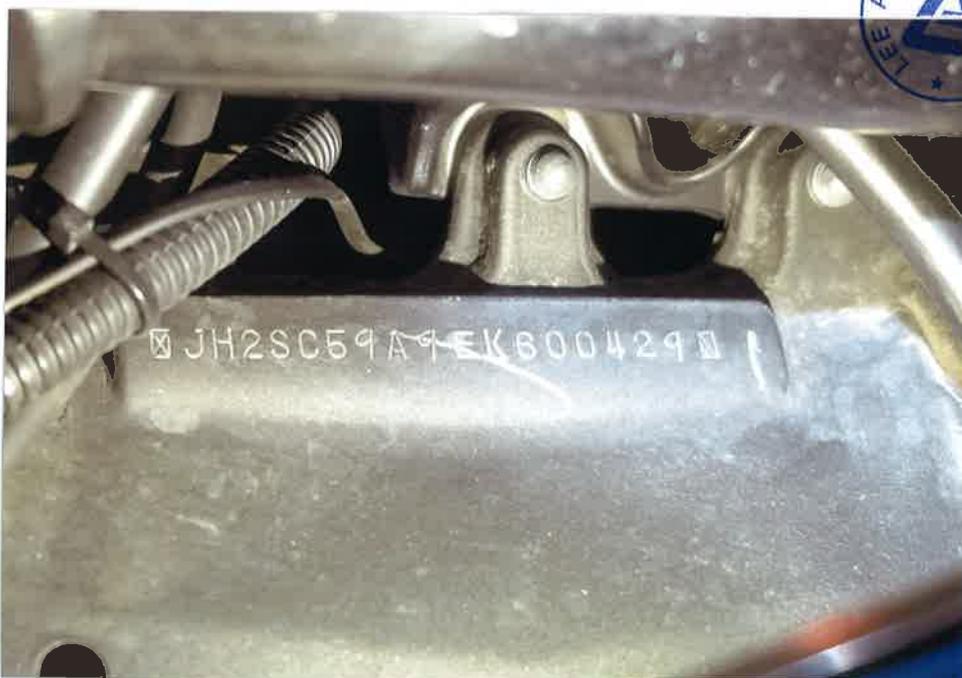
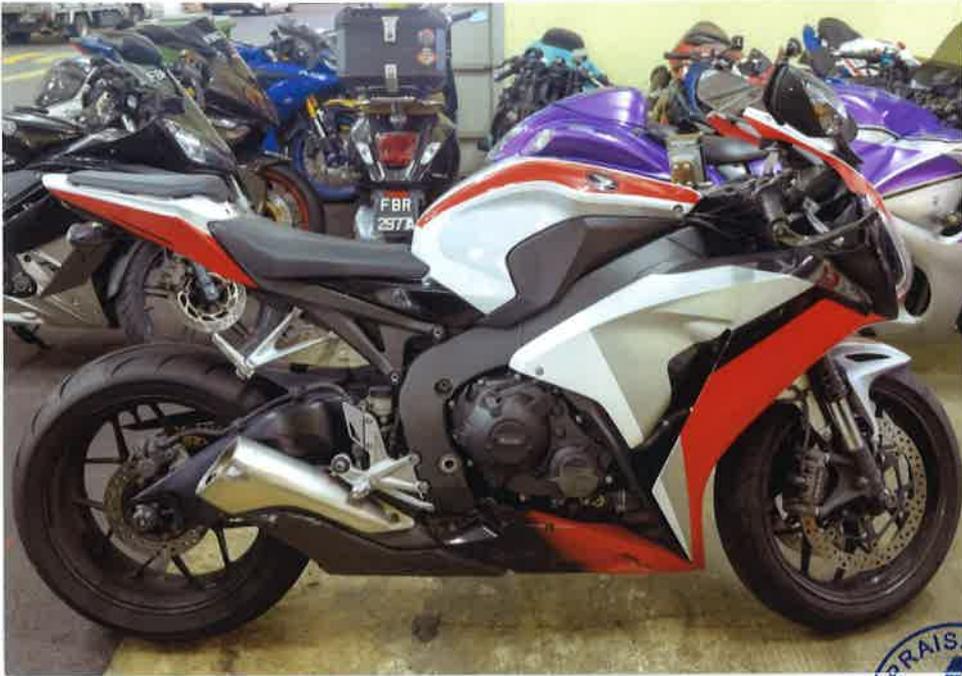
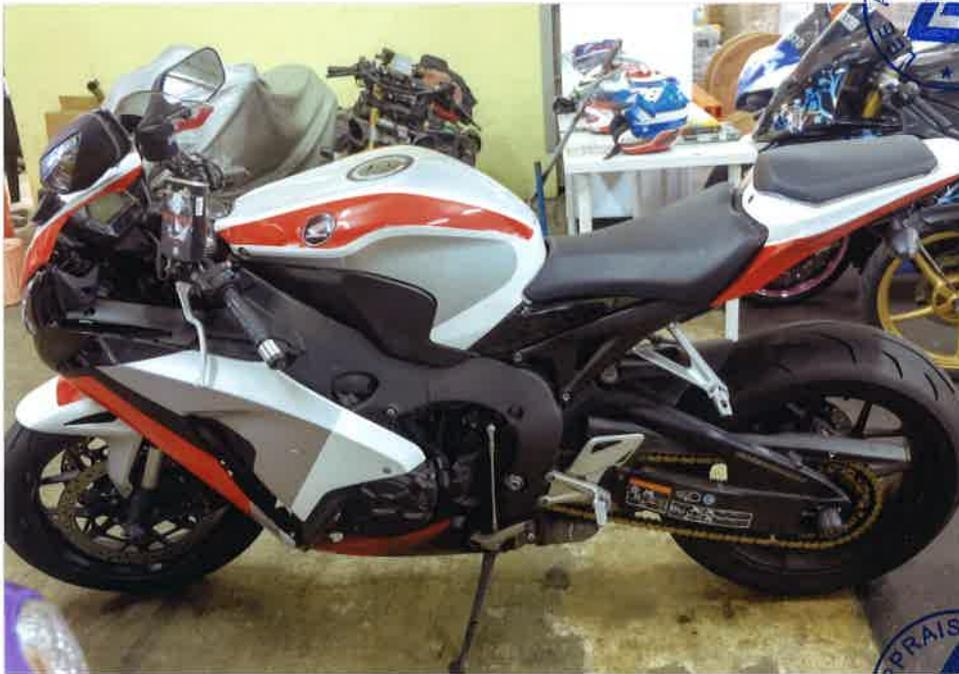
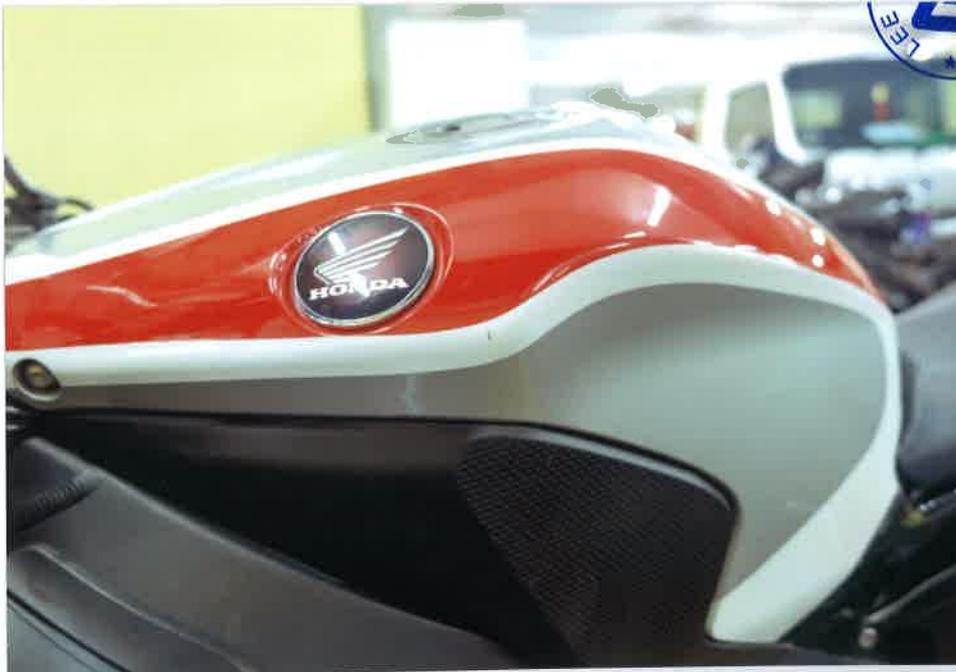
Please refer to photographs and assessment of repairs for details.

Repair cost to the vehicle is assessed as **\$12,750.00** on **lump sum basis**
