Our Reference : KAAS/TA/5348/2794/TP/01.19
Date : 10 February 2019

VEHICLE APPRAISAL REPORT

Registration No.	: SLJ 2794J	Chassis Frame No.	: WBA3X32020DZ23268
Make / Model	: BMW 328i GT 5Dr ABD HID DSC NAV	Engine No. (Logcard)	: B4870553N20B20A
Year of Manufacture/Reg	: 2013	Odometer Reading	: 82,357 KM
Colour	: White		
Class / Type	: Saloon

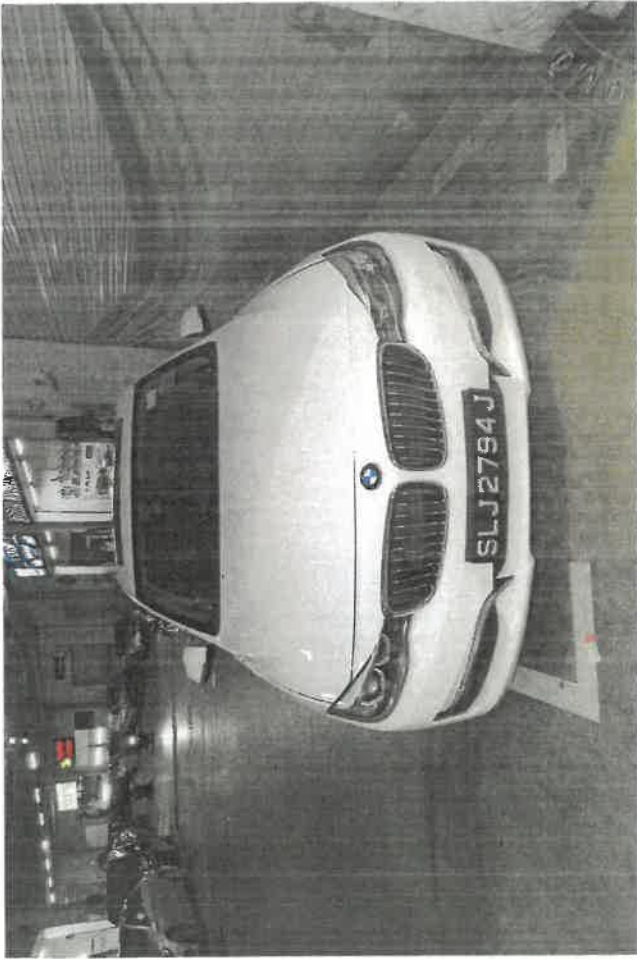
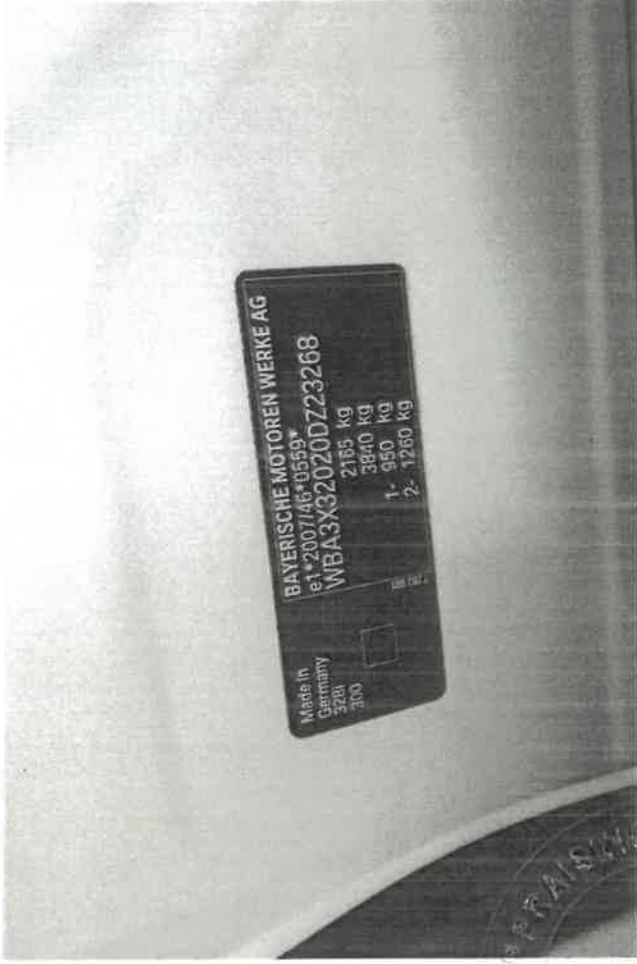
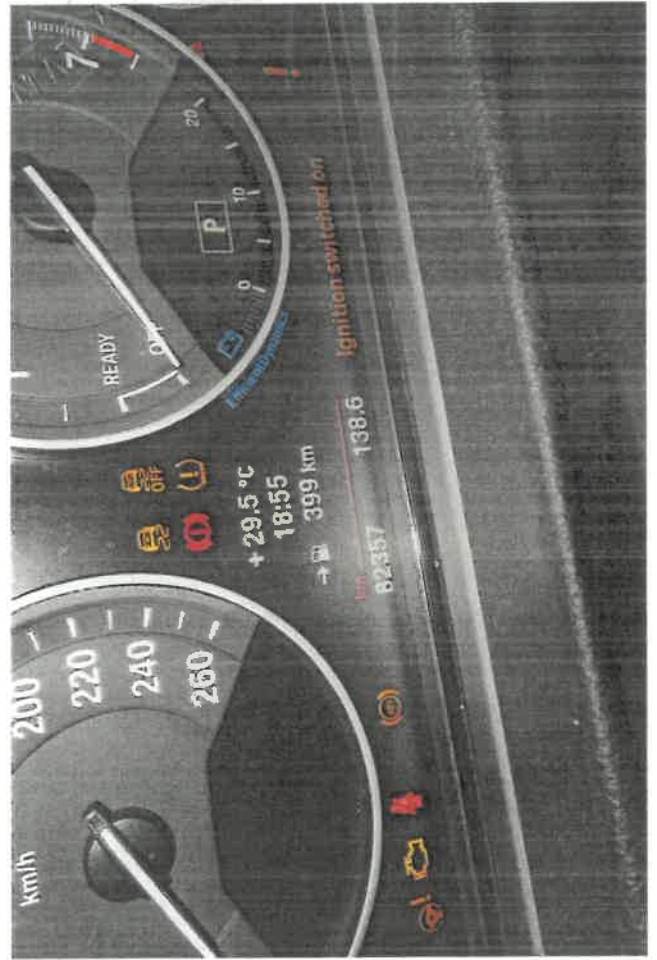
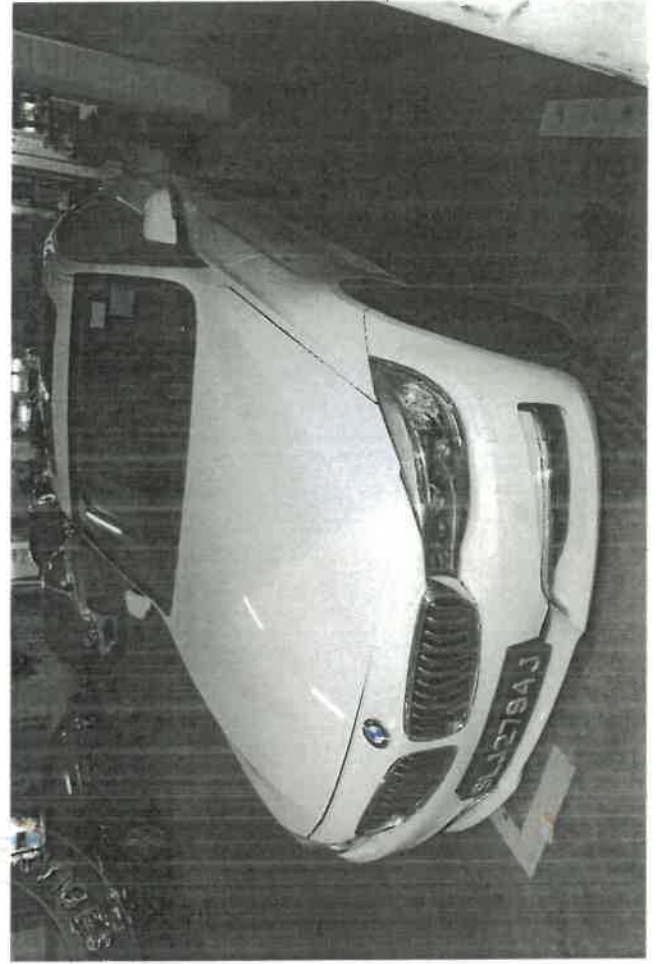
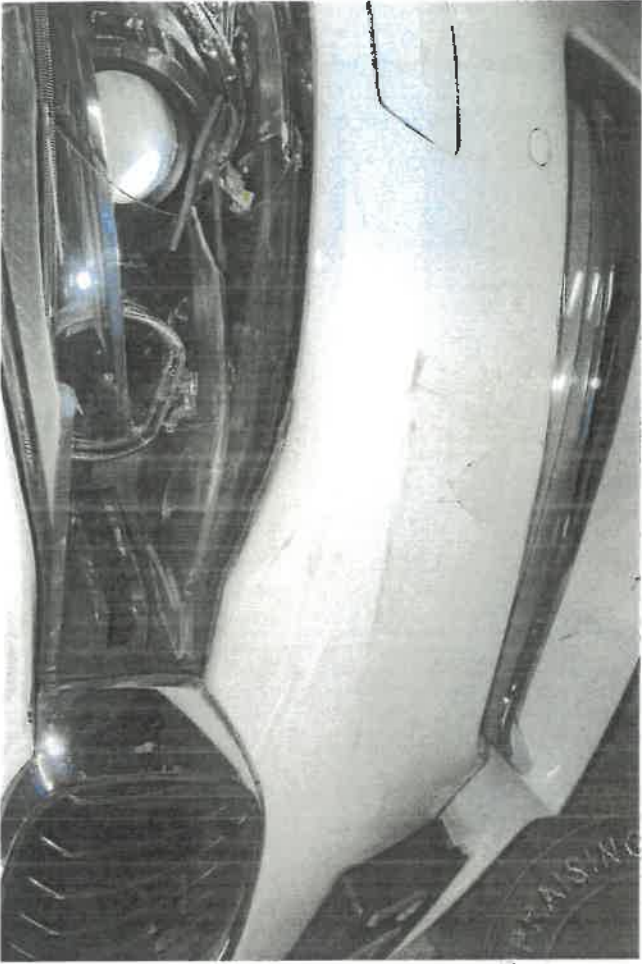
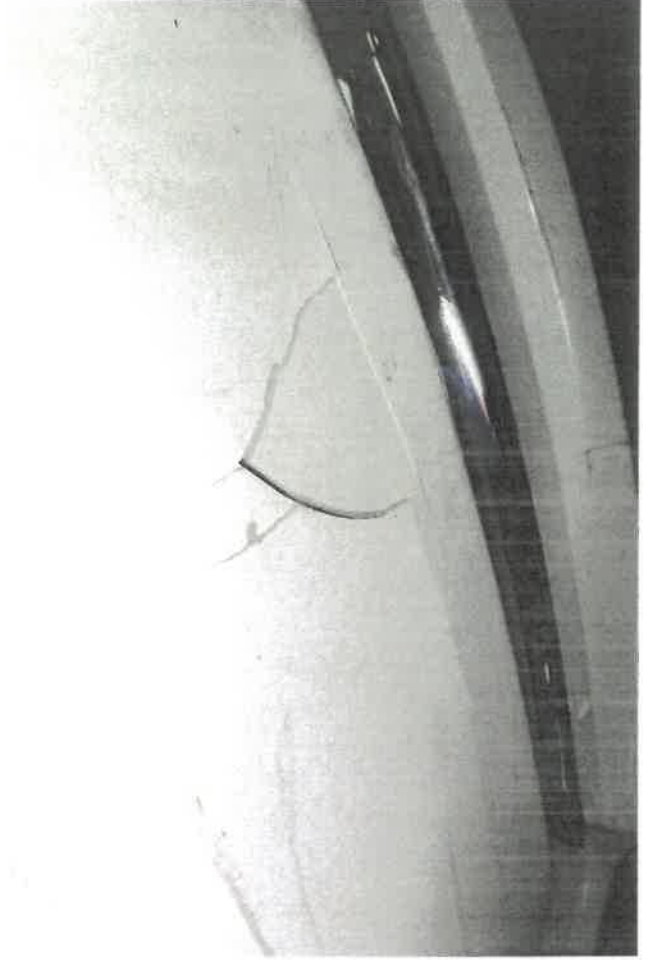
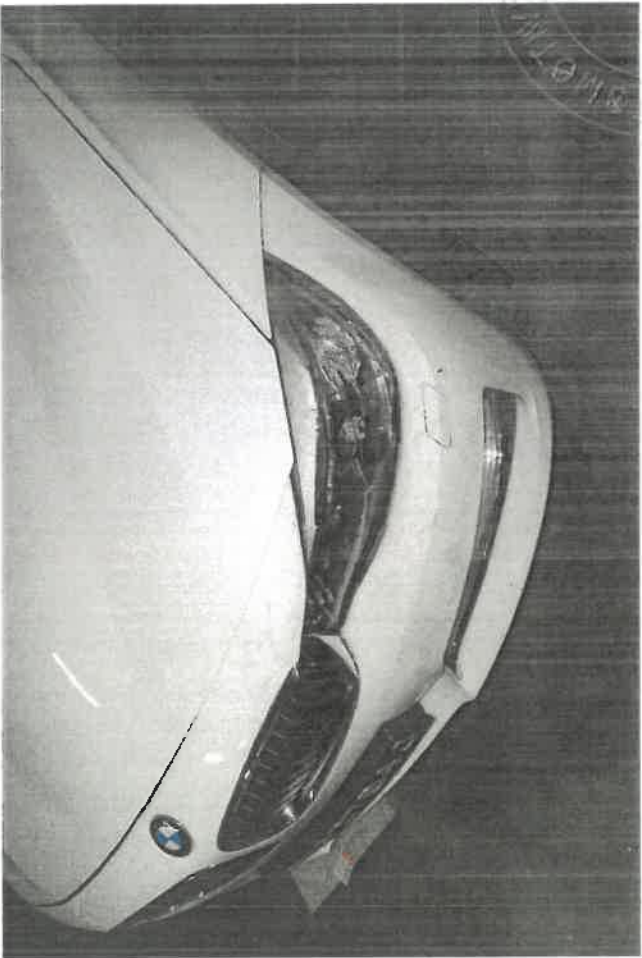
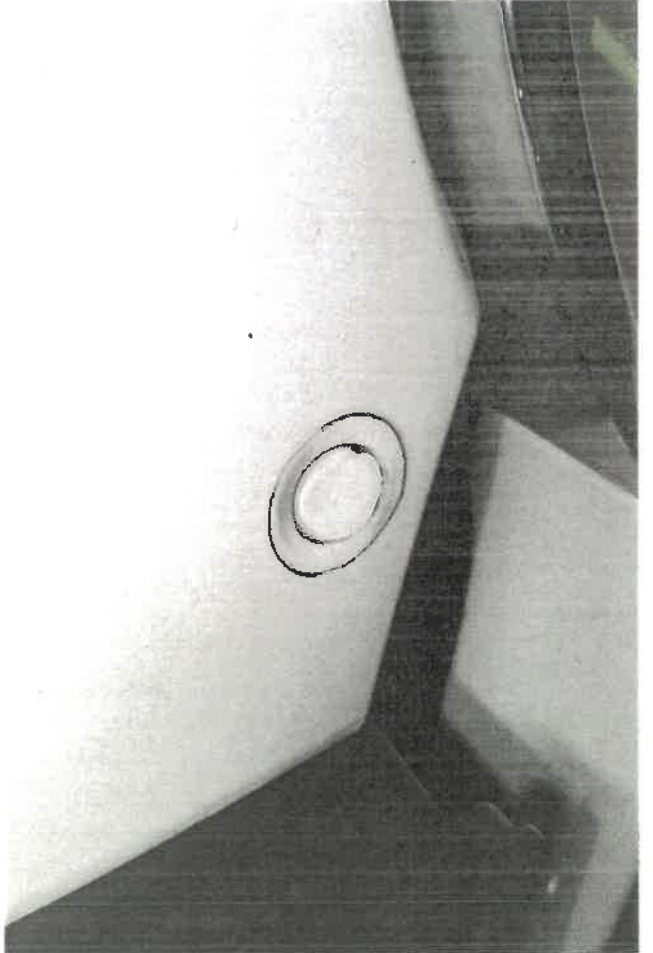
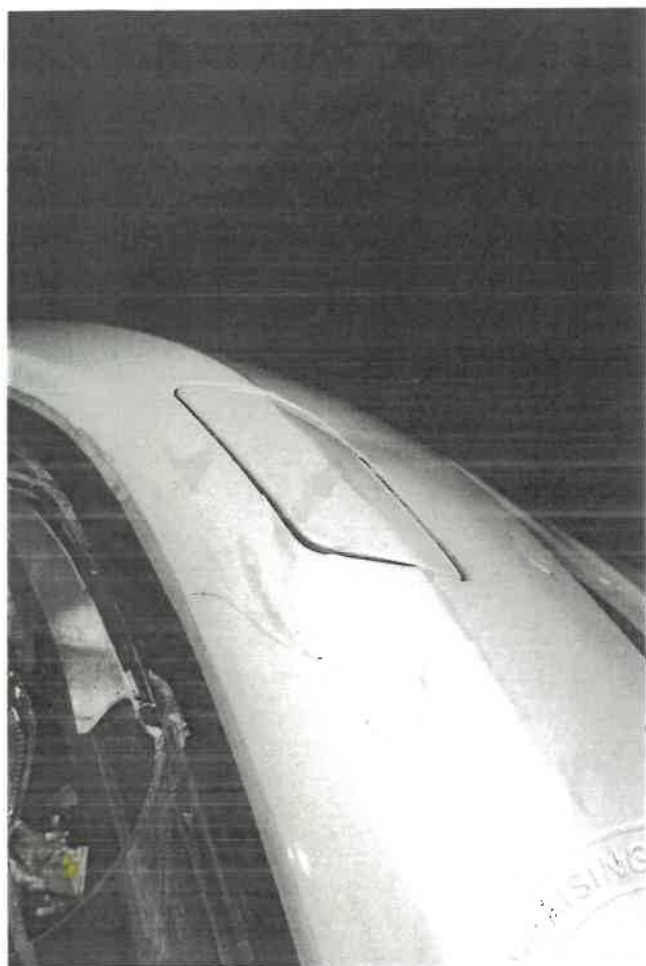
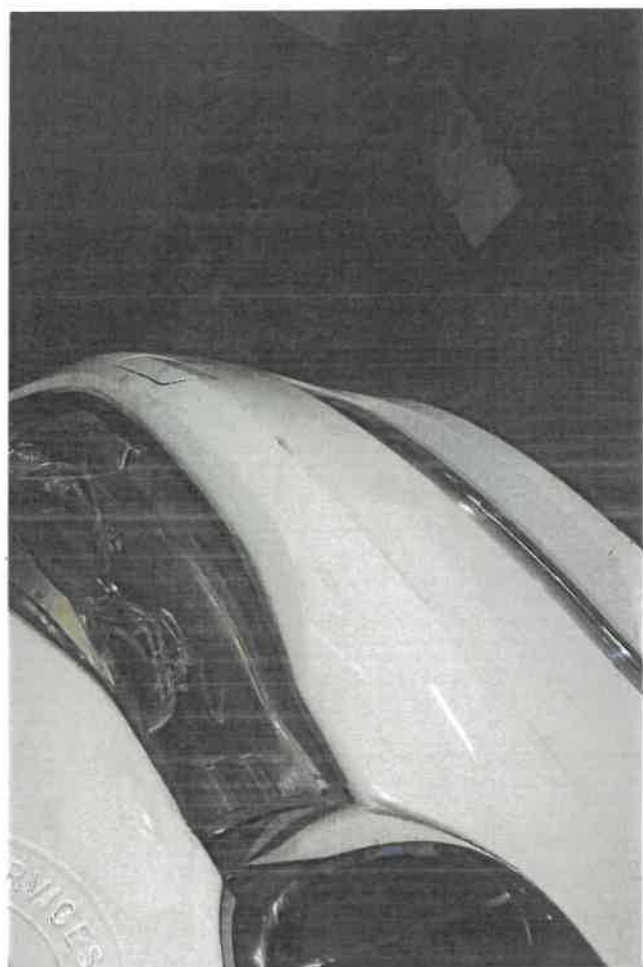
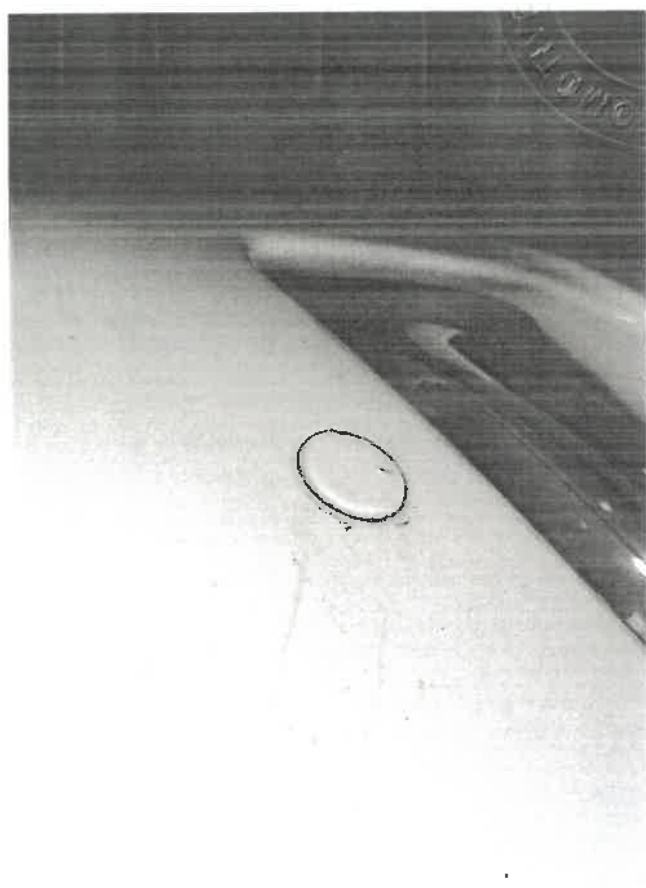
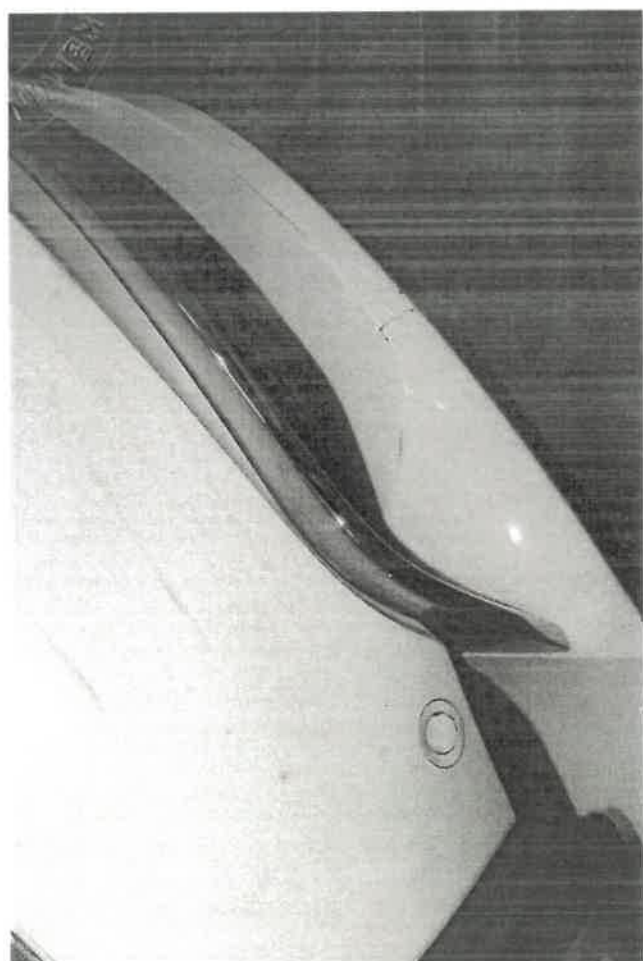
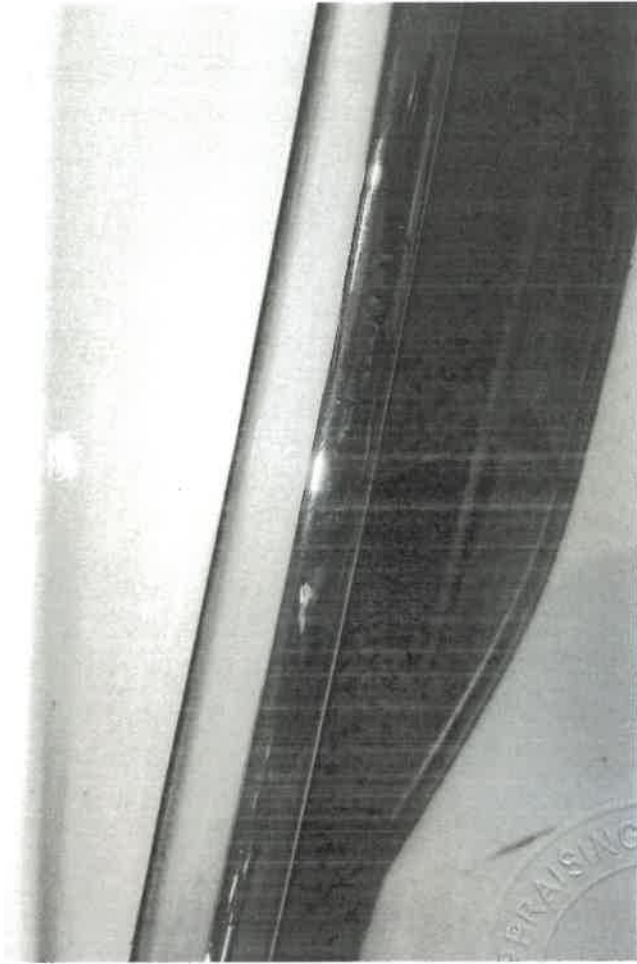
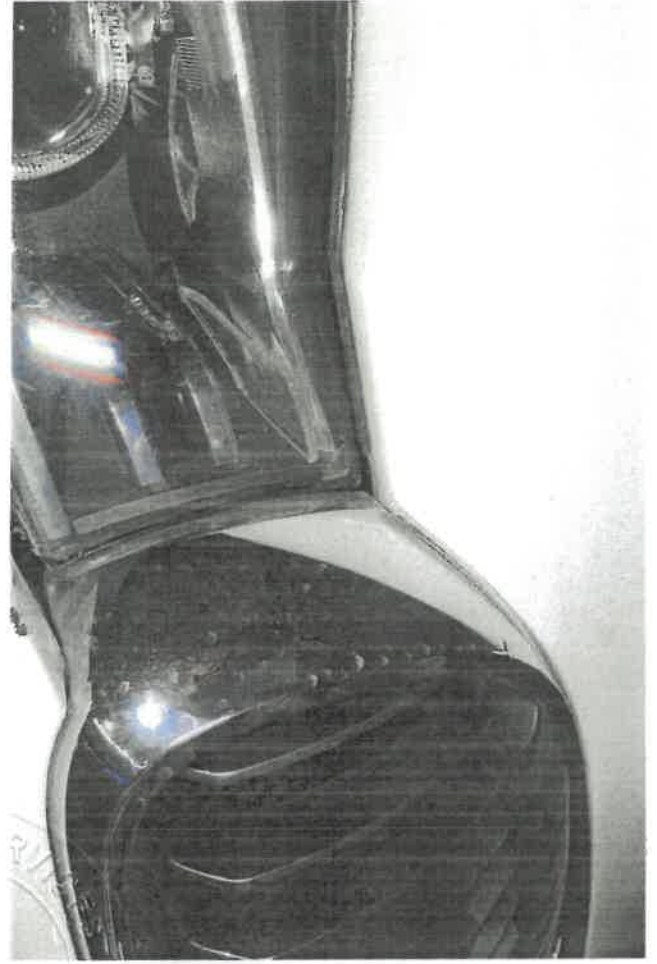
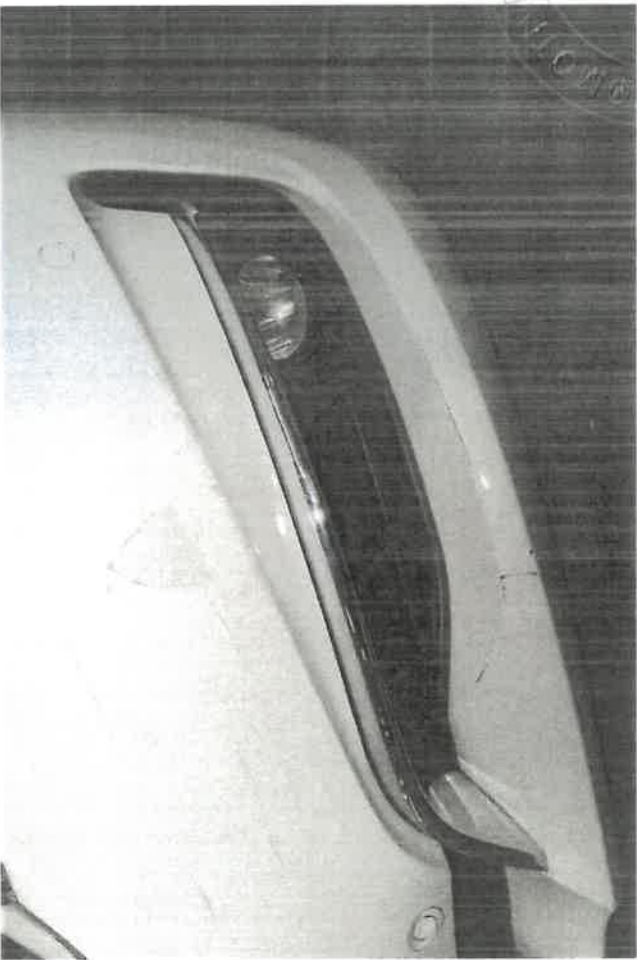
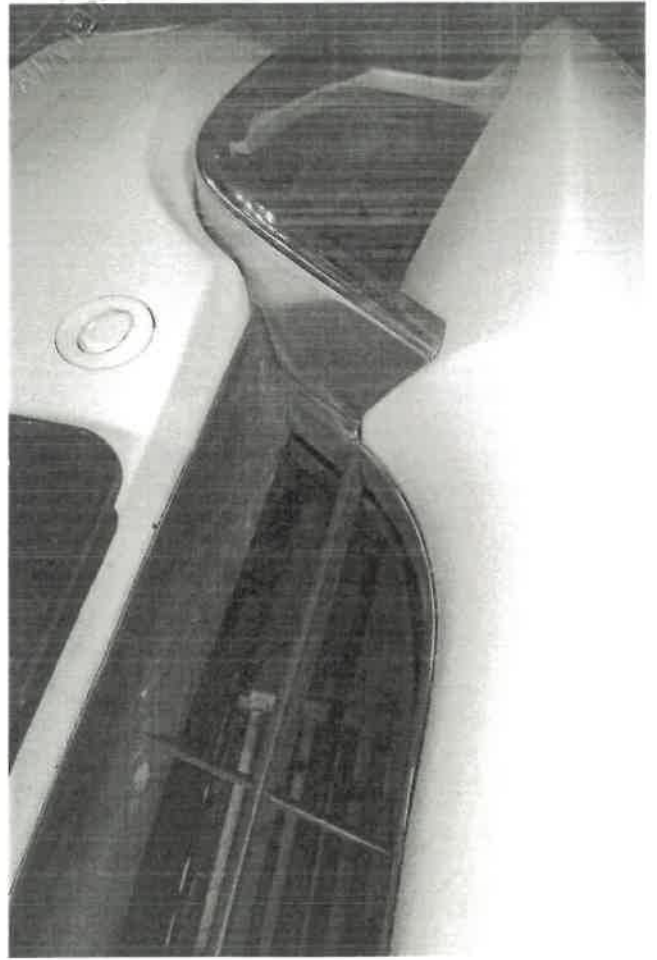
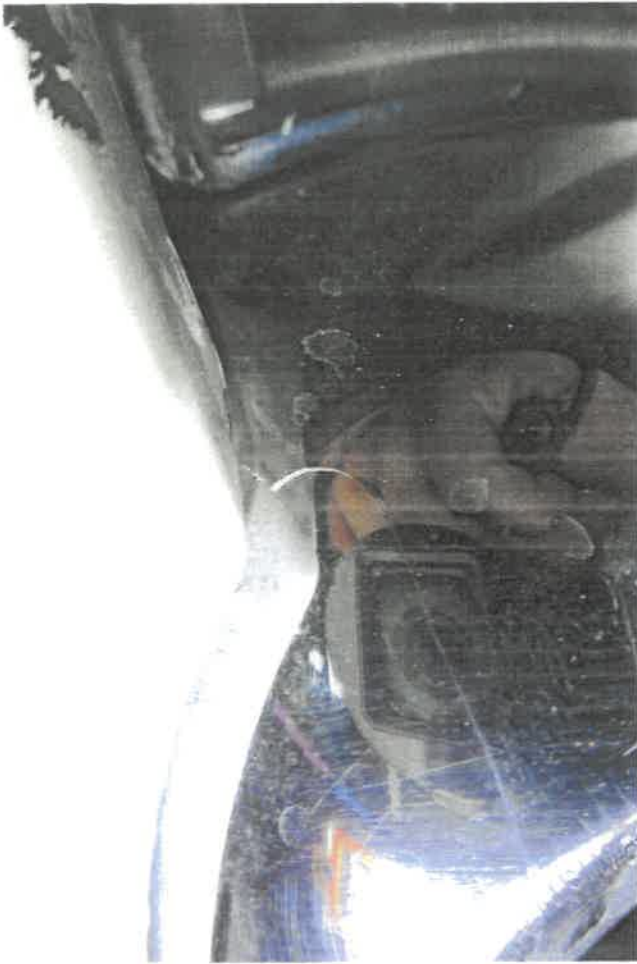
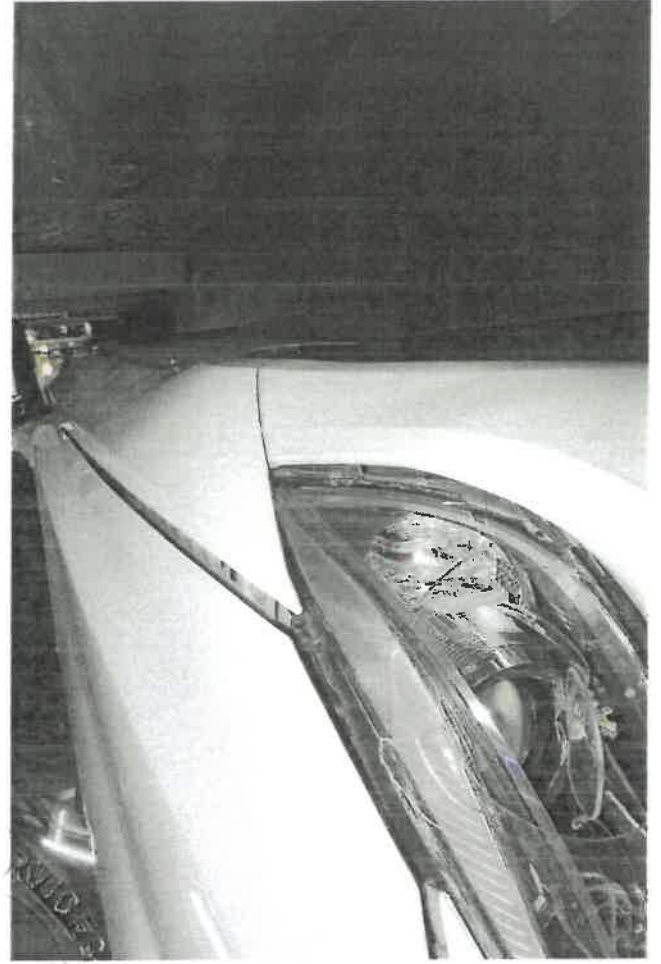
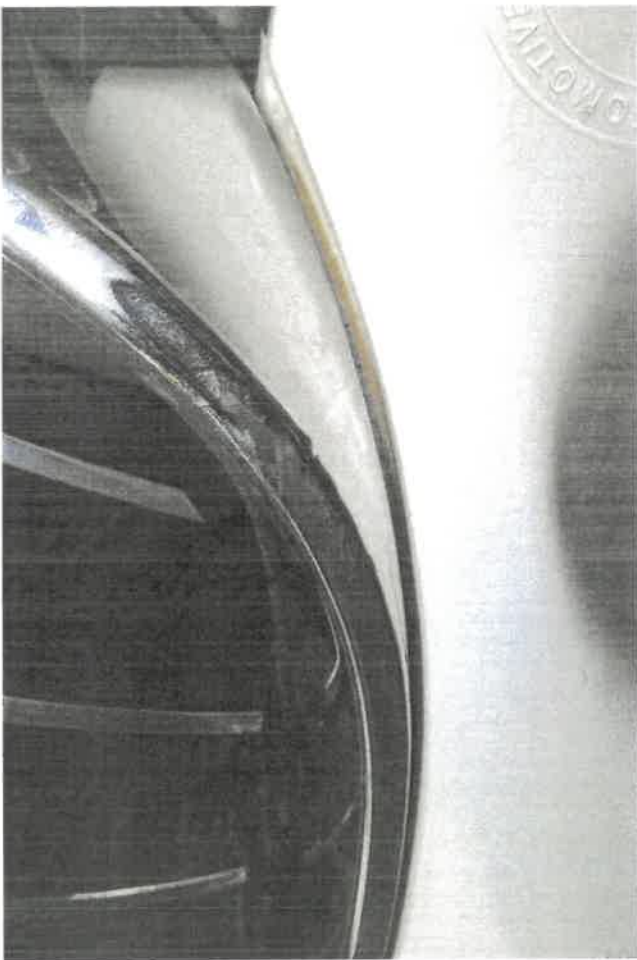
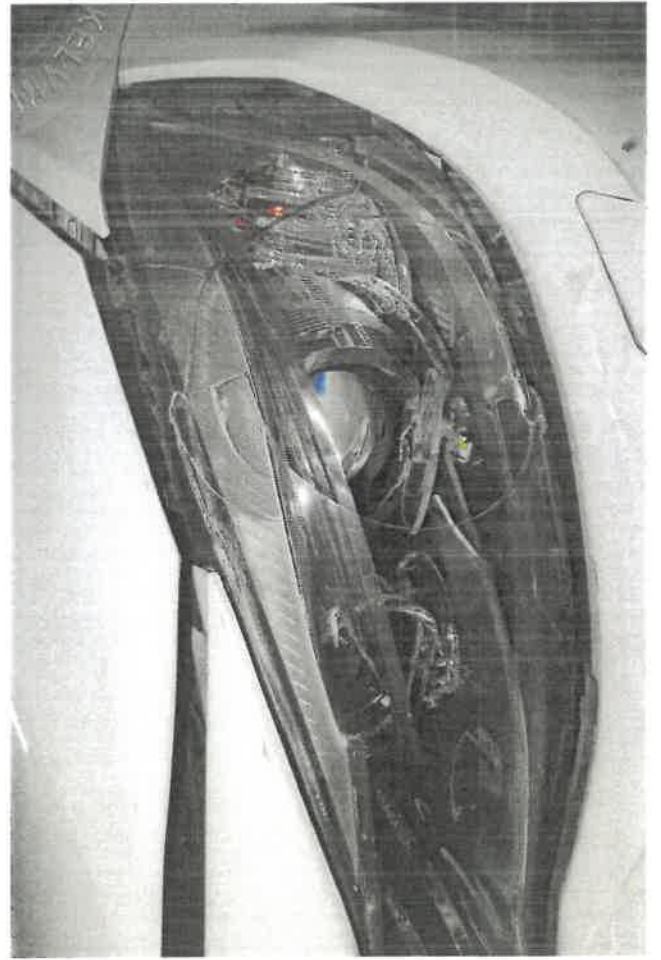
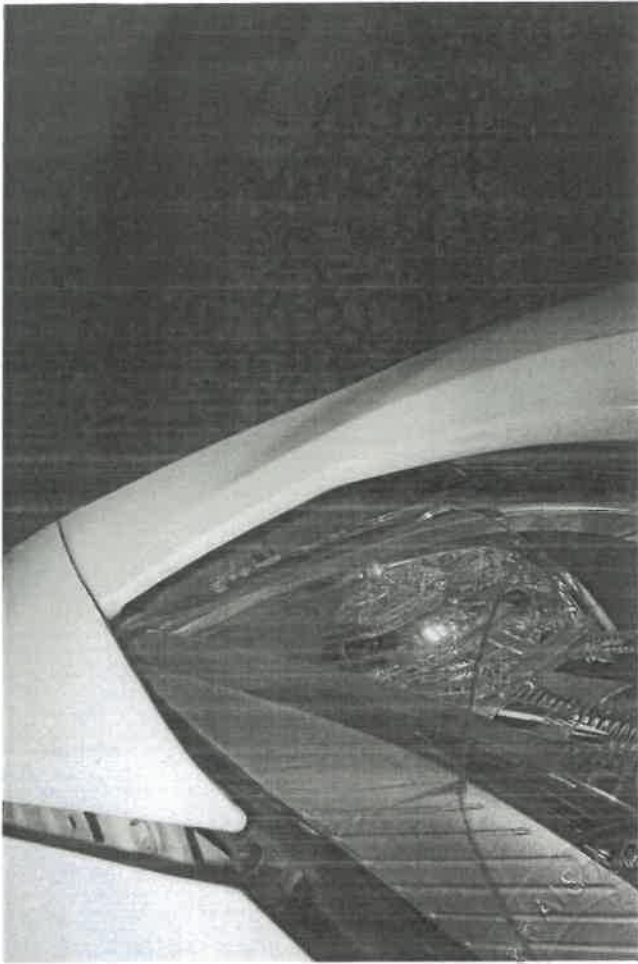
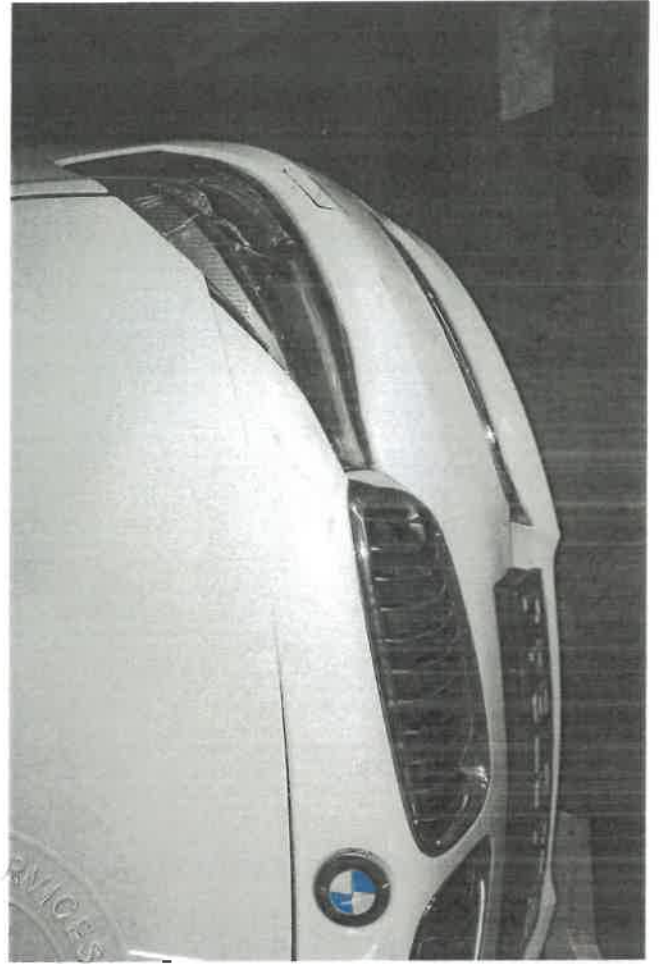
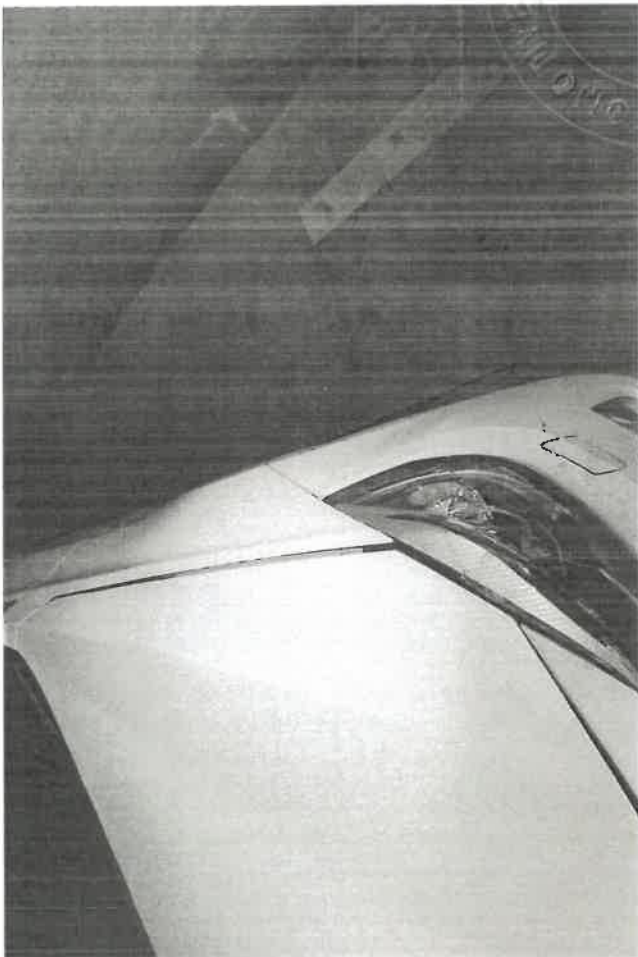
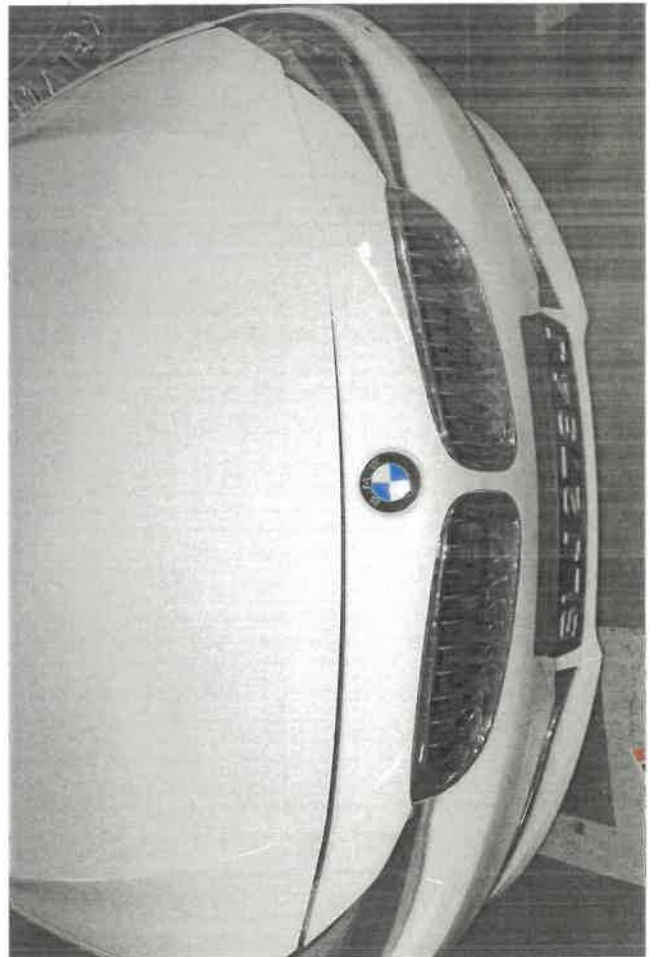
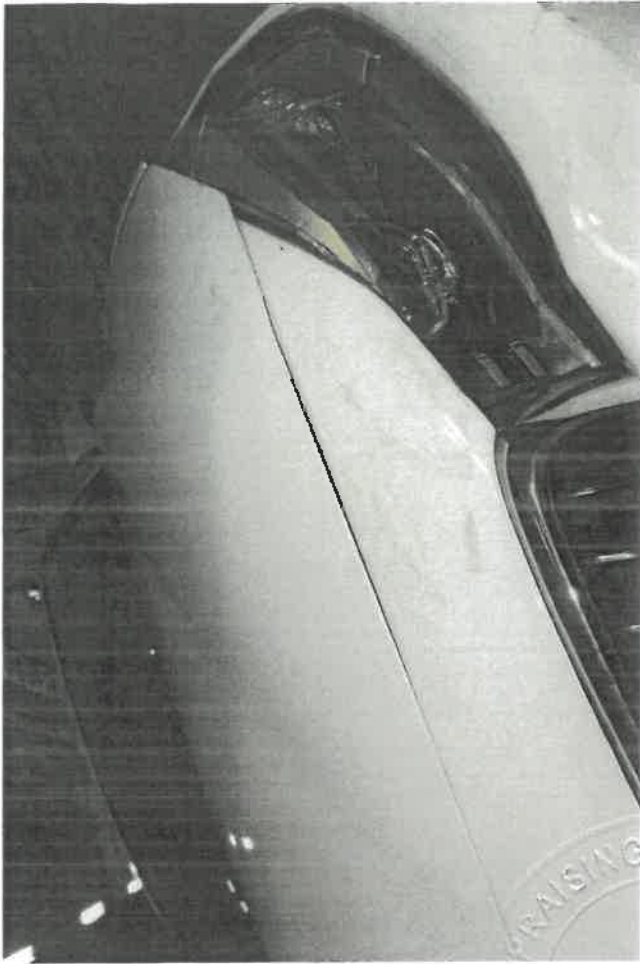
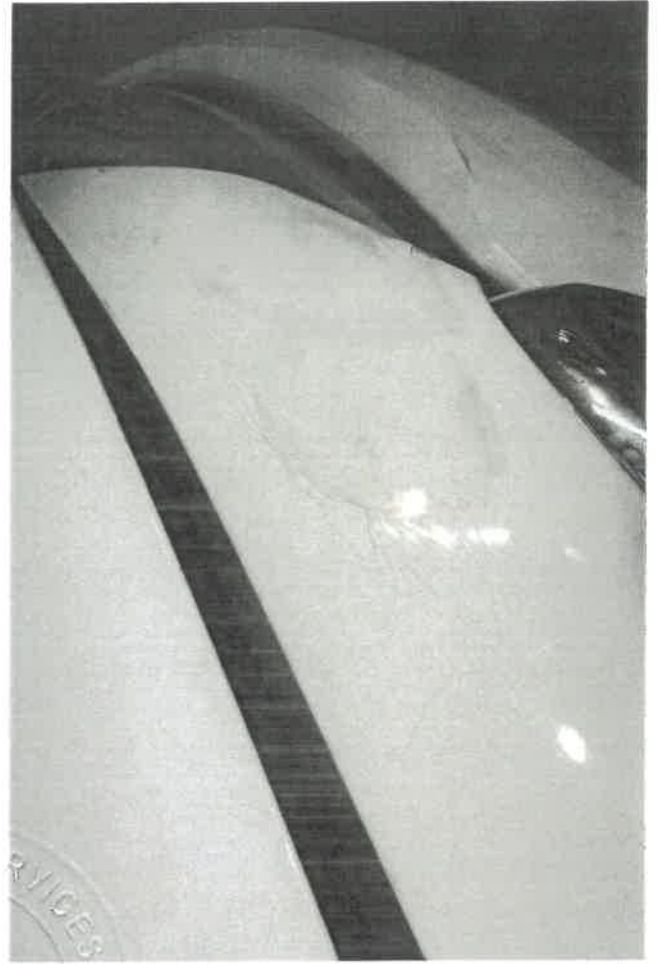
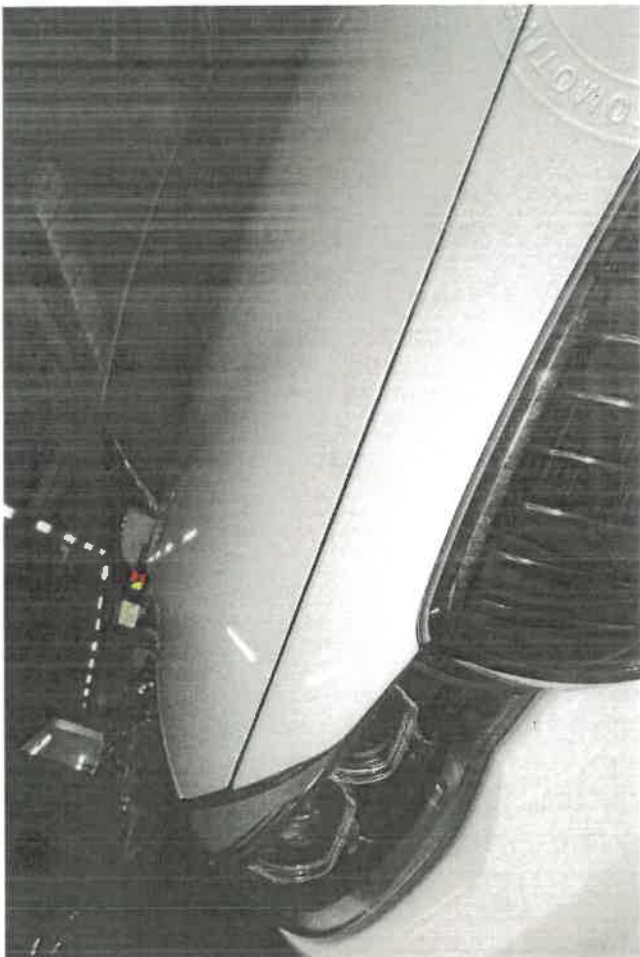
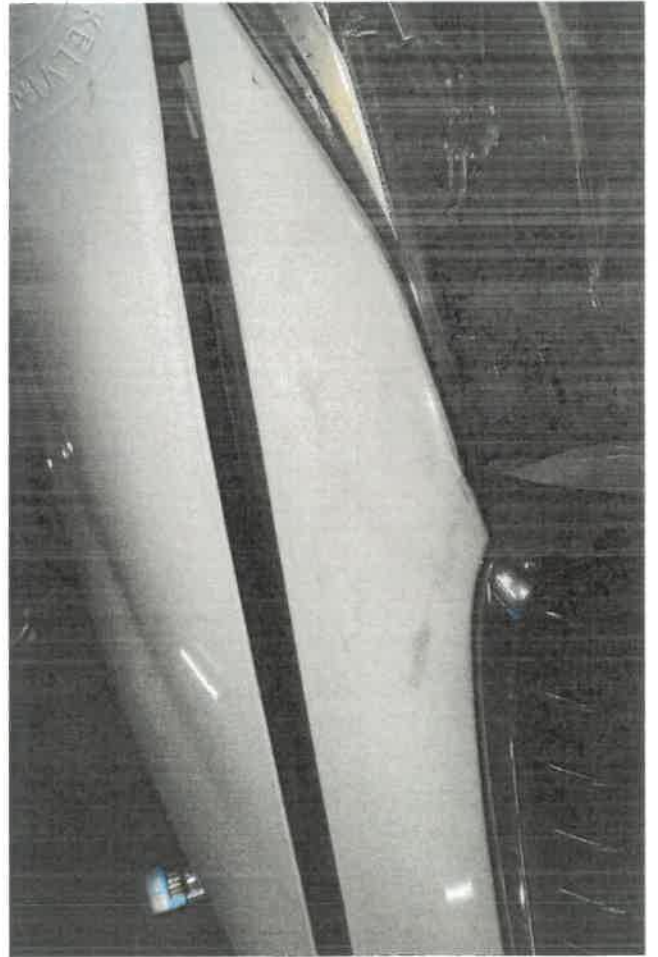
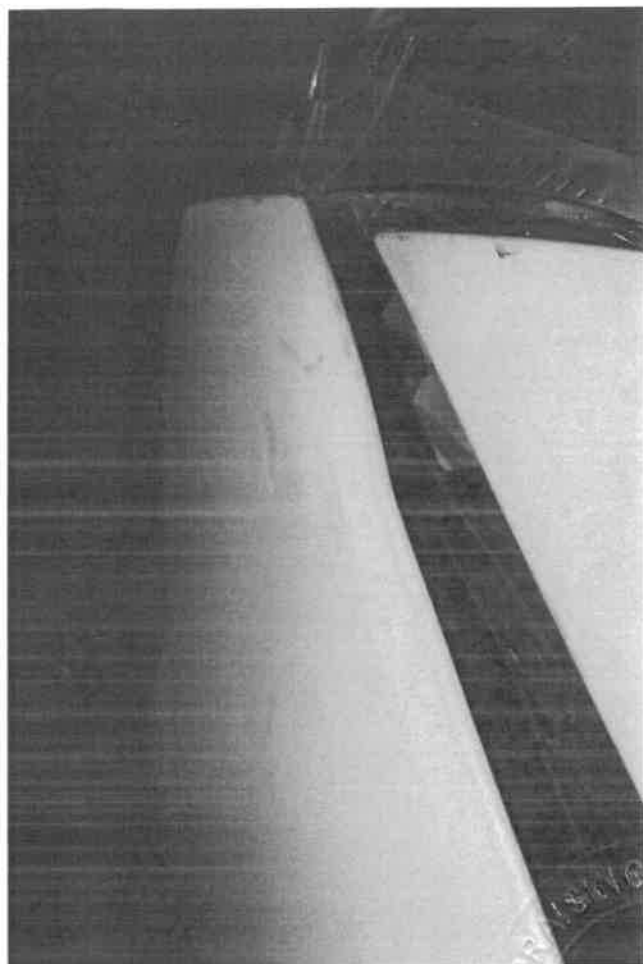
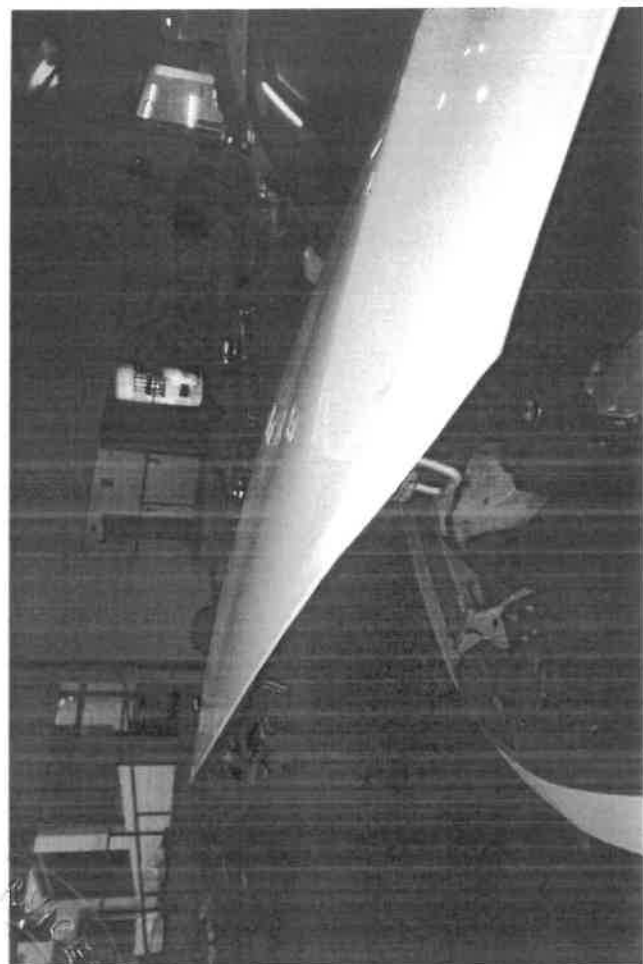
Damages sustained were consistent with the subject vehicle being involved in a collision with another vehicle and the impact was delivered **Diagonally to the LH Front from left to right; rear to front;** portion of the vehicle.

The general area of damages is at the **LH Front portion**
(Please refer to the parts list and photographs as attached for more information)

The estimated repair costs submitted by Messrs **Apex Motoring** is \$ 11,363.00
We have adjusted the cost to \$ 9,187.78 and the repairer has agreed to undertake the repairs at a
Contract Lump Sum of \$ 7,350.00 to a acceptable quality and standards.
However, we have not given authorization and instruction to the repairer to proceed with the repairs.
