Our Reference : KAAS/TA/5348/2794/TP/01.19
Date : 10 February 2019

VEHICLE APPRAISAL REPORT

Registration No.	: SLJ 2794J	Chassis Frame No.	: WBA3X32020DZ23268
Make / Model	: BMW 328i GT 5Dr ABD HID DSC NAV	Engine No. (Logcard)	: B4870553N20B20A
Year of Manufacture/Reg	: 2013	Odometer Reading	: 82,357 KM
Colour	: White		
Class / Type	: Saloon

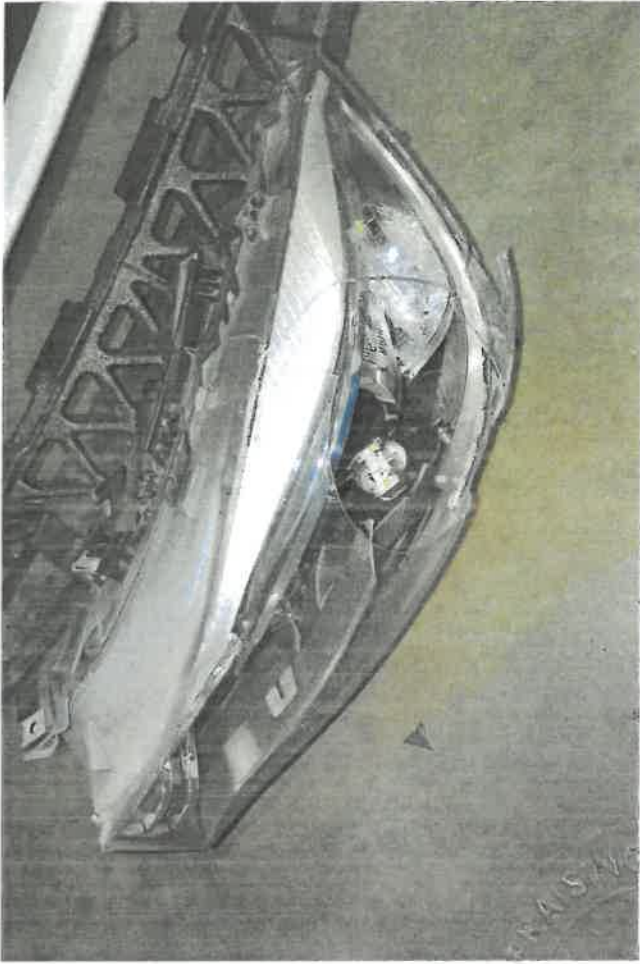
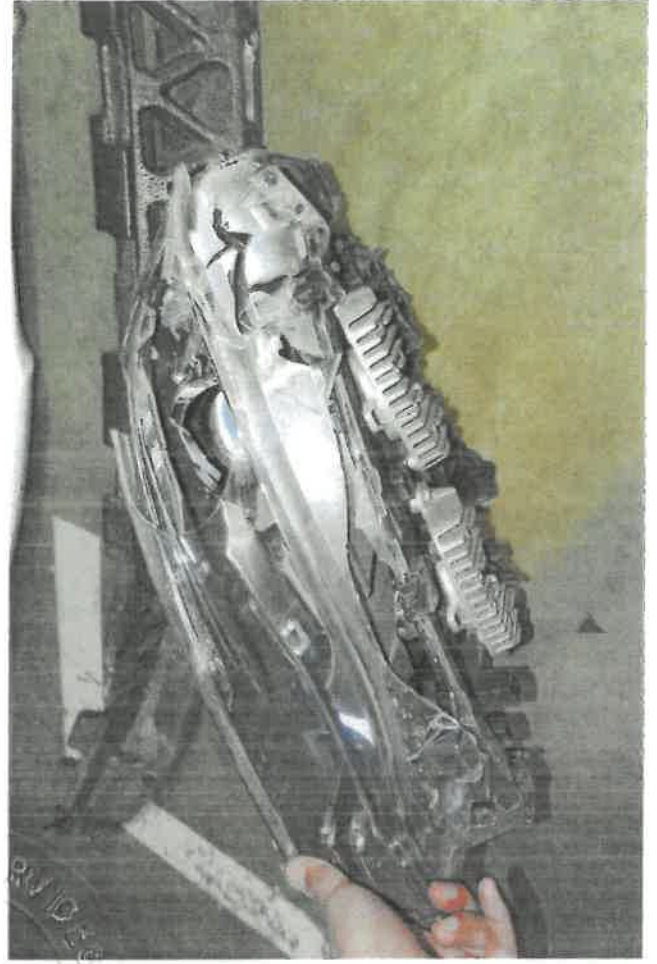
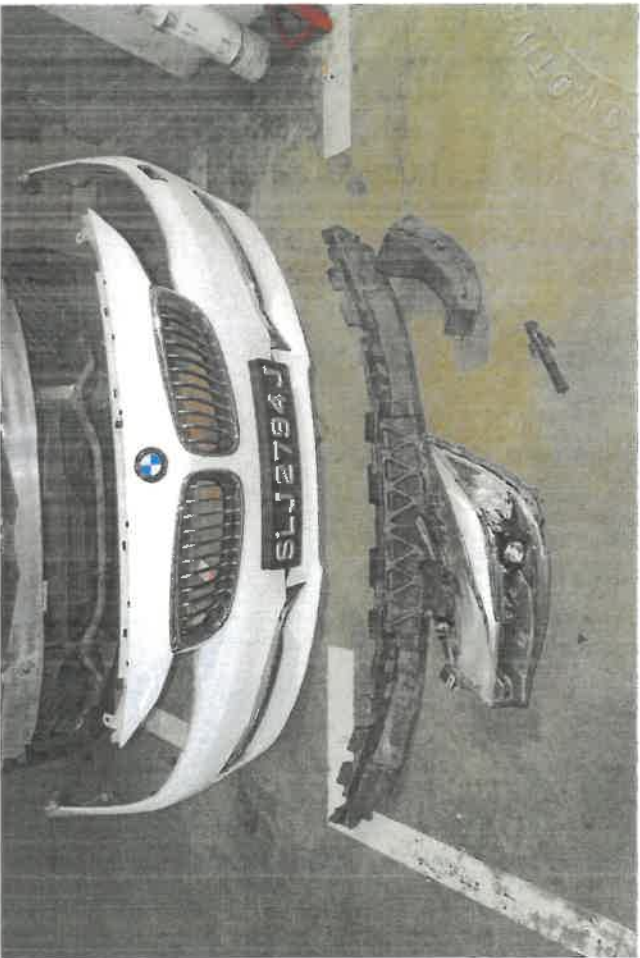
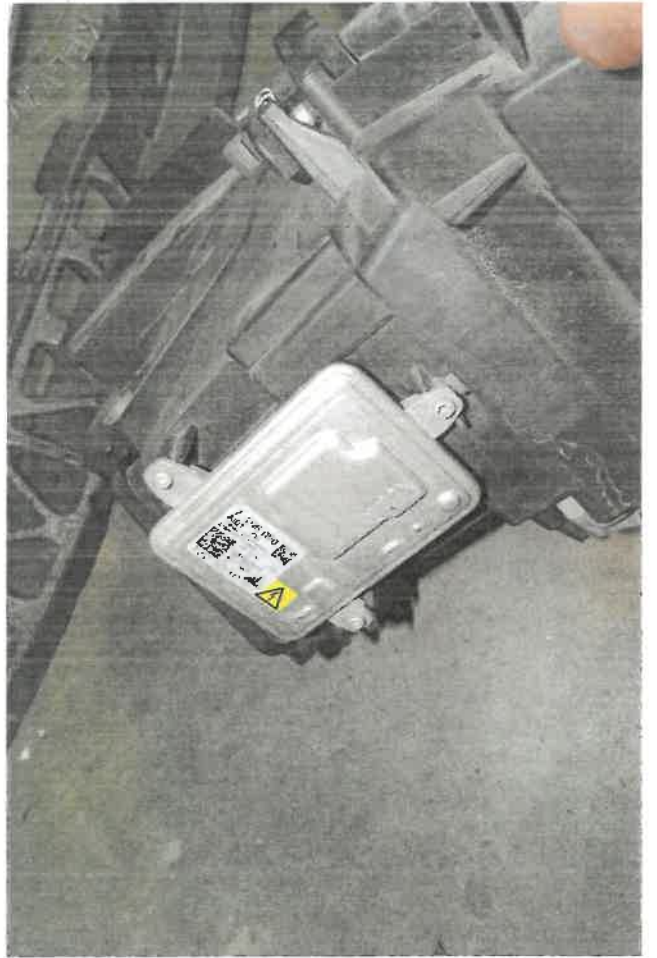
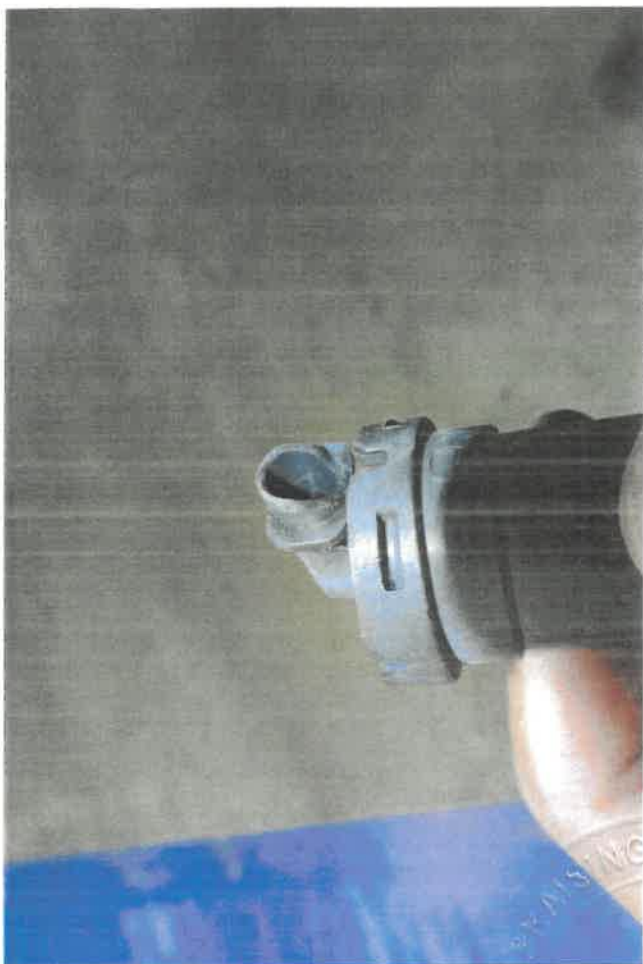
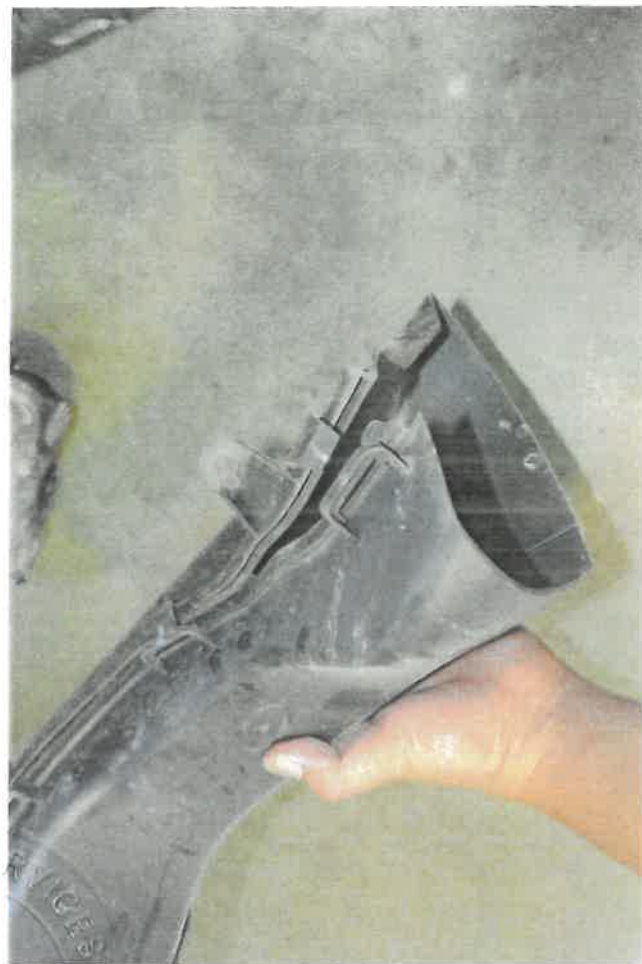
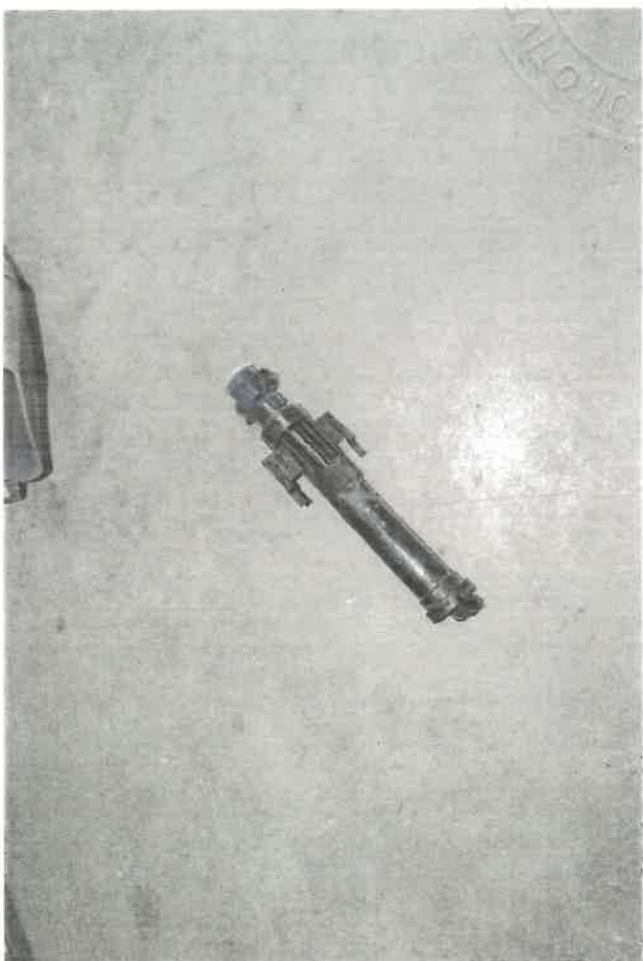
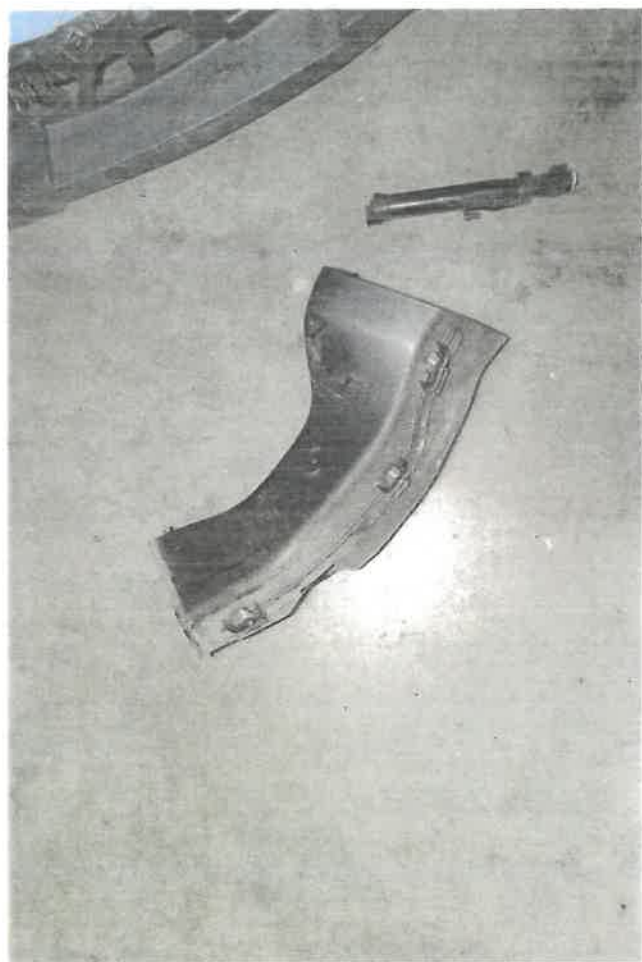
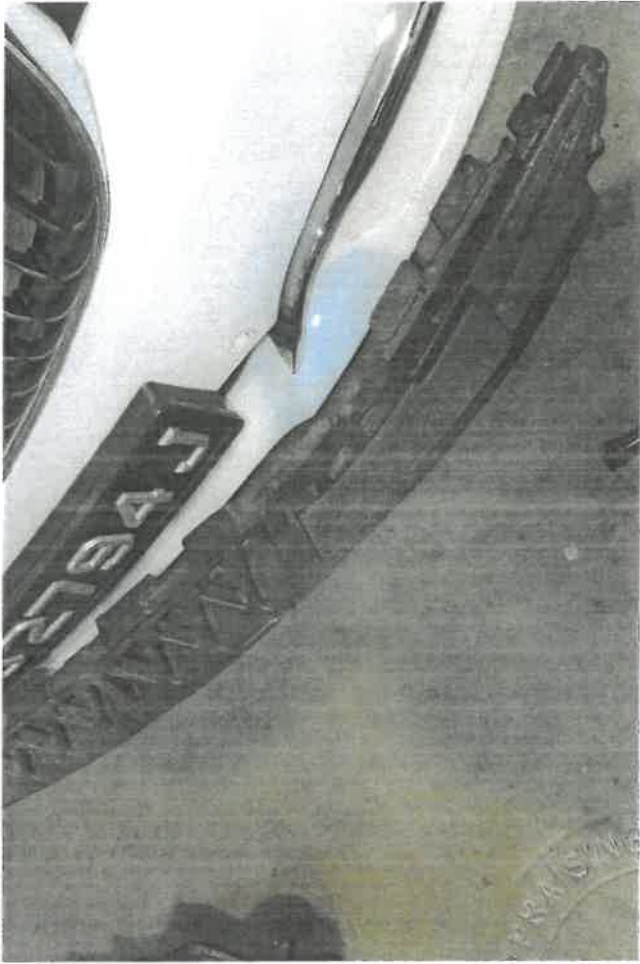
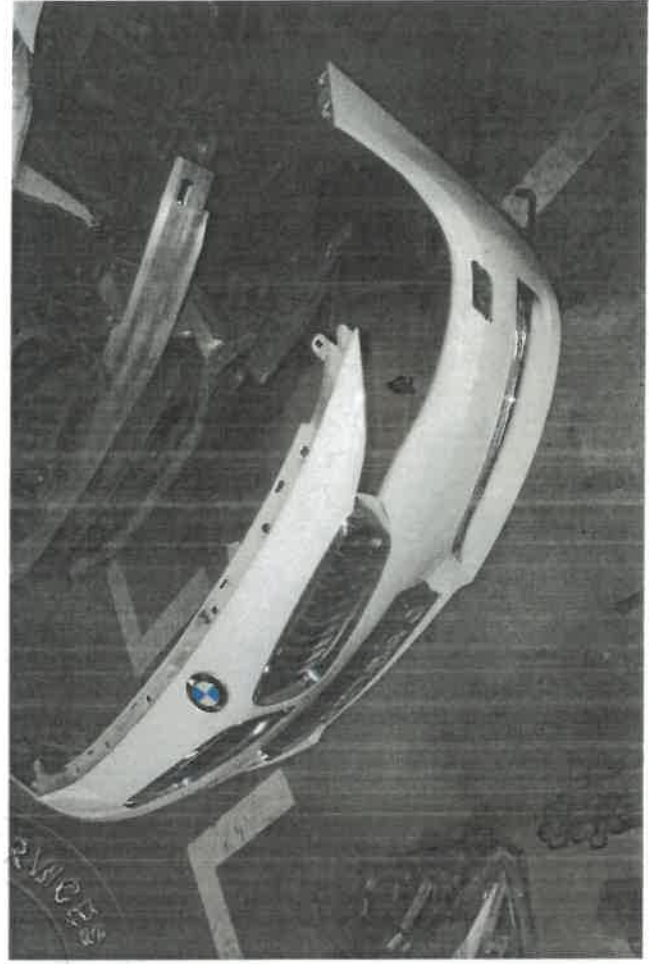
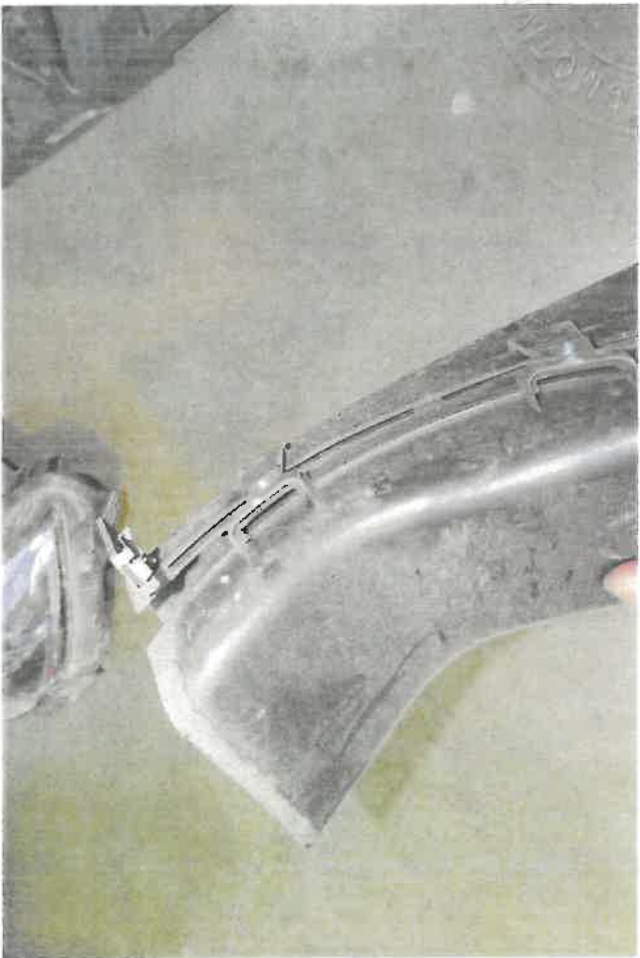
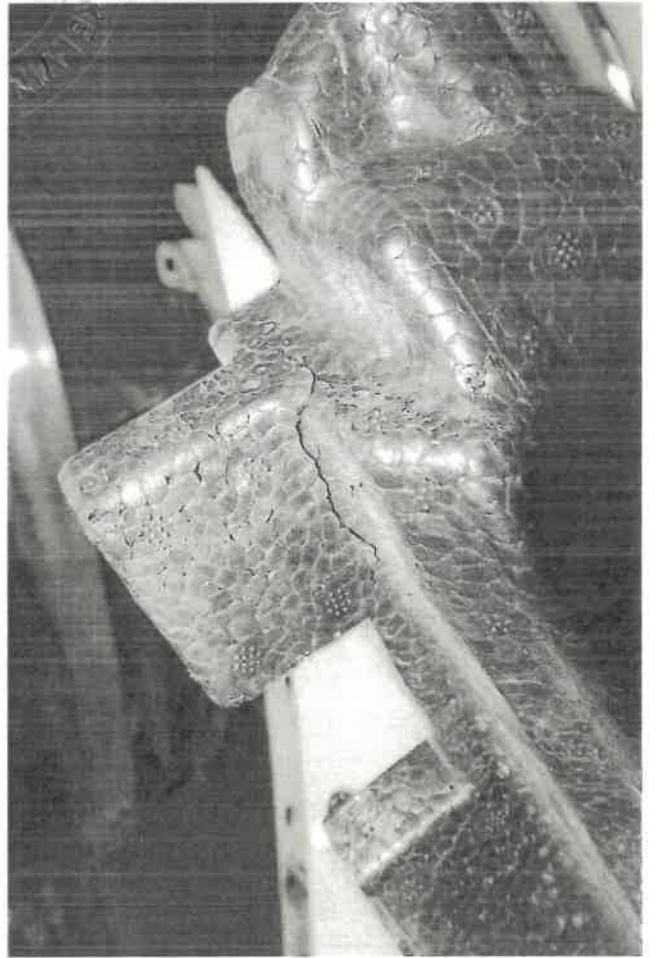
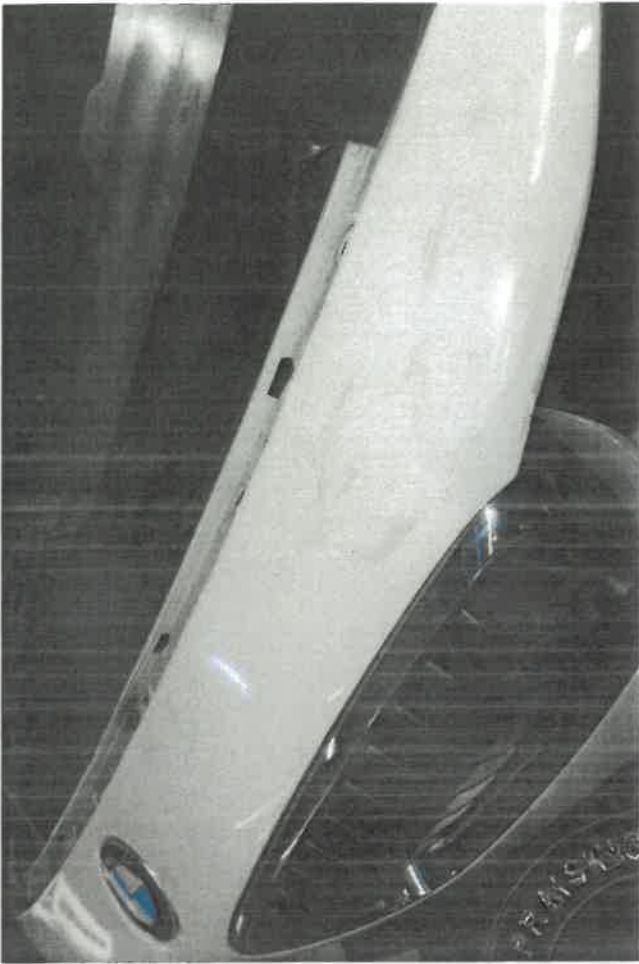
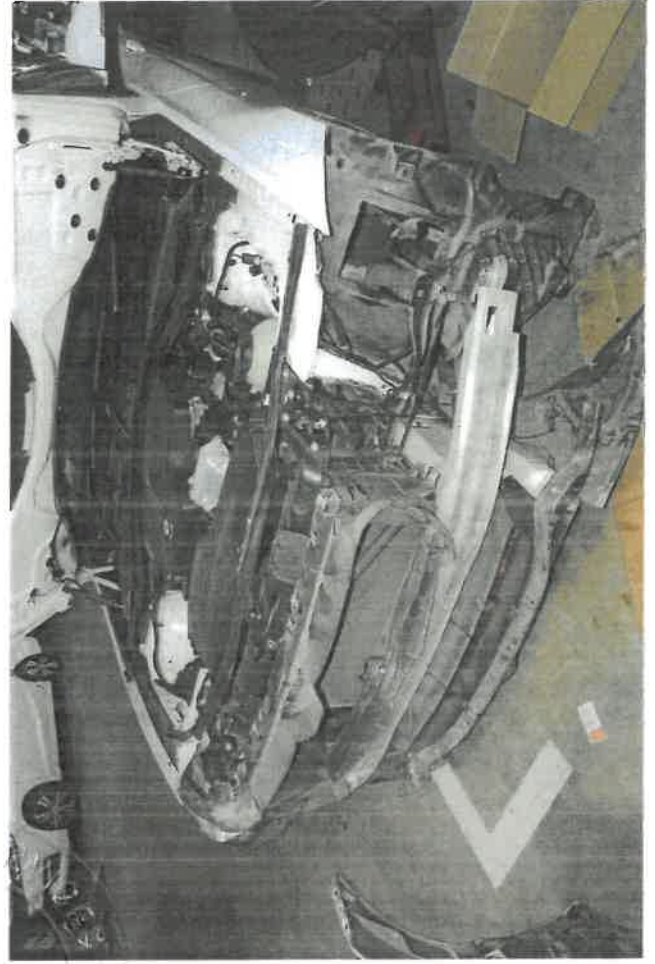
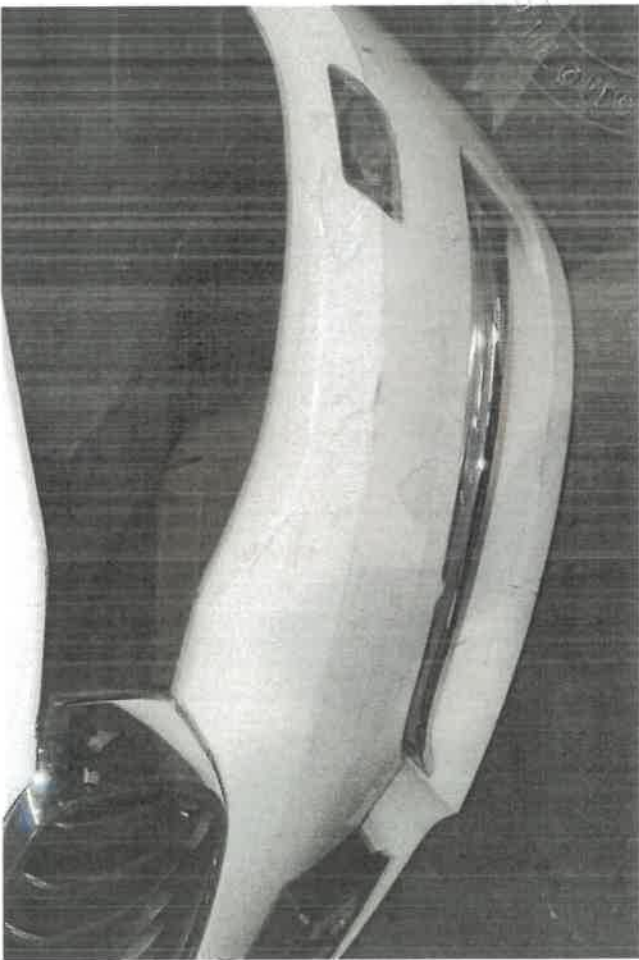
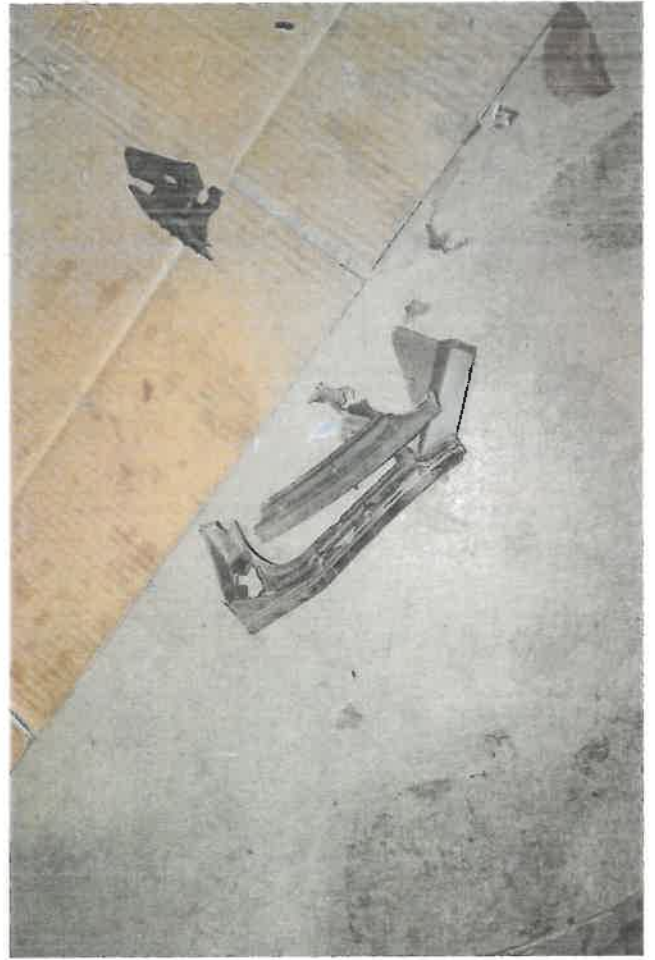
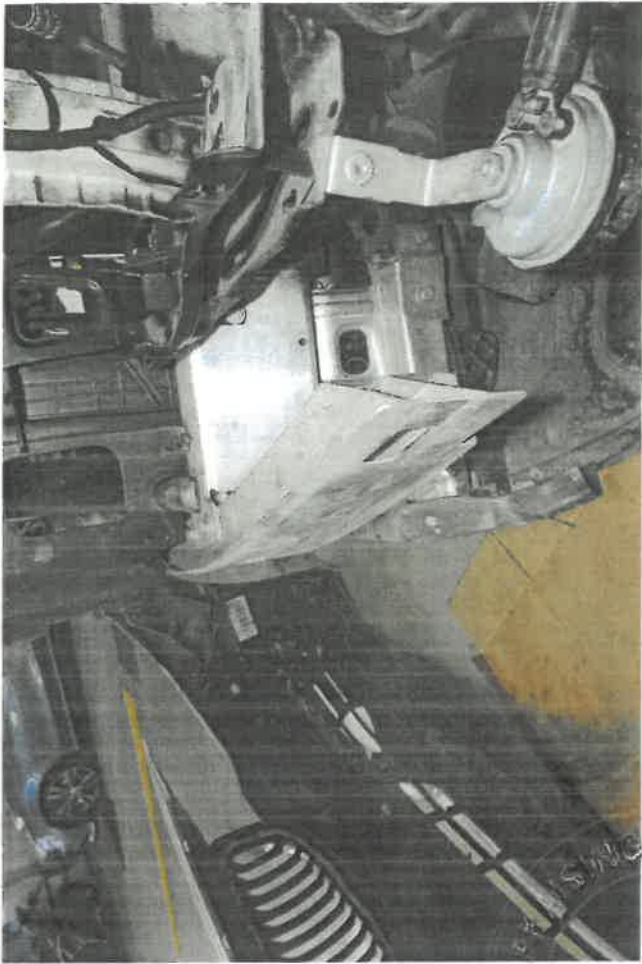
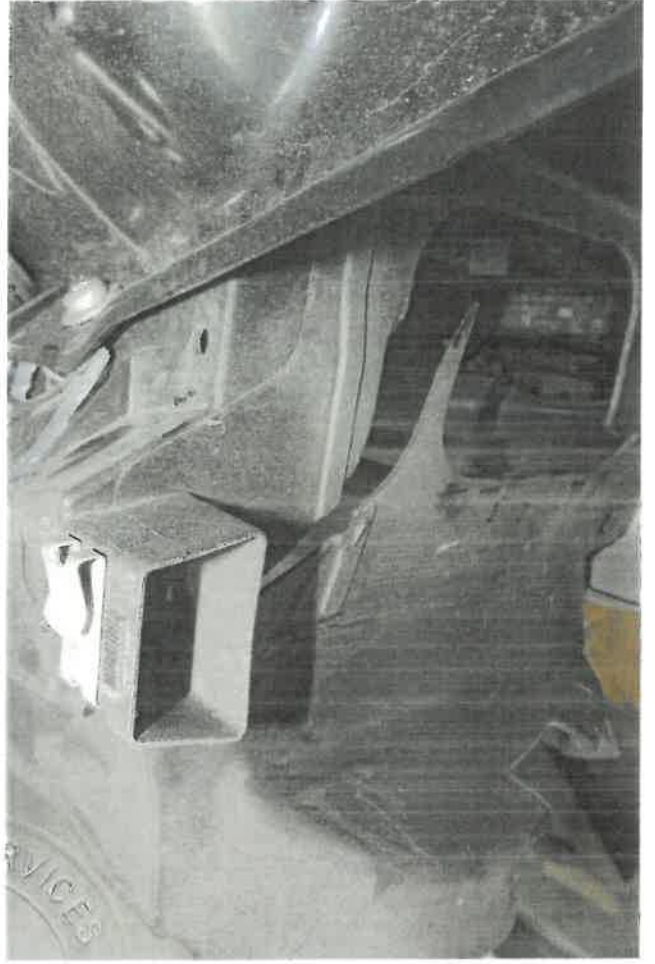
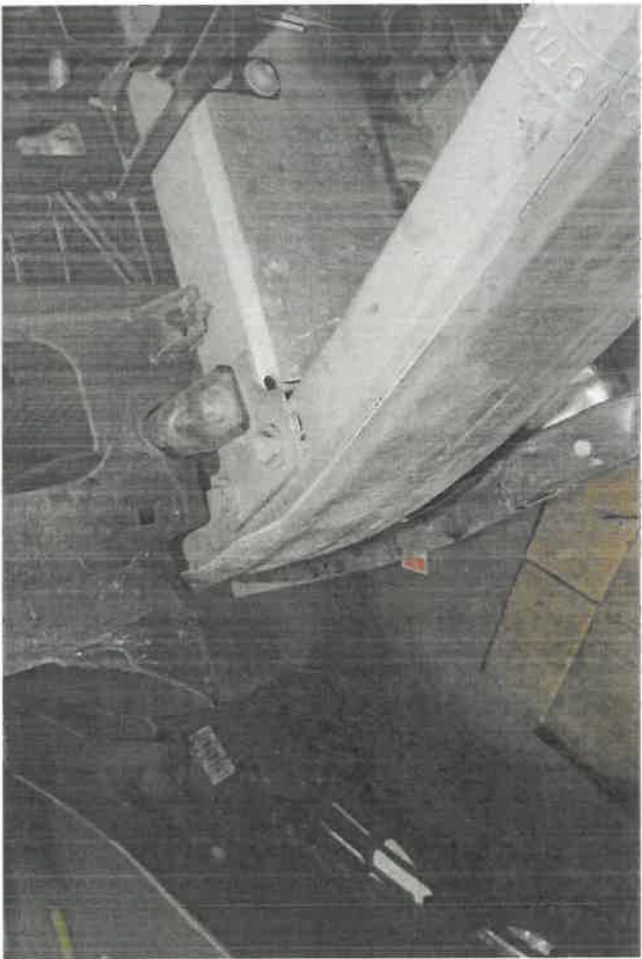
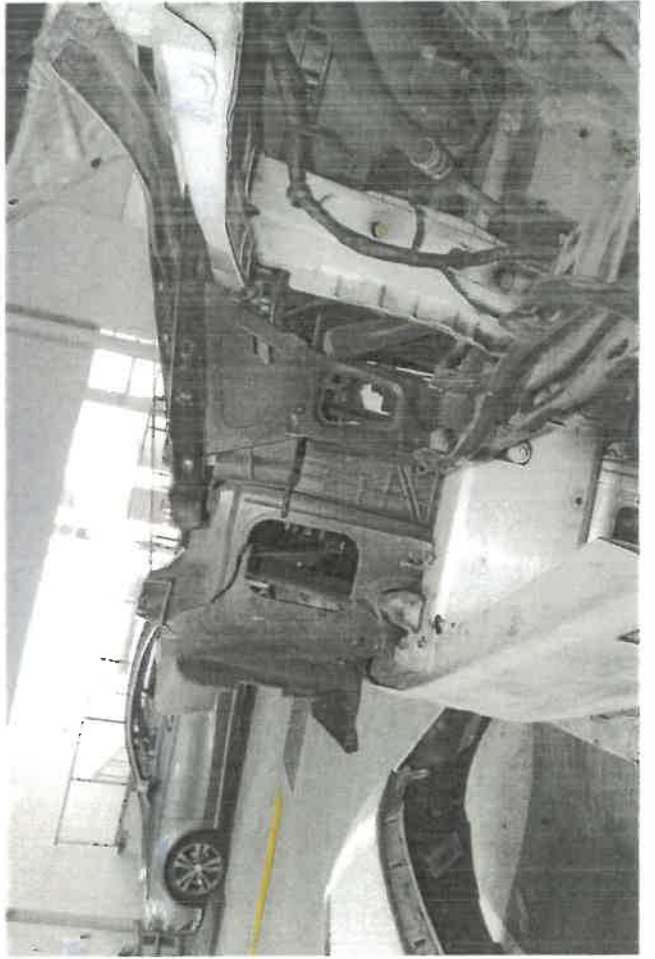
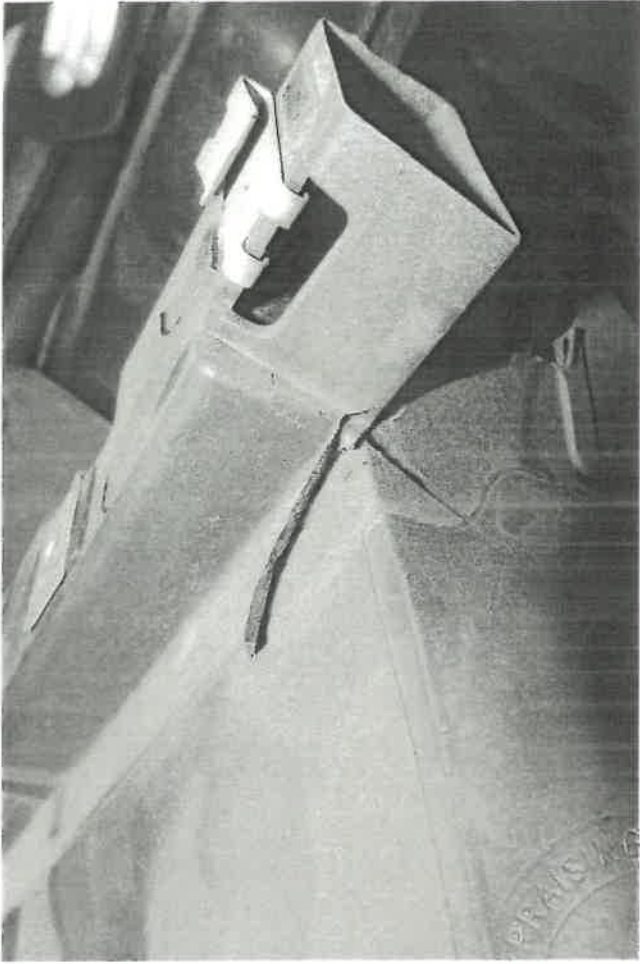
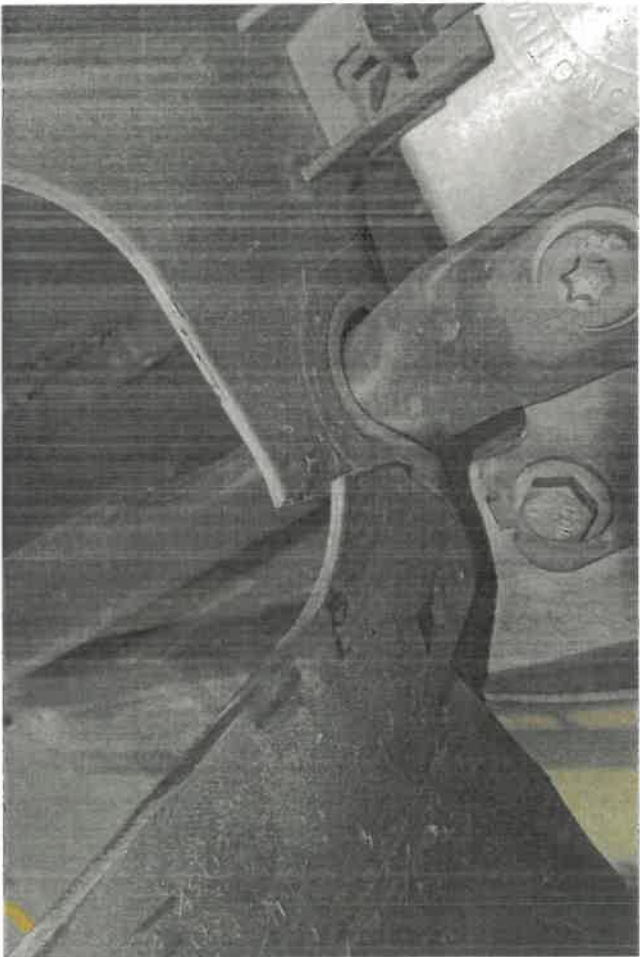
Damages sustained were consistent with the subject vehicle being involved in a collision with another vehicle and the impact was delivered **Diagonally to the LH Front from left to right; rear to front;** portion of the vehicle.

The general area of damages is at the **LH Front portion**
(Please refer to the parts list and photographs as attached for more information)

The estimated repair costs submitted by Messrs **Apex Motoring** is \$ 11,363.00
We have adjusted the cost to \$ 9,187.78 and the repairer has agreed to undertake the repairs at a
Contract Lump Sum of \$ 7,350.00 to a acceptable quality and standards.
However, we have not given authorization and instruction to the repairer to proceed with the repairs.
