Your Ref: TP/IP/40473/2021  
Our Ref : CI/TPD21010014/P

**MECHANICAL INSPECTION REPORT OF MOTOR BUS SG 5051H**

1. I refer to your request on 22<sup>nd</sup> September 2021 to conduct a physical inspection of a Motor Bus bearing registration number SG 5051H (herein referred to as “**Motor Bus**”), which was involved in a fatal road traffic accident on 25<sup>th</sup> August 2021.
2. The objective of this inspection is to determine if there was any possible mechanical failure to the Motor Bus that may have contributed to the accident.
3. Following the request, I had carried out a physical inspection of the Motor Bus on 7<sup>th</sup> December 2021 at the premises of Traffic Police vehicle pound, 517 Airport Road Singapore 539942. I now set out below my observations and comments with respect to this inspection.

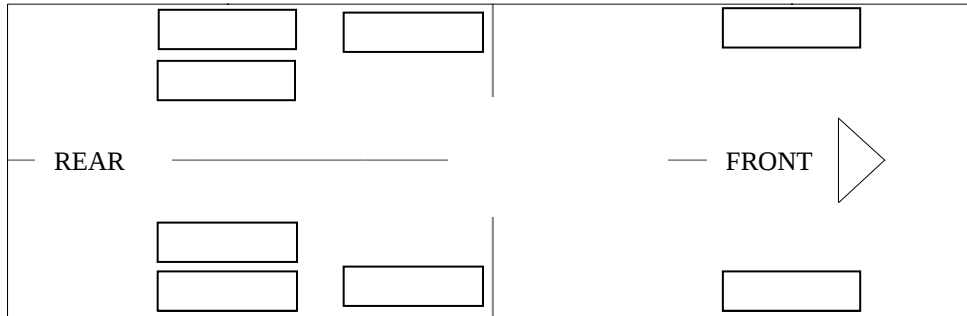
6. The 2 front tyres and 6 rear tyres of the Motor Bus were observed to be in serviceable condition and sufficiently inflated for vehicular operation. I did not find any tear, cut or burst mark(s) on the outer and the inner sidewalls as well as across the tread of the 8 tyres. The tyre brand, tyre size and remaining tread depth of the 8 tyres of the Motor Bus were recorded as follows:-

Bridgestone 275/70R22.5 (9.5mm)

Bridgestone 275/70R22.5 (9.1mm)

Bridgestone 275/70R22.5 (10mm)

Bridgestone 275/70R22.5 (9.8mm)
