Your Ref: TP/IP/35321/2021  
Our Ref : CI/TPD21010020/P

30<sup>th</sup> September 2021

**Fatal Accident Investigation Team**

**MECHANICAL INSPECTION REPORT OF MOTOR CAR SGH 1678M**

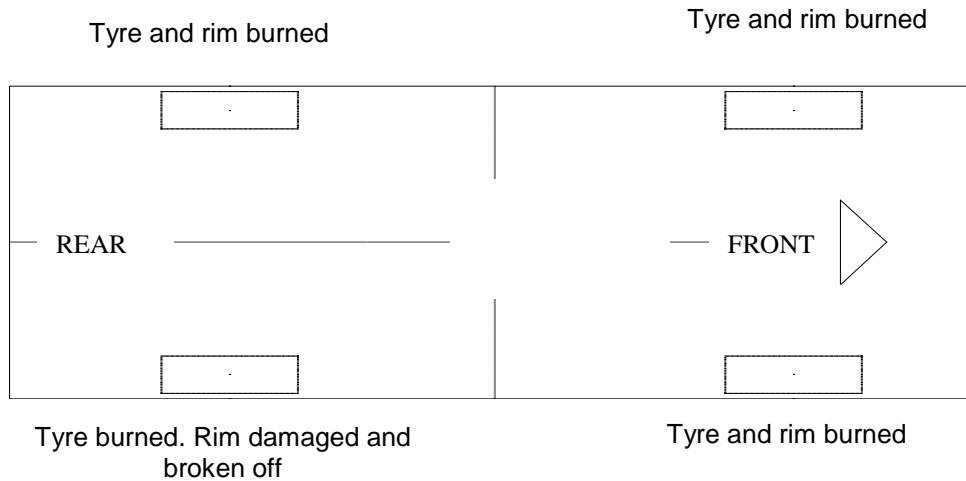
6. The condition of the Motor Car's 4 tyres and wheel rims was observed to be burned and damaged as a result of the accident.

7. All 4 tyres and wheel rims was observed to be burned and damaged as a result of the accident and fire. See photo 1 – 10 below.
