Your Ref: TP/IP/43407/2021
Our Ref : CI/TPD21010024/P

Fatal Accident Investigation Team

MECHANICAL INSPECTION REPORT OF MOTOR LORRY GBE 4524D

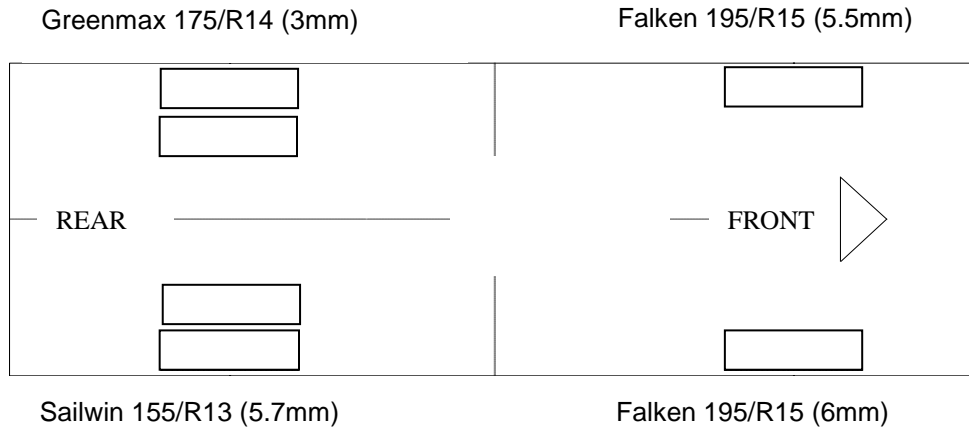
6. The 6 tyres of the Motor Lorry were observed to be in serviceable condition and sufficiently inflated for vehicular operation. I did not find any tear, cut or burst mark(s) on the outer and the inner sidewalls as well as across the tread of the 6 tyres. The tyre brand, tyre size and remaining tread depth of the 6 tyres of the Motor Lorry were recorded as follows:-
