## LKK Auto Consultants Pte Ltd

Vehicle No. SFH 6336D  
Insured Veh. SBS 3337K  
Claim No. D21002915MFBP  
Policy No.  
Accident Date 18/10/2021  
Inspection Date 19/10/2021

## ADJUSTMENT ON REPAIR COST FOR VEHICLE NO. SFH 6336D

### PHOTOGRAPHS FOR VEHICLE NO. SFH 6336D

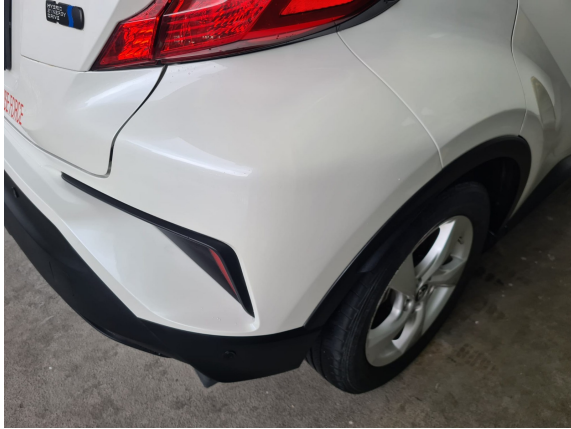
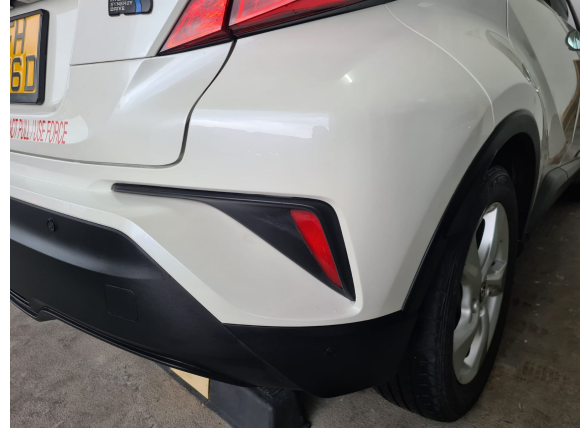
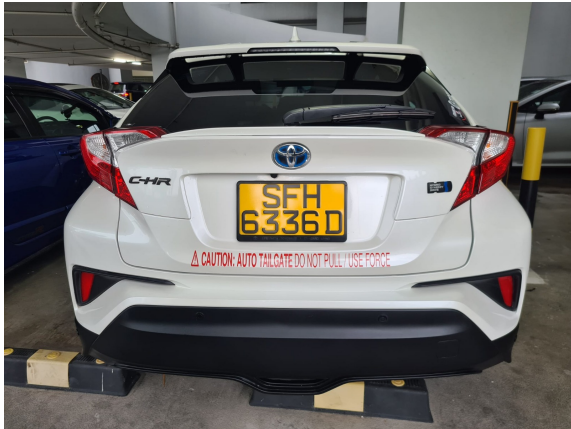
### RE-INSPECTION

<b>4. Description of Damages</b>				
	THE VEHICLE SUSTAINED DAMAGES AT THE REAR O/S PORTION.  DAMAGES SEE DETAILS.			
<b>5. General Information</b>				
	Accident Date	18/10/2021	Inspection Date	19/10/2021
	Survey held at	A T AUTO CONSULTANT 113 TECK WHYE LANE, #05-650, SINGAPORE 680113		
<b>5a. Remarks</b>				
	A)THE INSPECTION WAS CONDUCTED ON A"WITHOUT PREJUDICE" BASIS. B)IN ACCORDANCE TO YOUR INSTRUCTIONS, WE HAVE NOT AUTHORISED REPAIRS.			
<b>5b. Estimate Days of Repair</b>				
	ESTIMATED NORMAL PERIOD FOR REPAIR:		2 Working Days
