Our Reference : KAAS/KT/6279/6767/TP/08.21  
Date : 06 September 2021

## VEHICLE APPRAISAL REPORT

Registration No.	: SNA 6767K	Chassis Frame No.	: GR11020367
Make / Model	: Honda Fit Basic 1.3 CVT	Engine No. ( Logcard )	: L13B1526691
Year of Manufacture/Reg	: 2020	Odometer Reading	: 538 KM
Colour	: Red		
Class / Type	: Hatchback

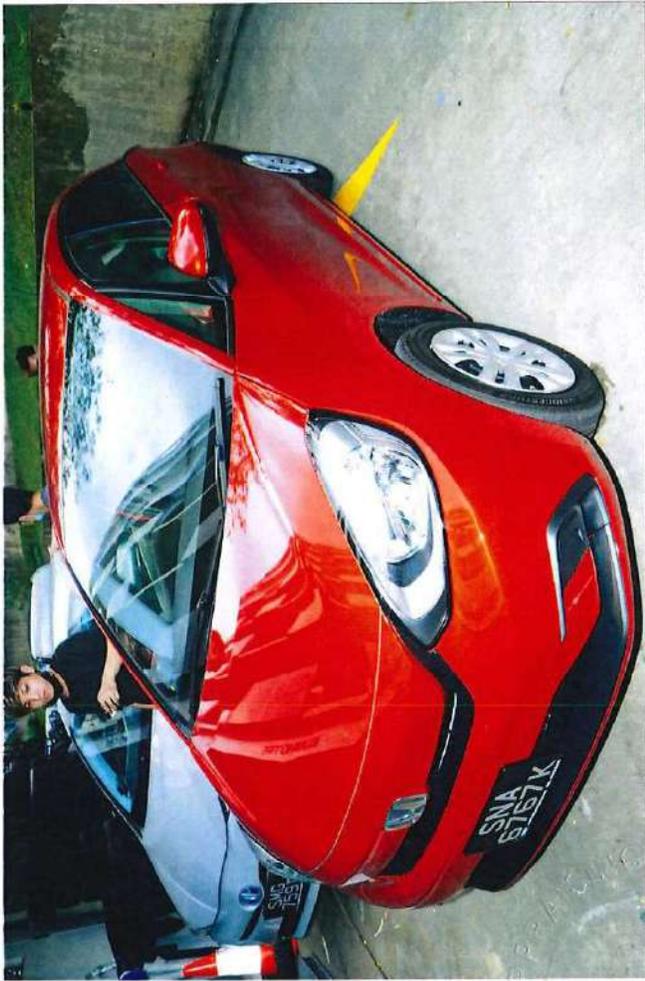
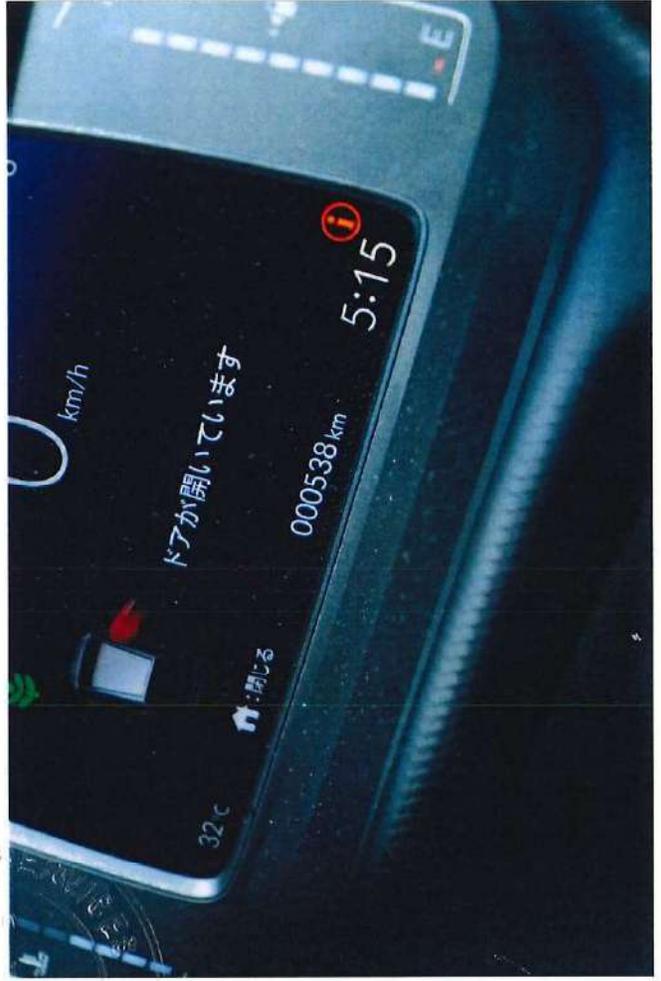
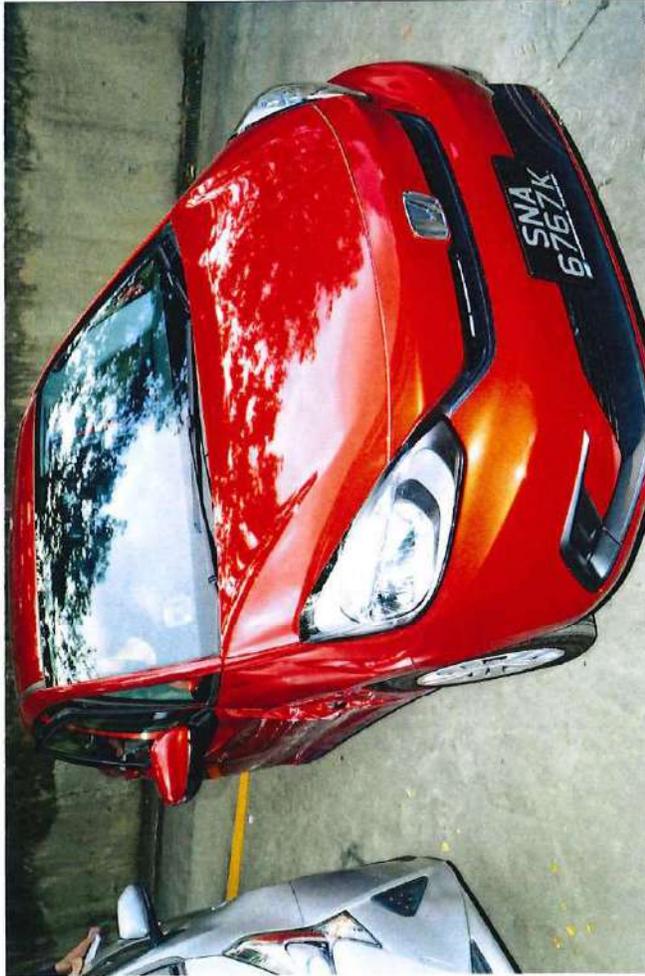
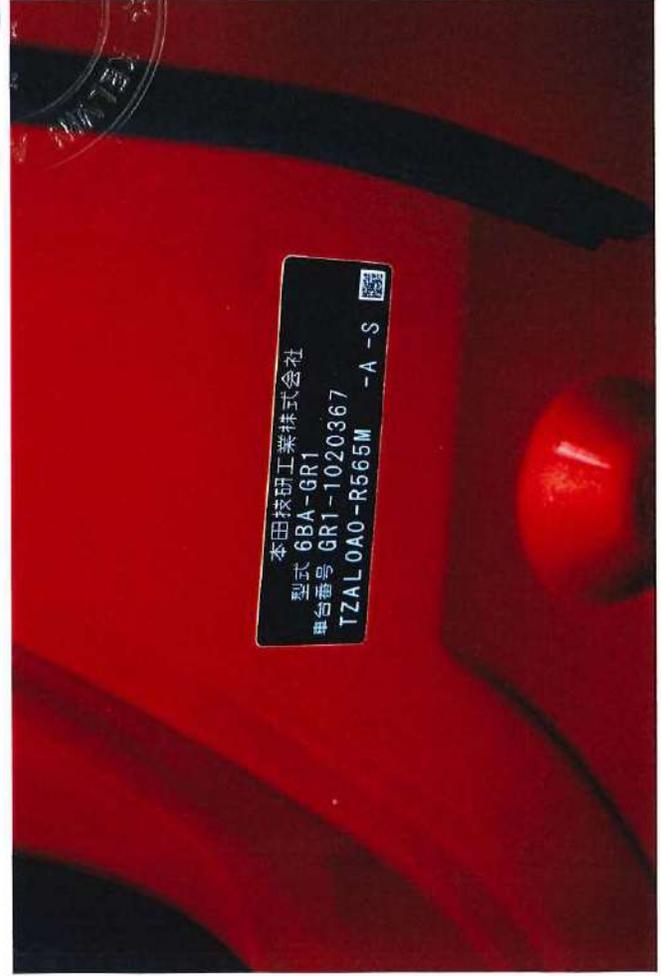
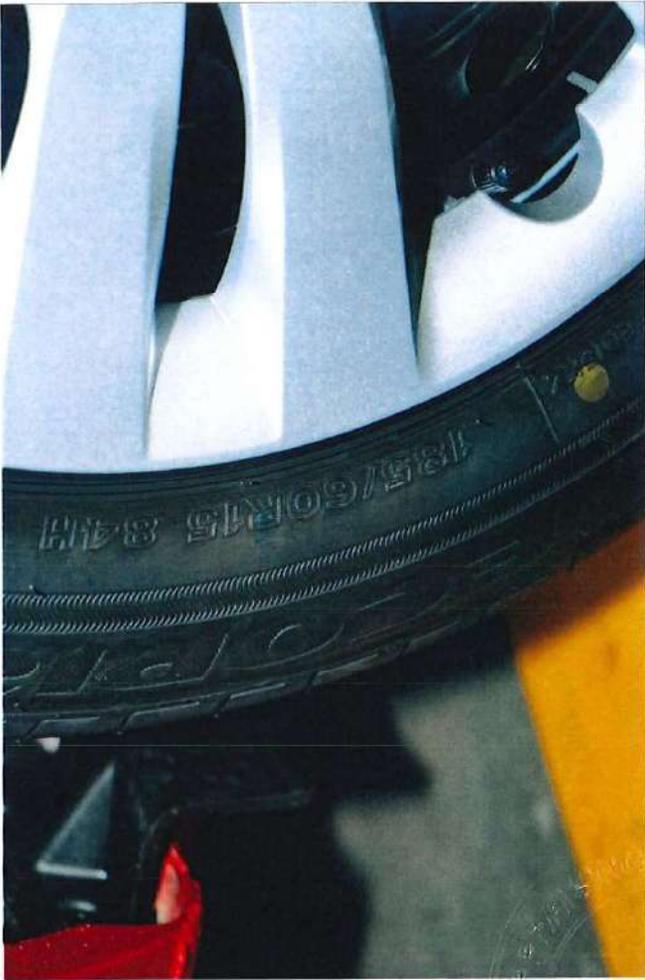
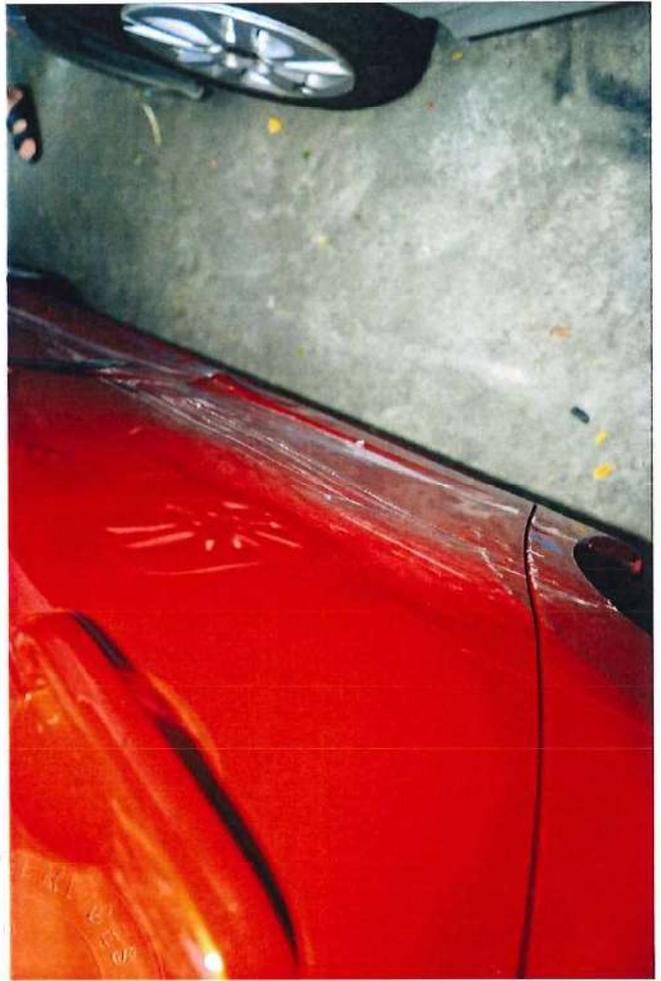
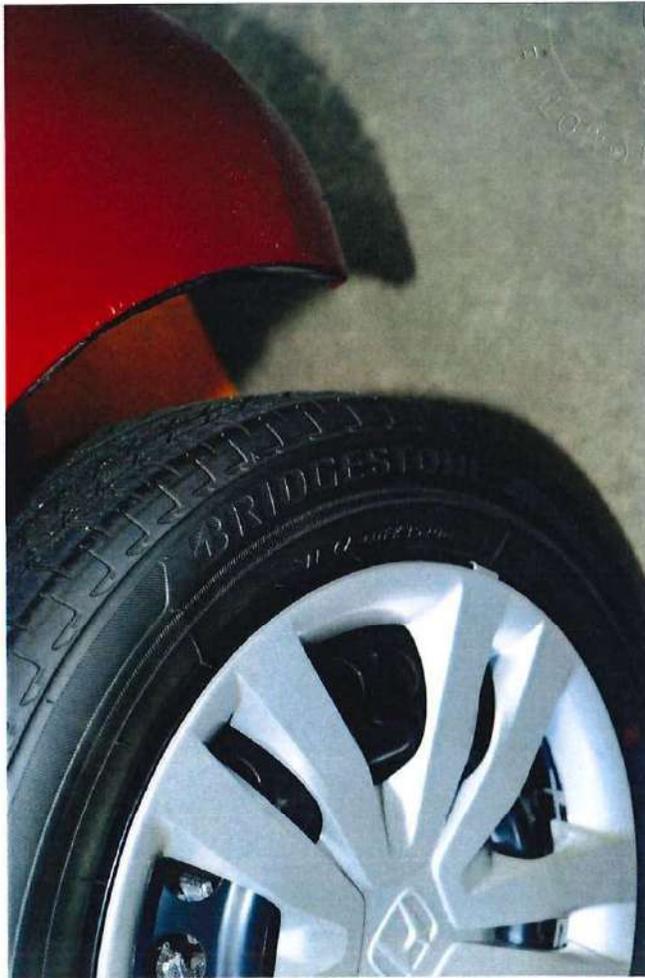
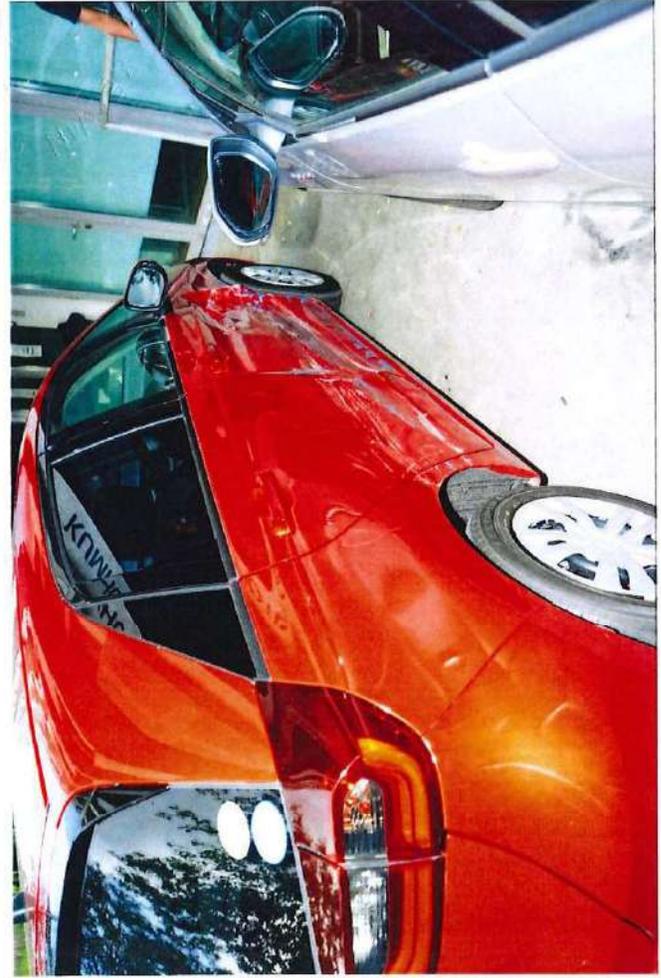
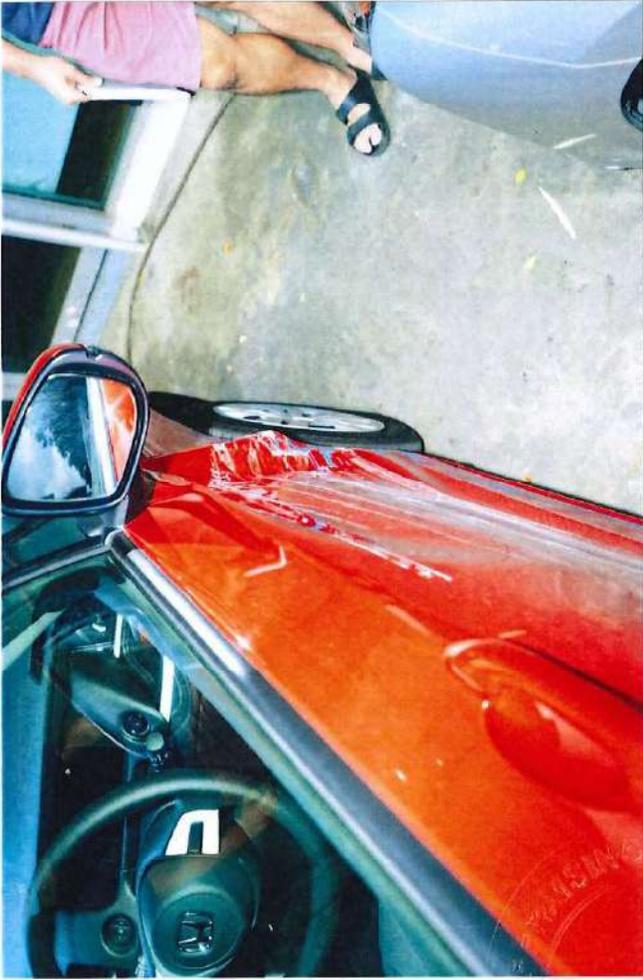
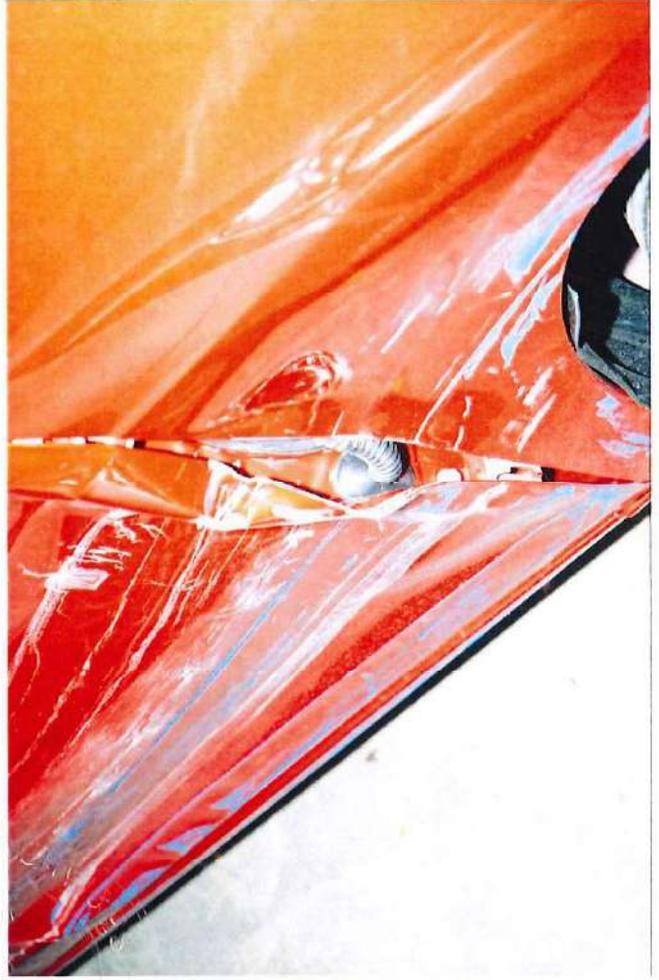
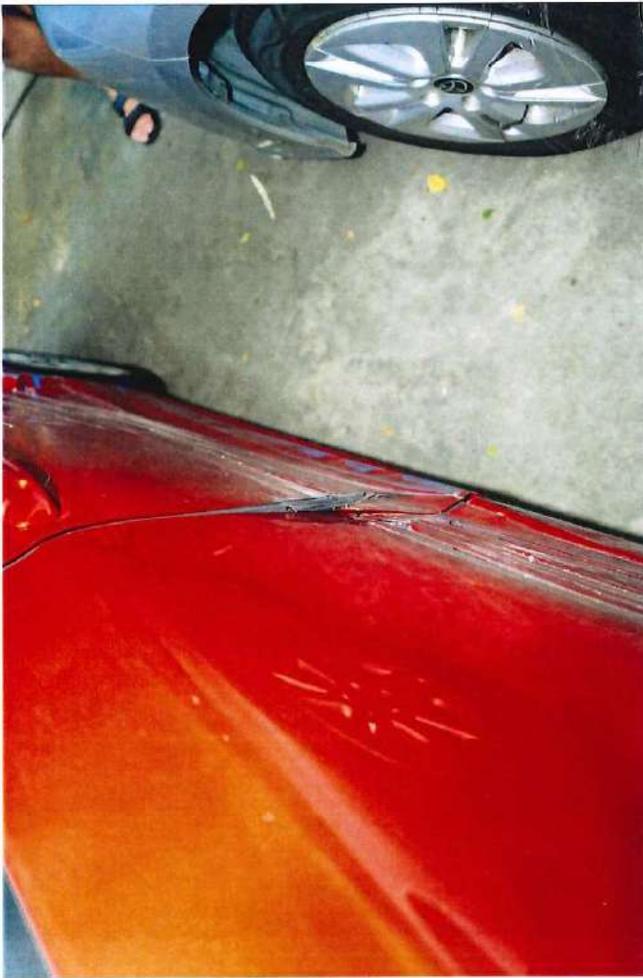
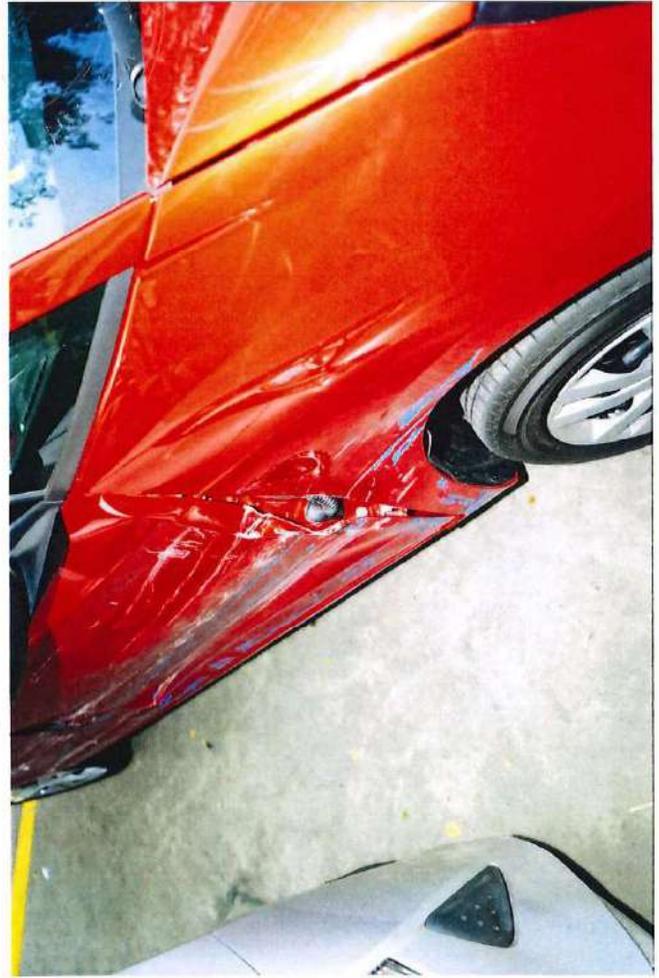
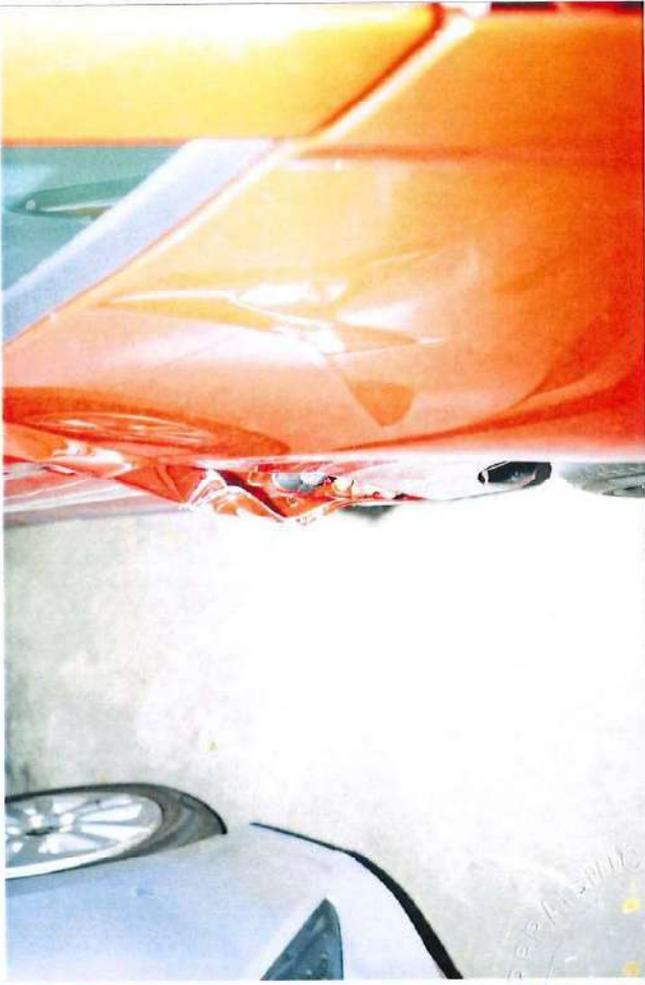
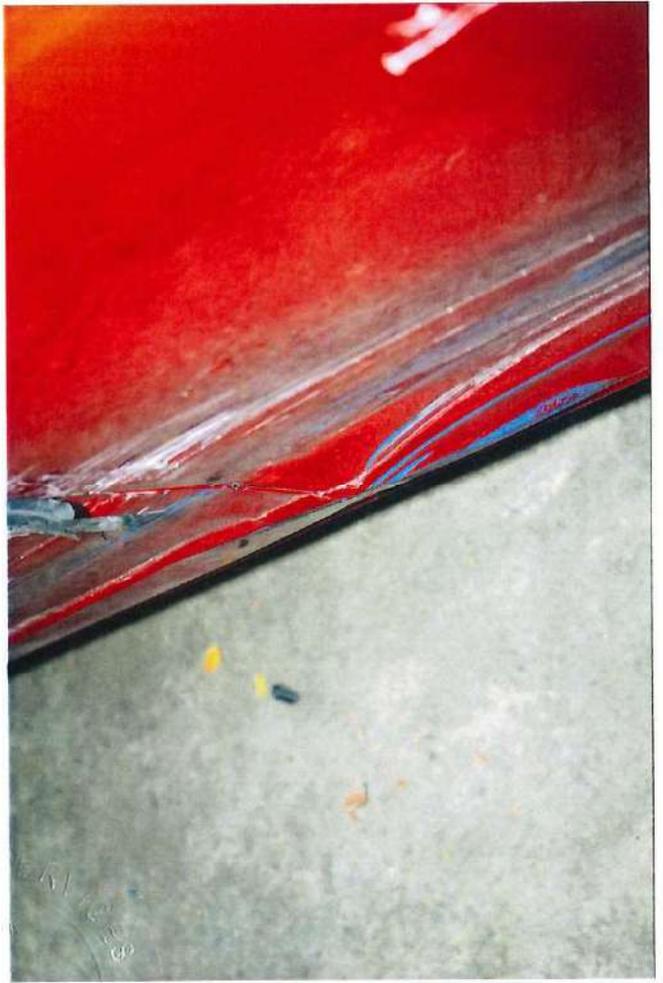
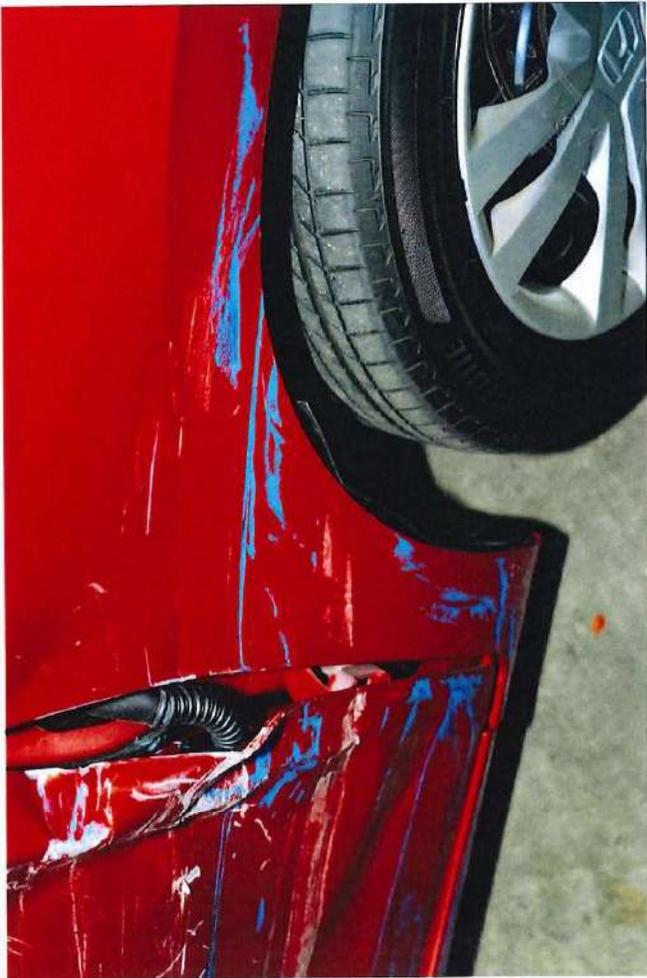
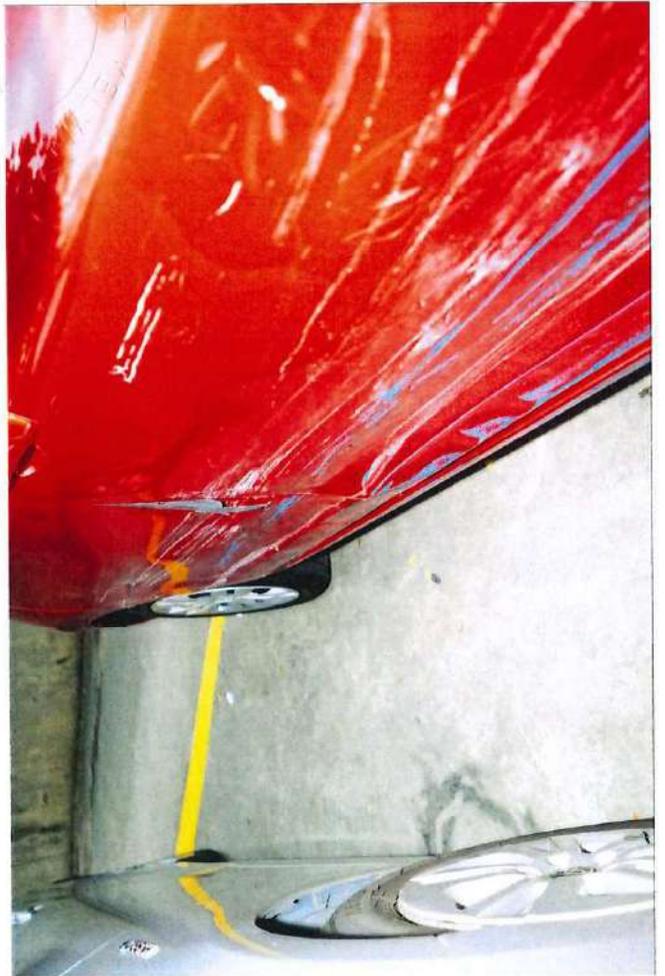
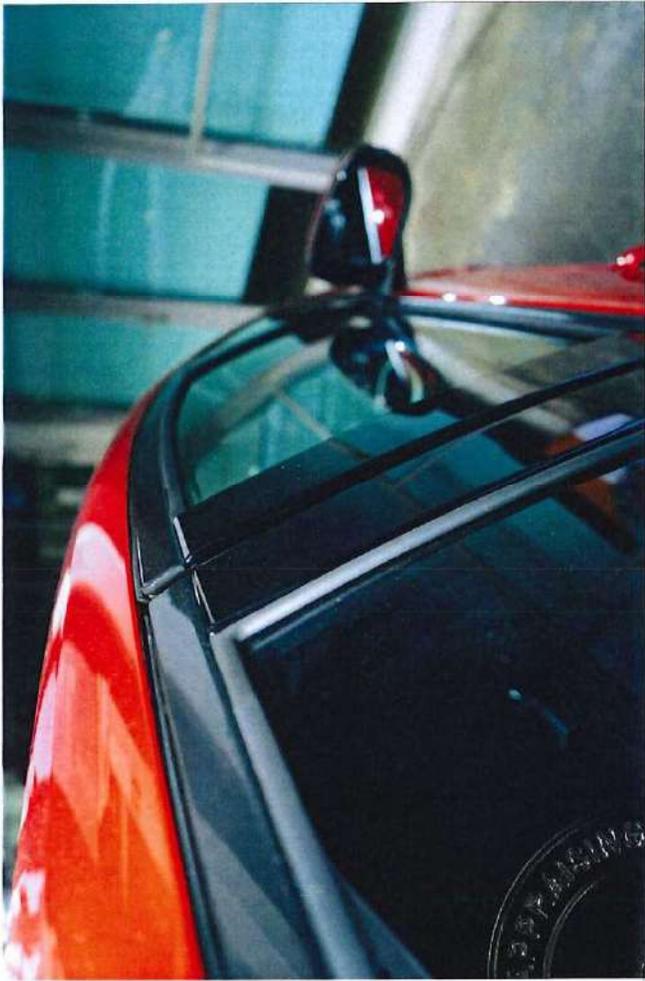
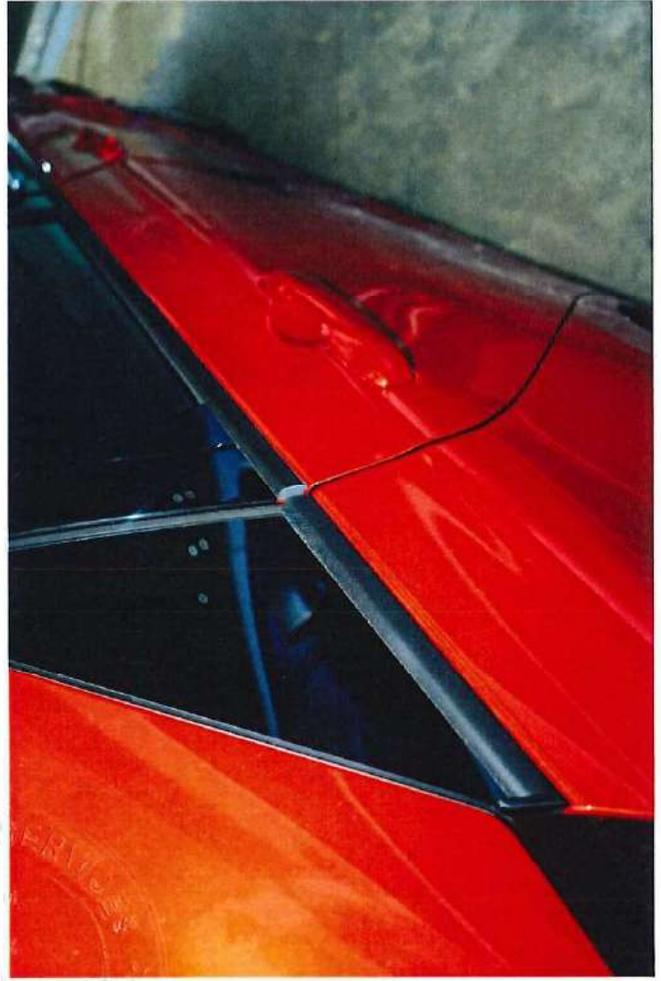
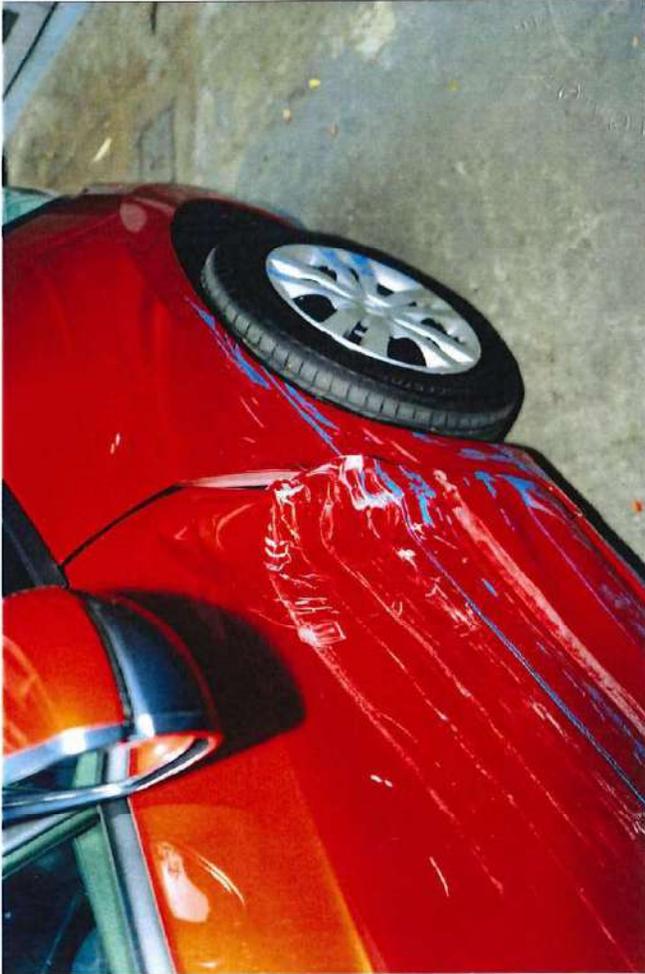
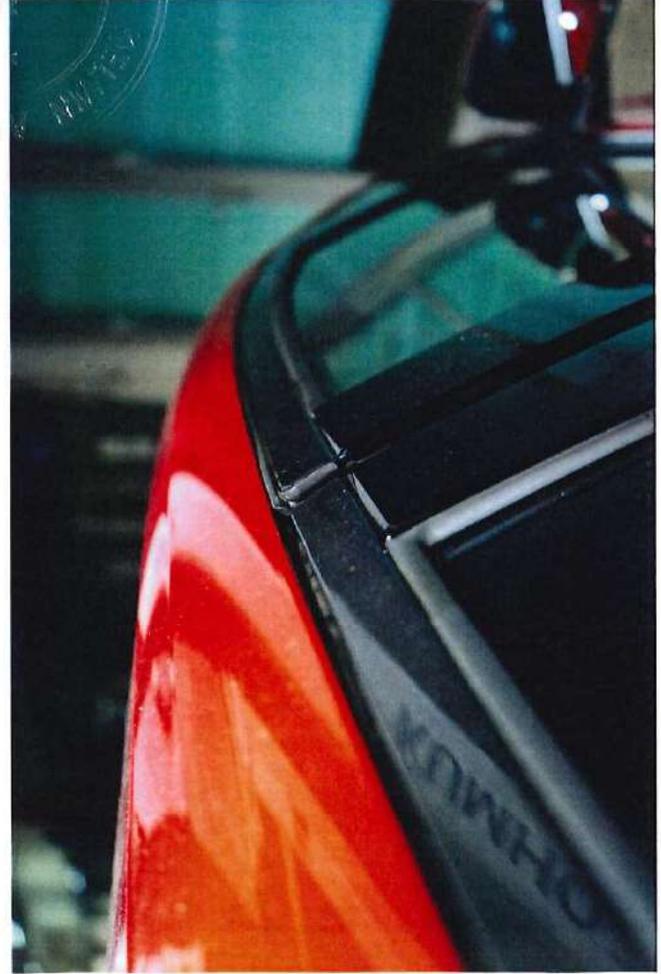
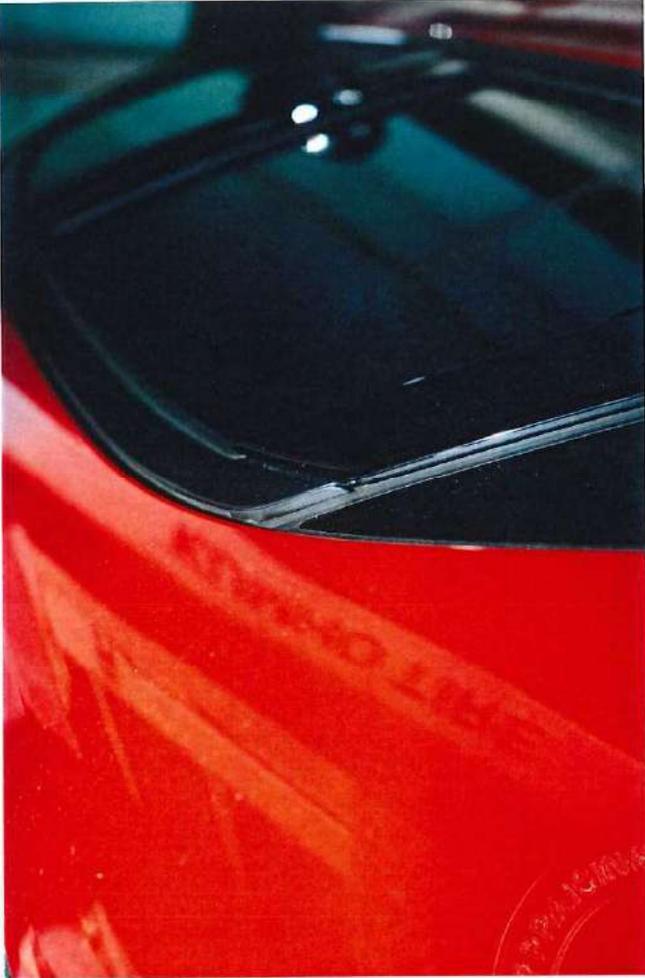
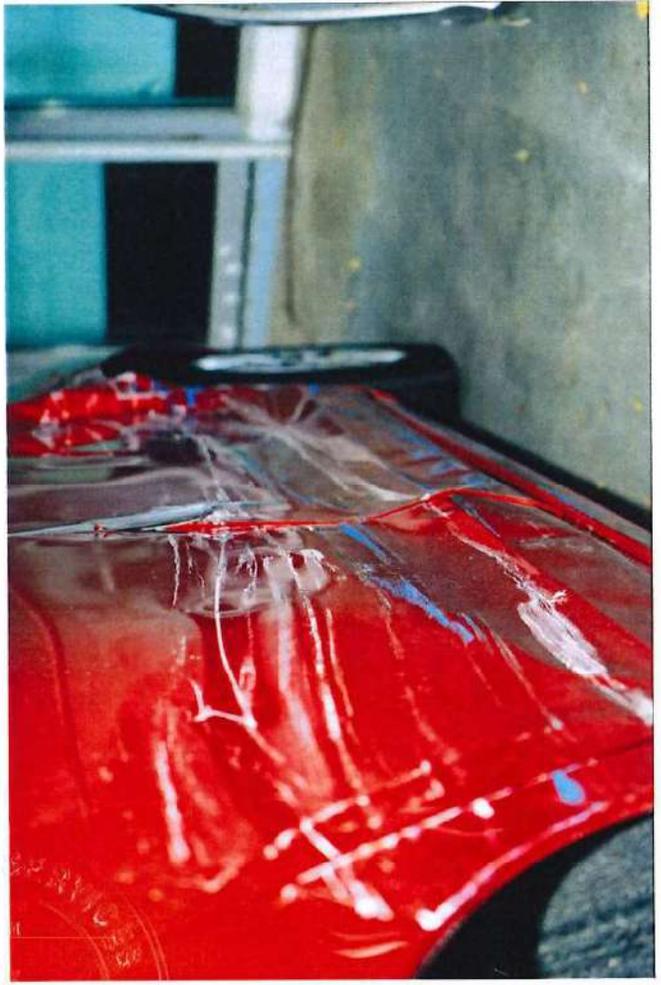
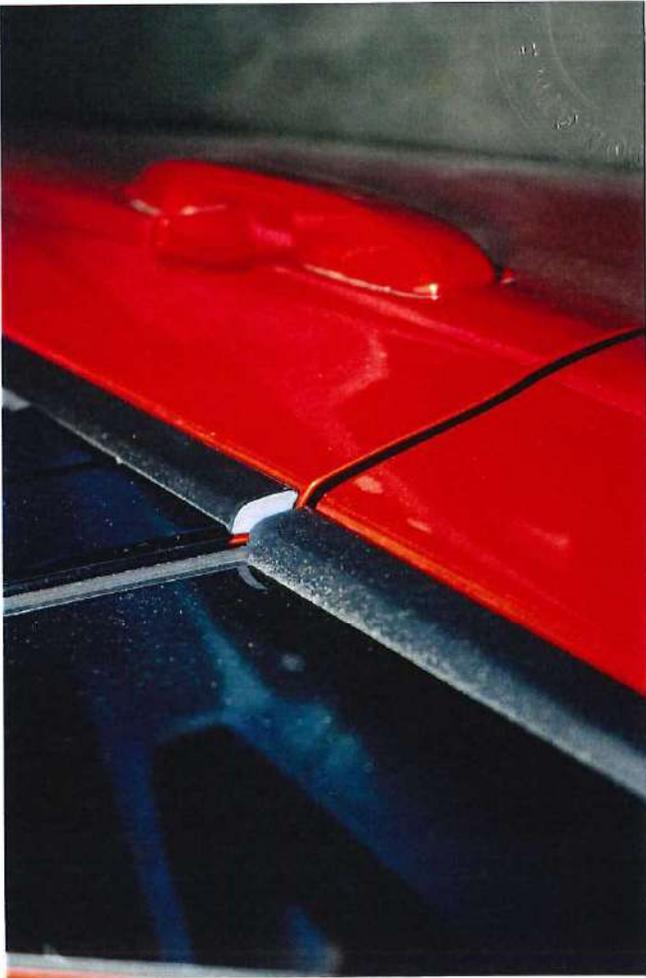
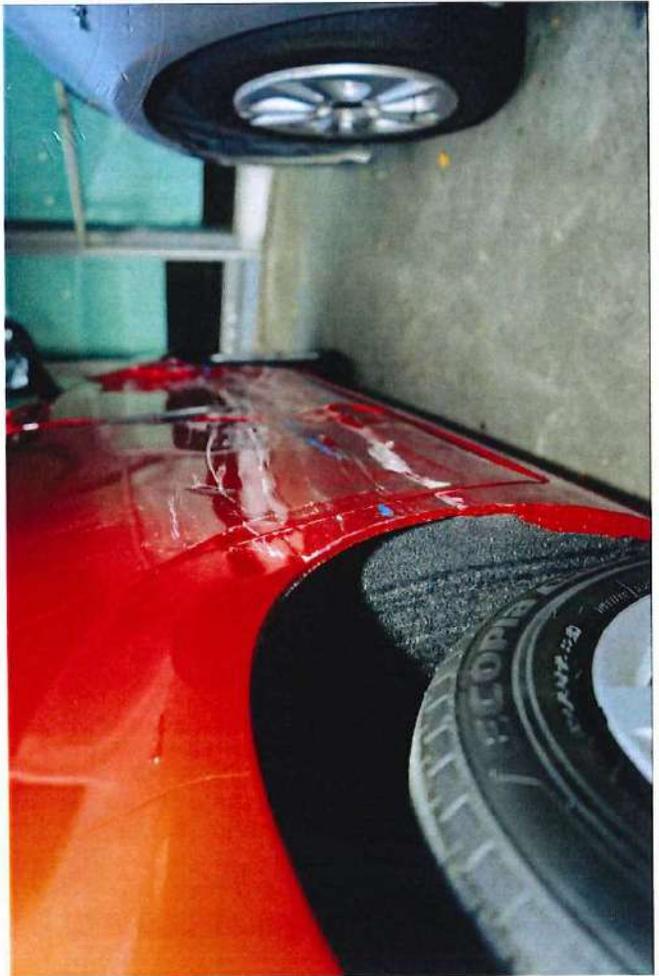
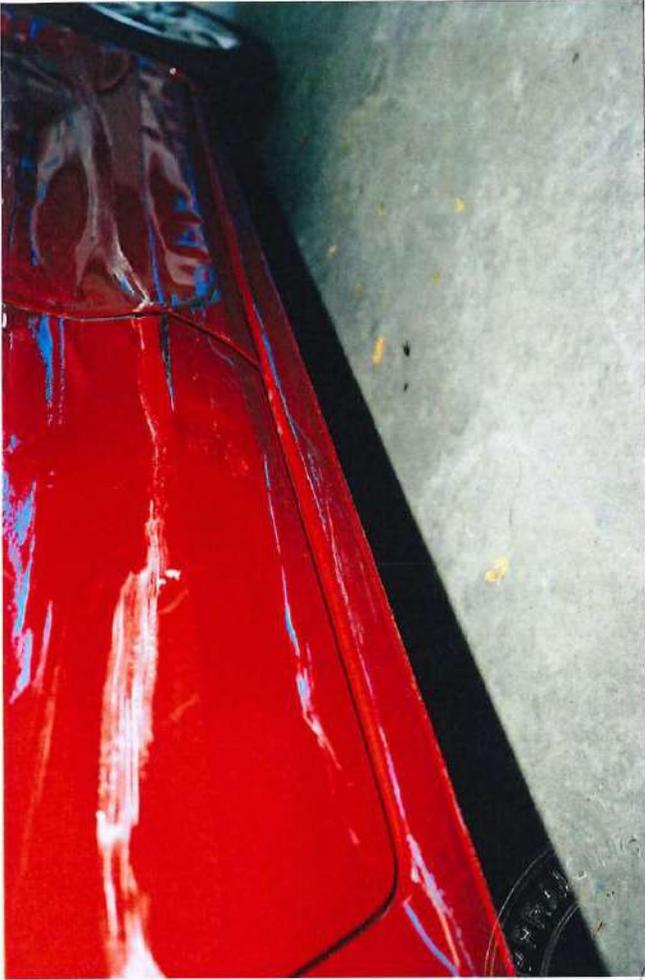
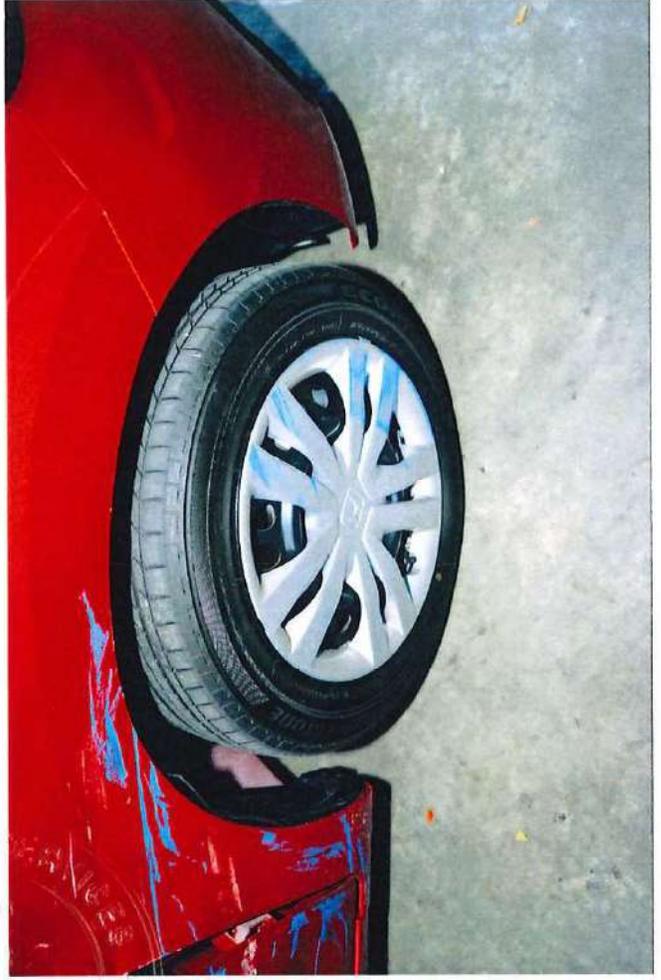
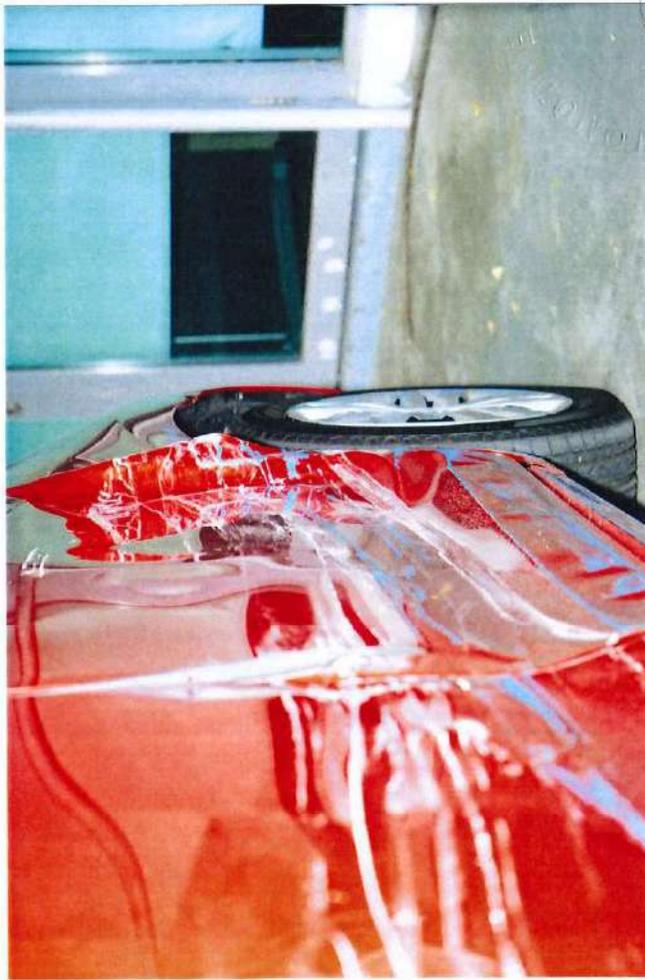
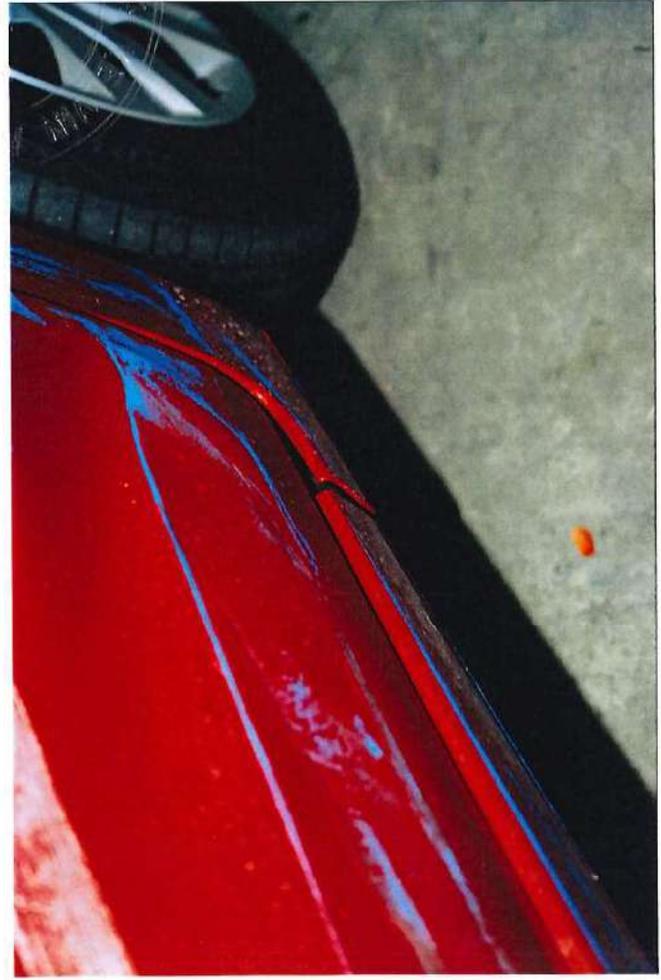
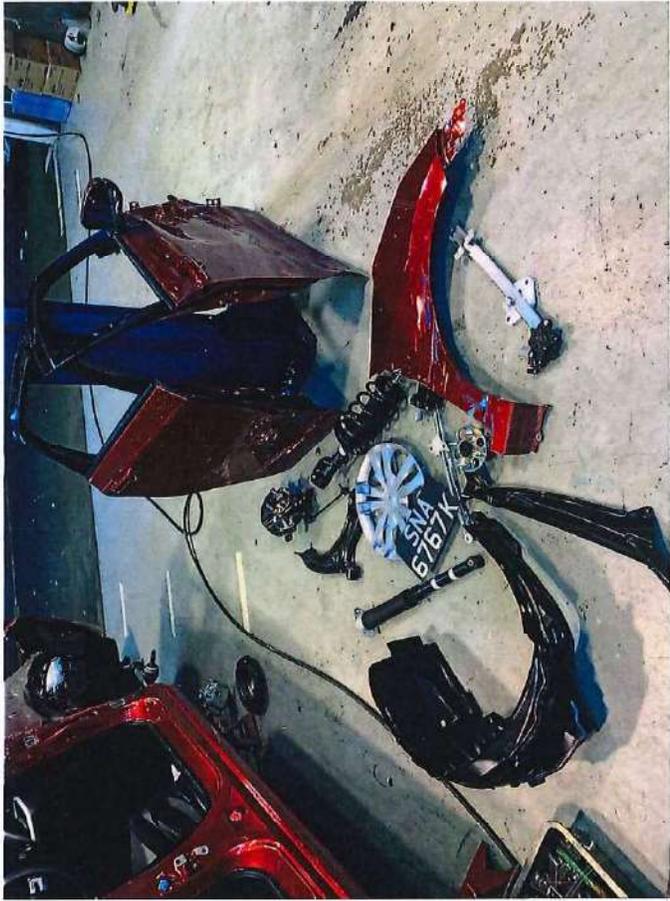
Damages sustained were consistent with the subject vehicle being involved in a collision with another vehicle and the impact was delivered **Diagonally to the RH Front from front to rear; left to right** portion of the vehicle.

The general area of damages is at the **RH Front portion**  
( Please refer to the parts list and photographs as attached for more information )

The estimated repair costs submitted by Messrs **Apex Motoring** is \$ 11,771.70 .  
We have adjusted the cost to \$ 8,044.16 and the repairer has agreed to undertake the repairs at a **Contract Lump Sum of \$ 6,440.00** to a acceptable quality and standards.  
However, we have not given authorization and instruction to the repairer to proceed with the repairs.
