Our Reference : KAAS/KT/6279/6767/TP/08.21  
Date : 06 September 2021

## VEHICLE APPRAISAL REPORT

Registration No.	: SNA 6767K	Chassis Frame No.	: GR11020367
Make / Model	: Honda Fit Basic 1.3 CVT	Engine No. ( Logcard )	: L13B1526691
Year of Manufacture/Reg	: 2020	Odometer Reading	: 538 KM
Colour	: Red		
Class / Type	: Hatchback

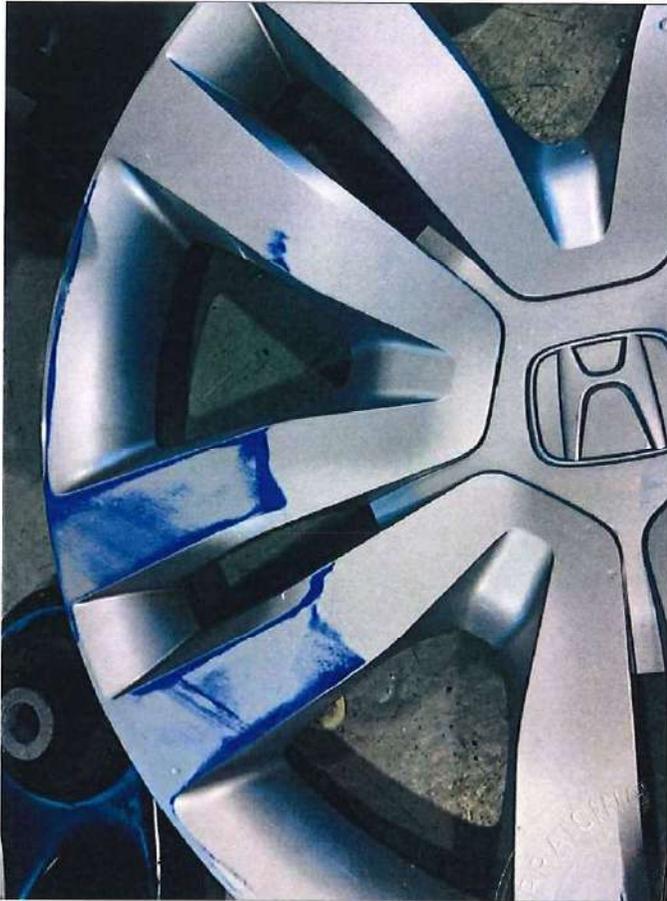
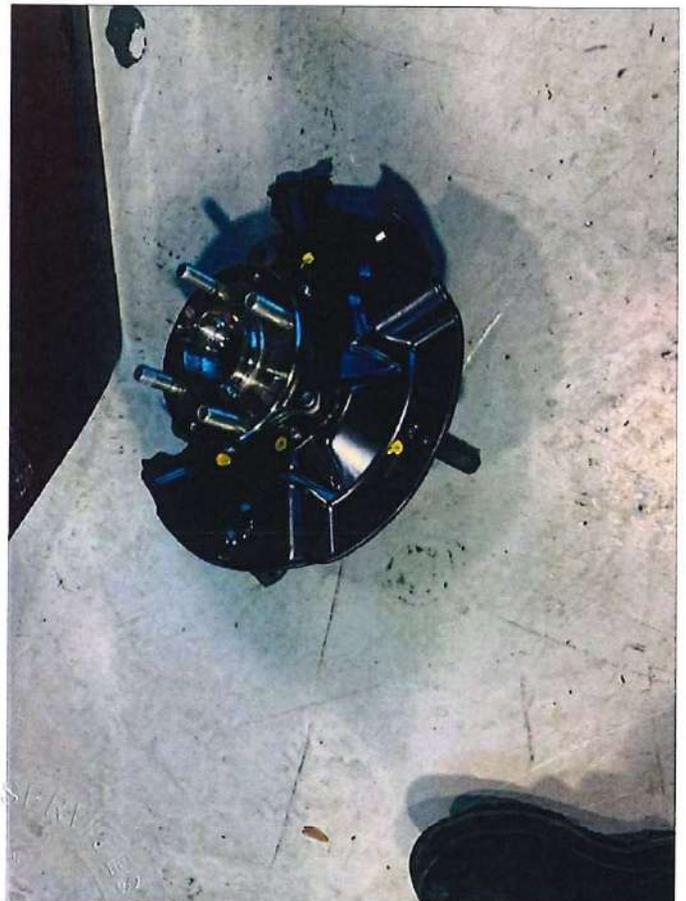
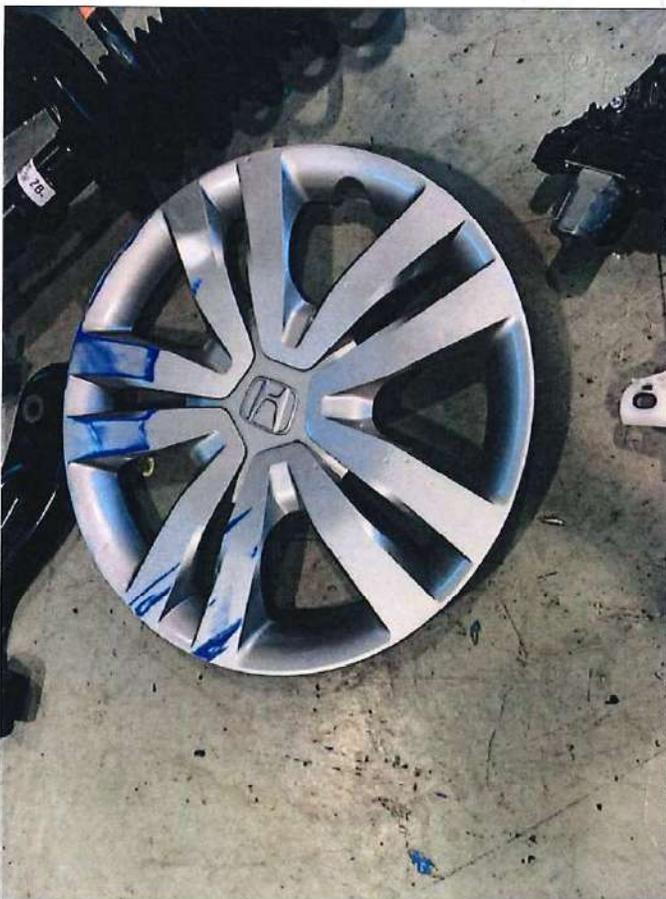
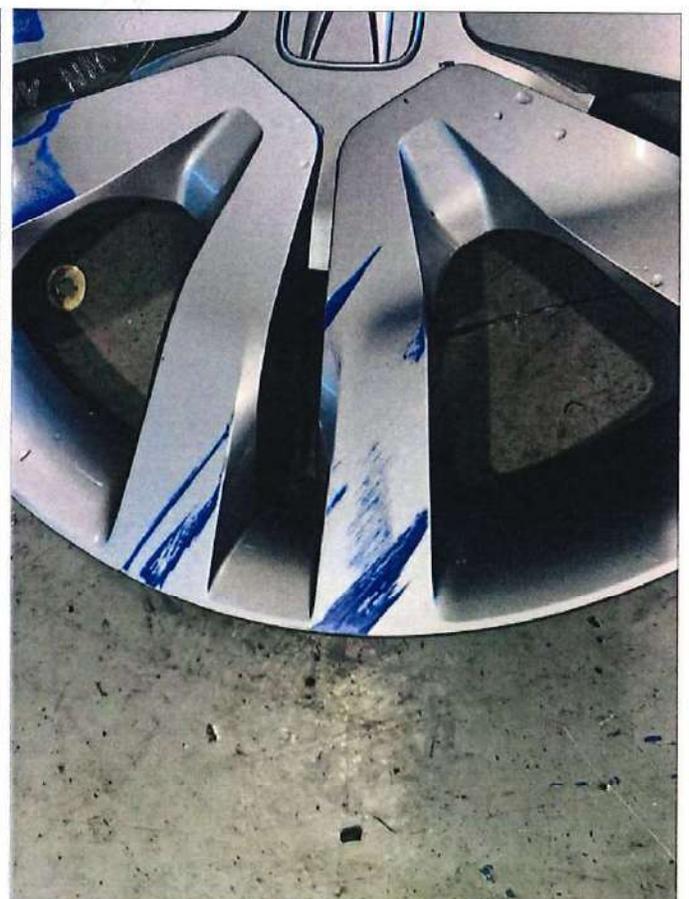
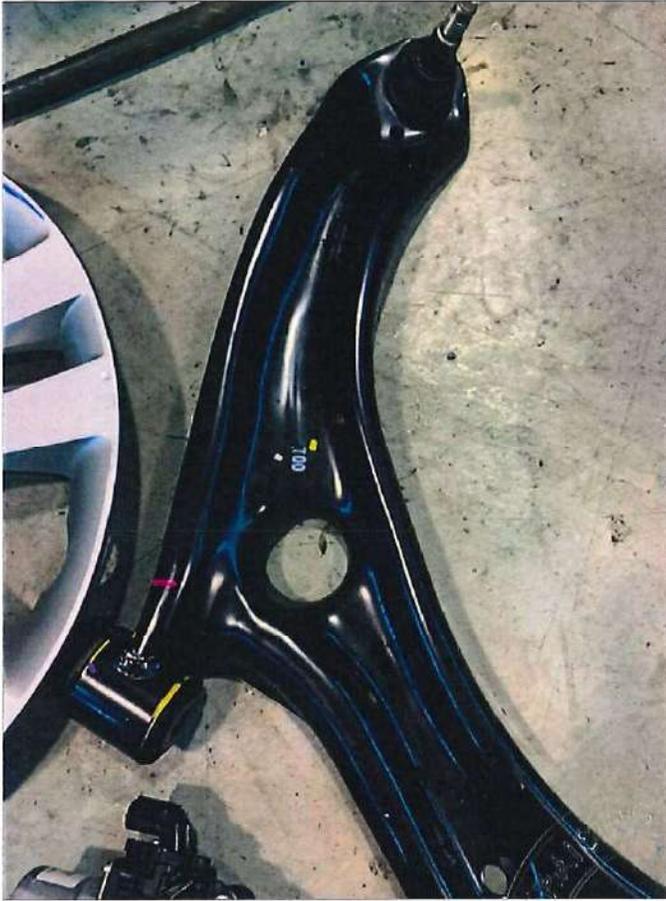
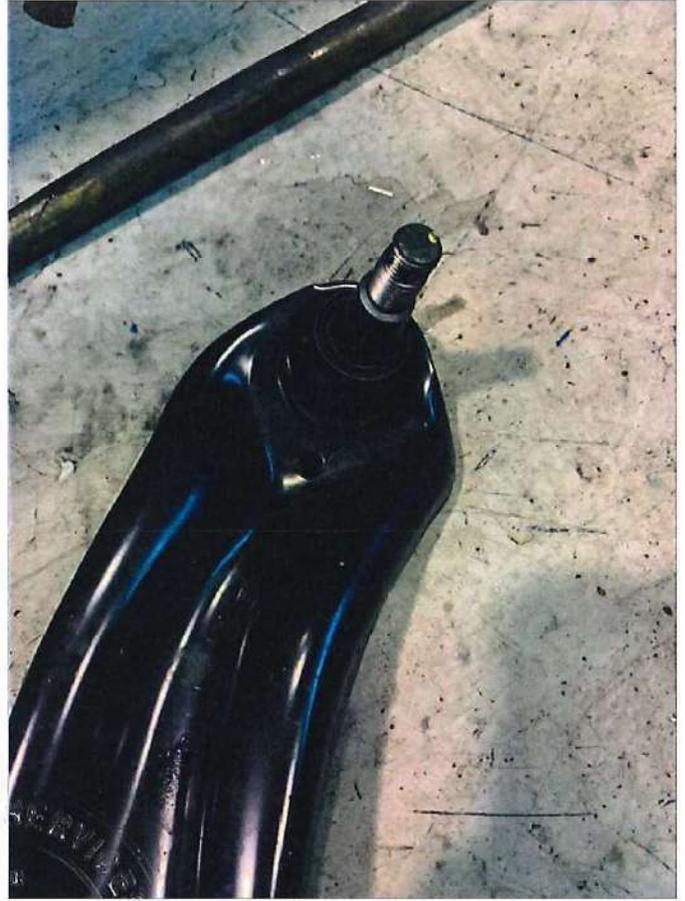
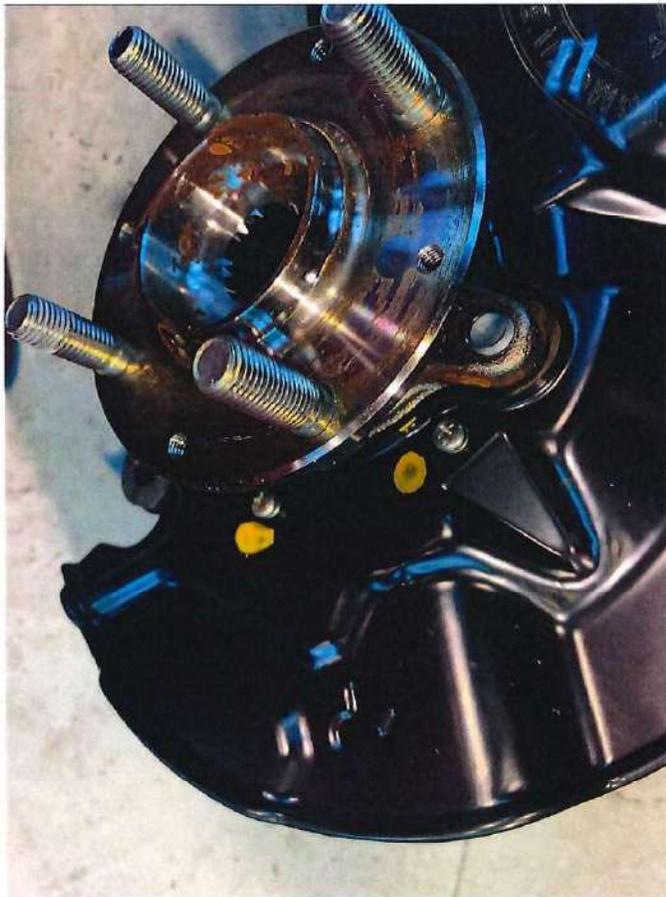
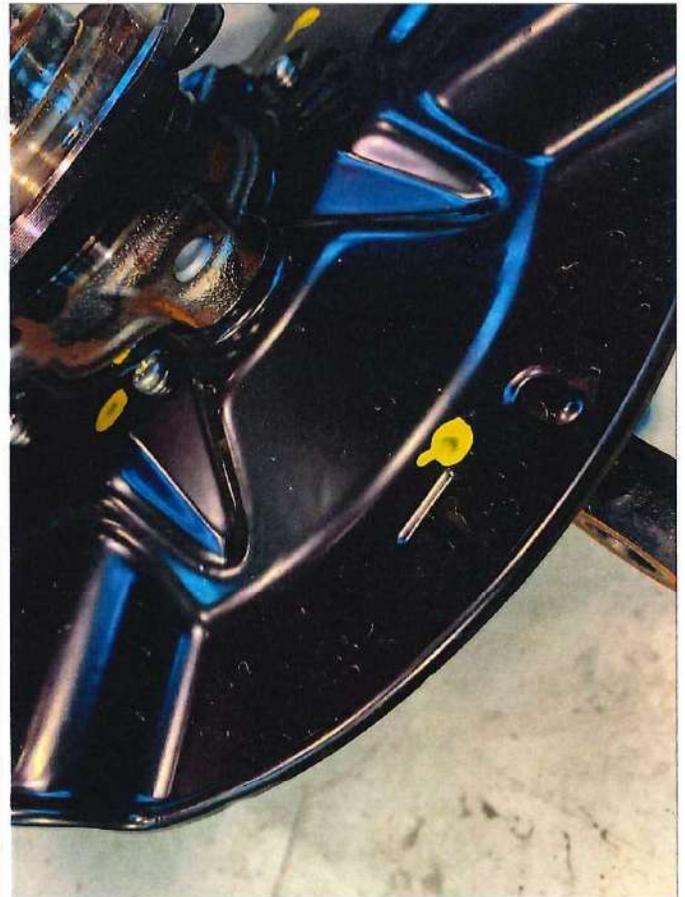
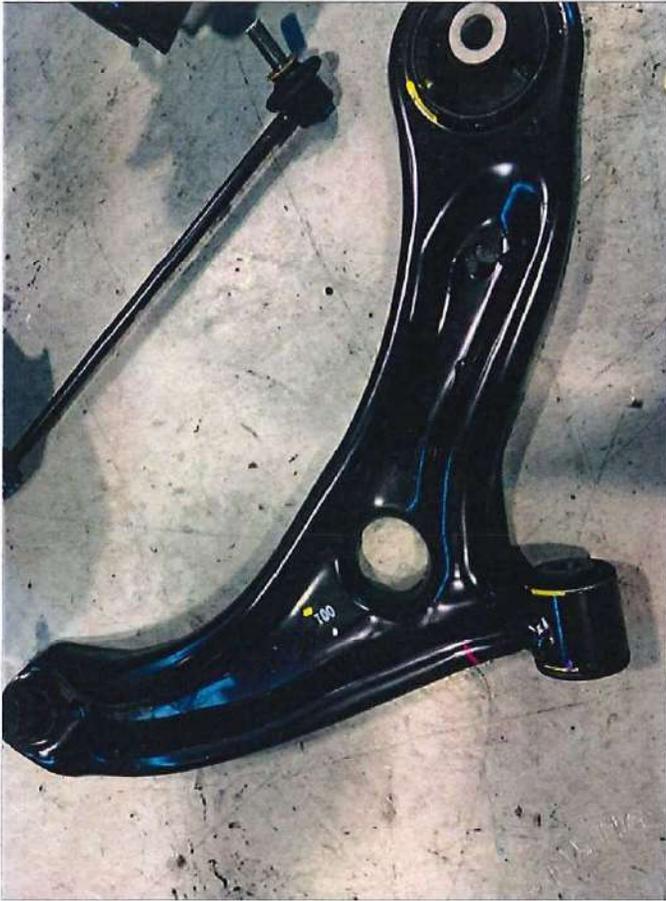
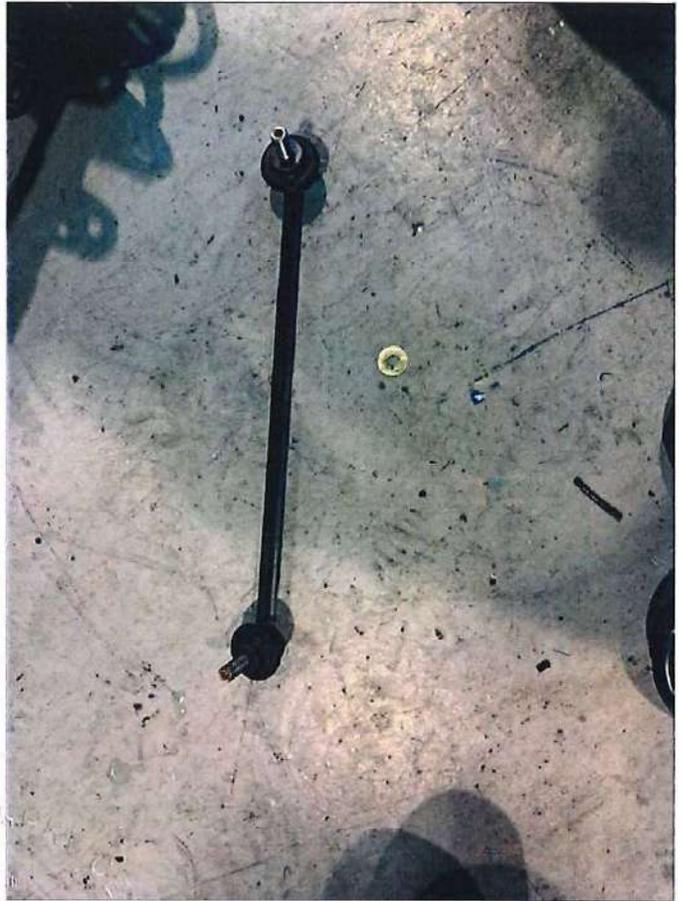
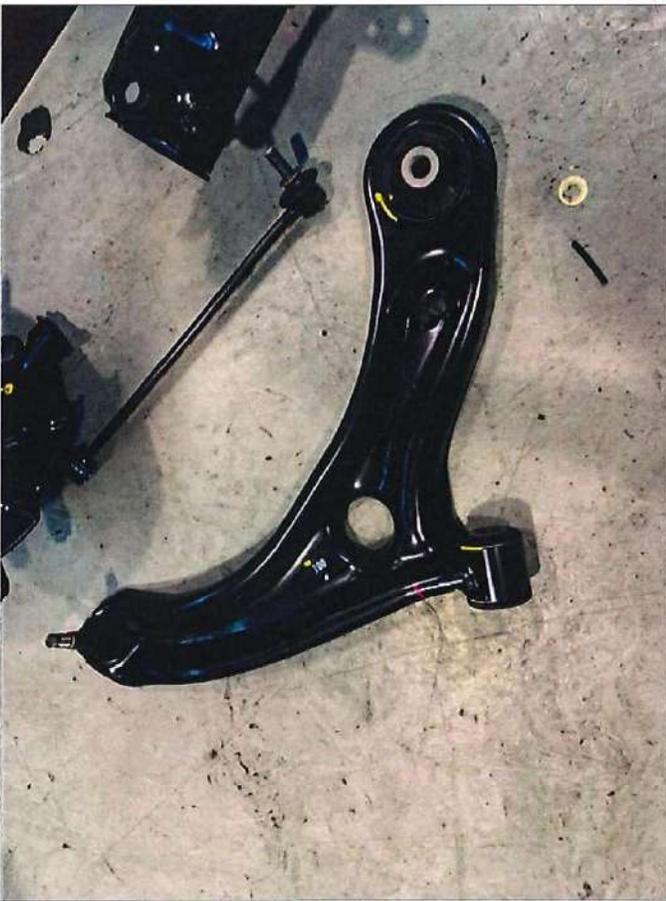
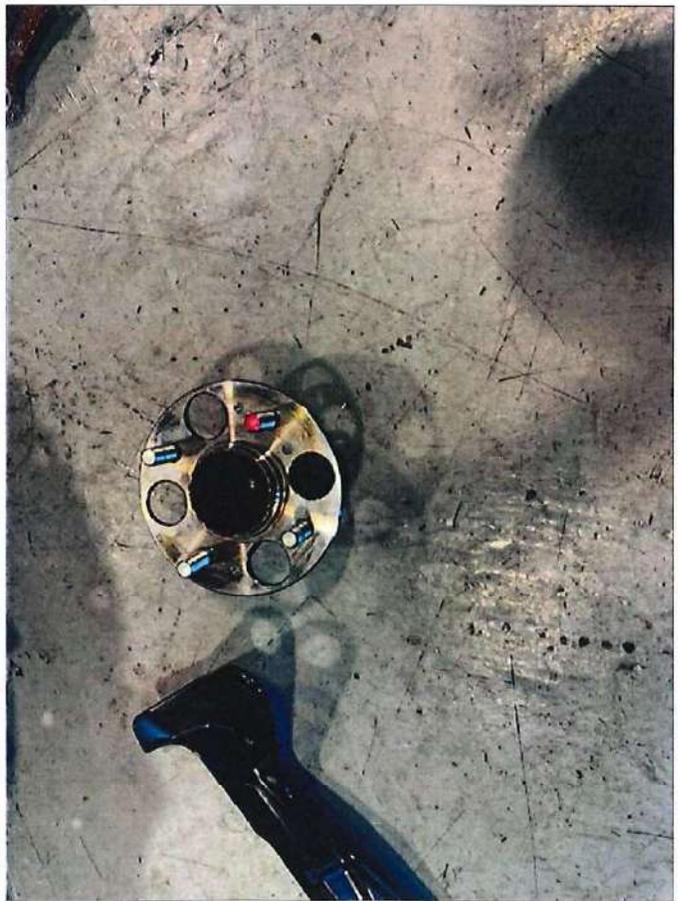
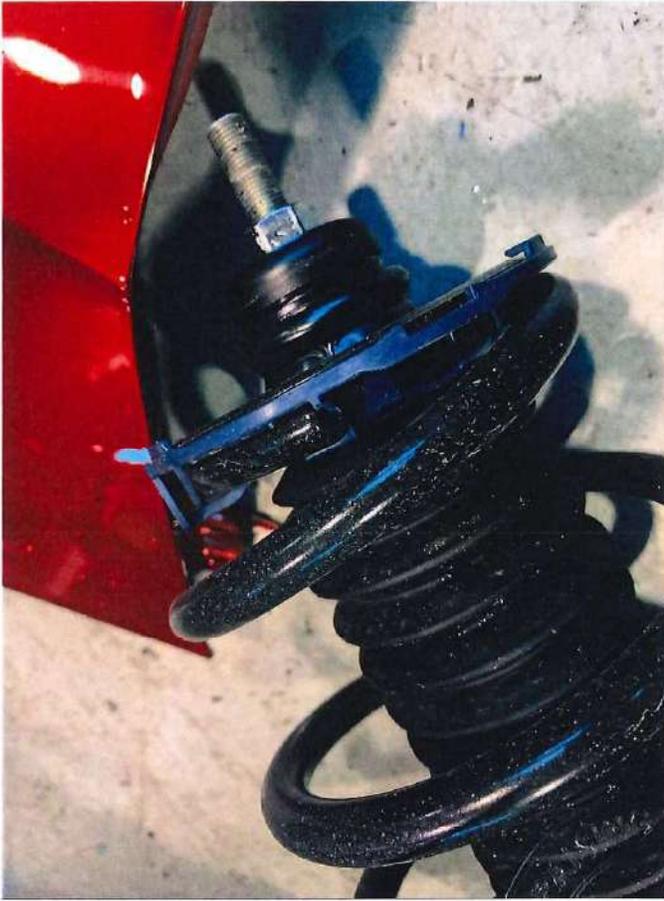
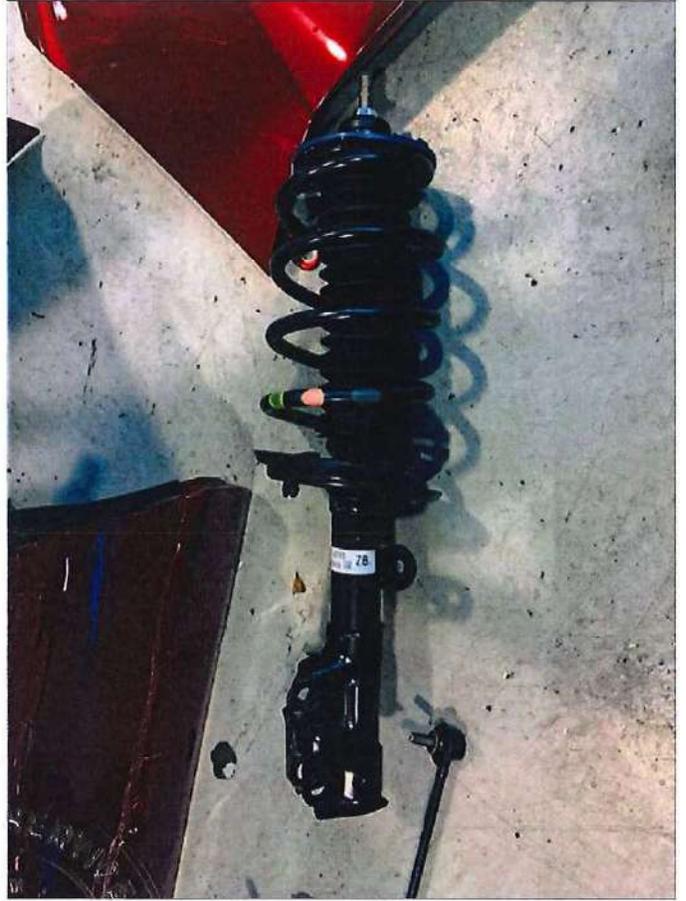
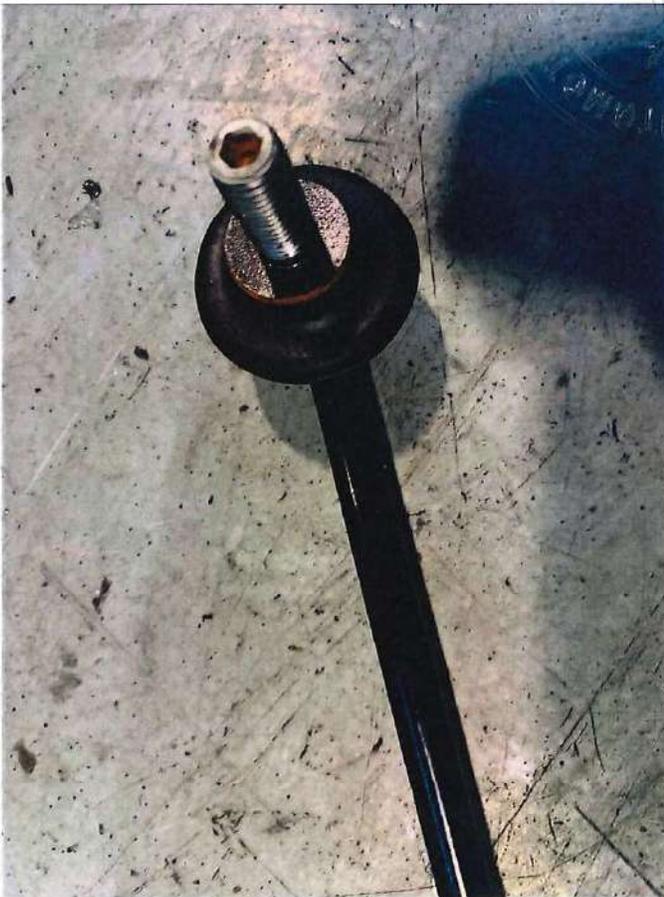
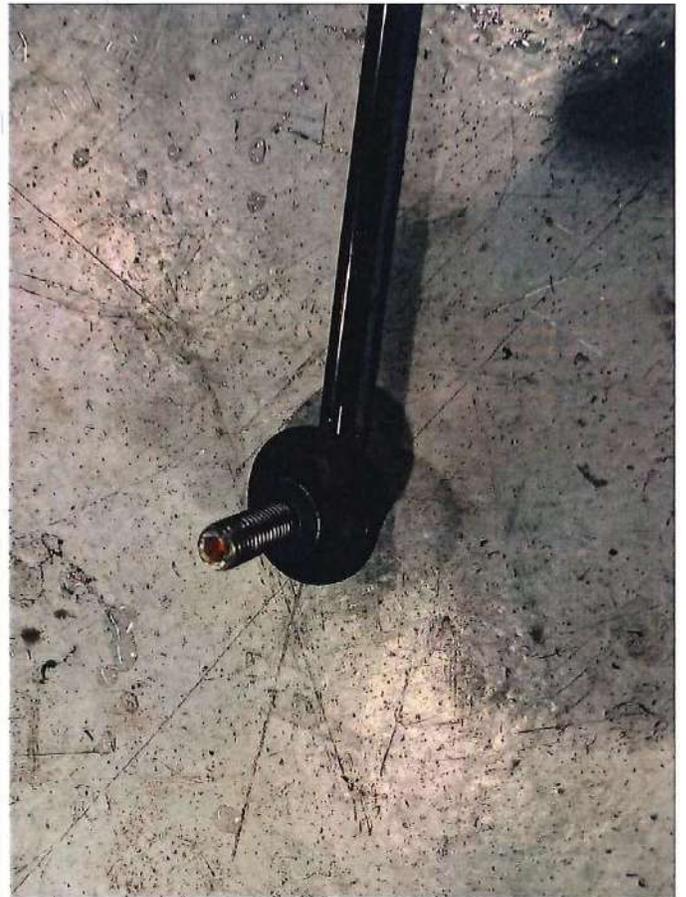
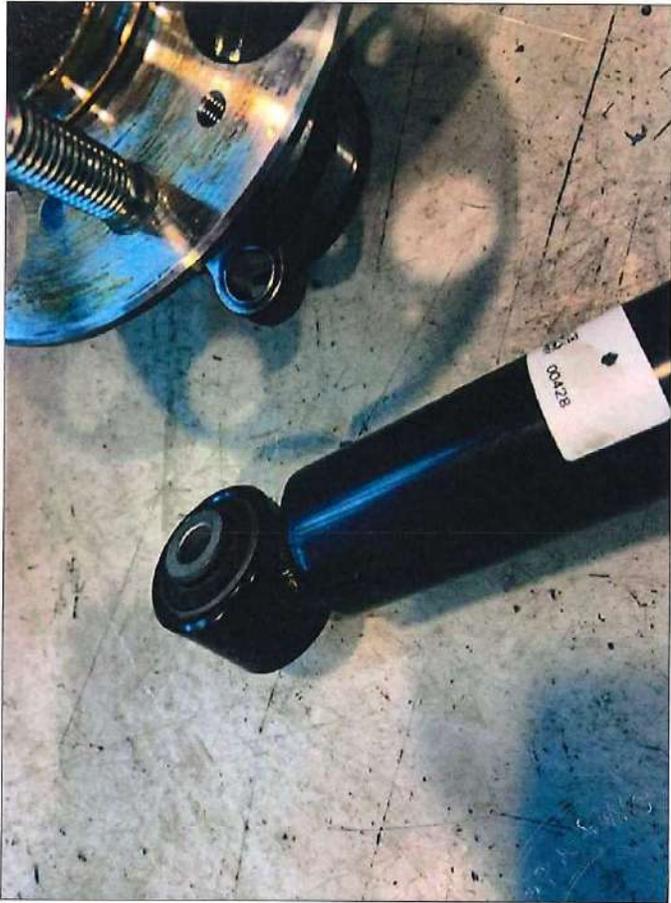
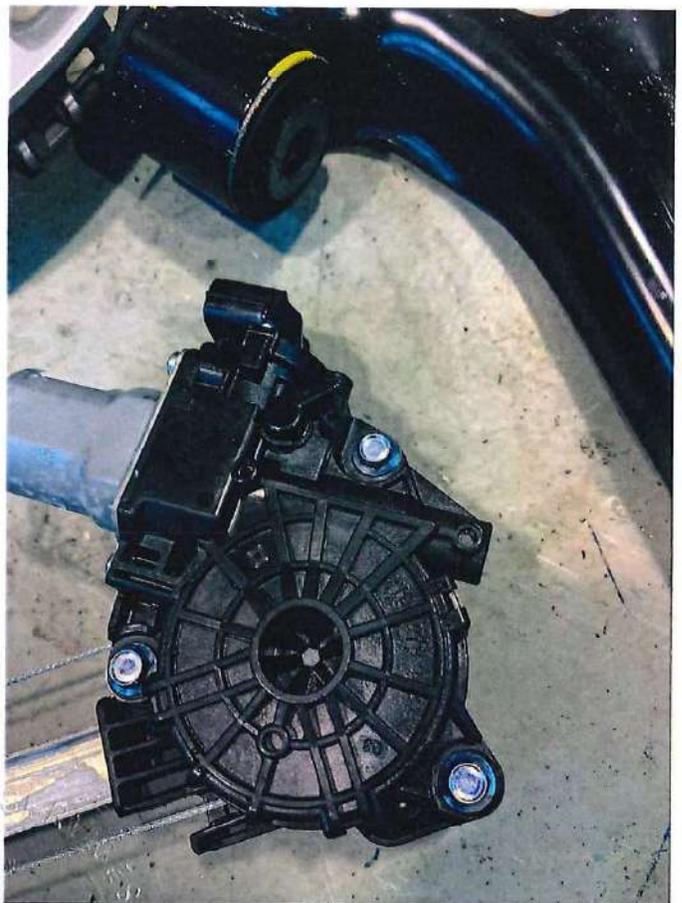
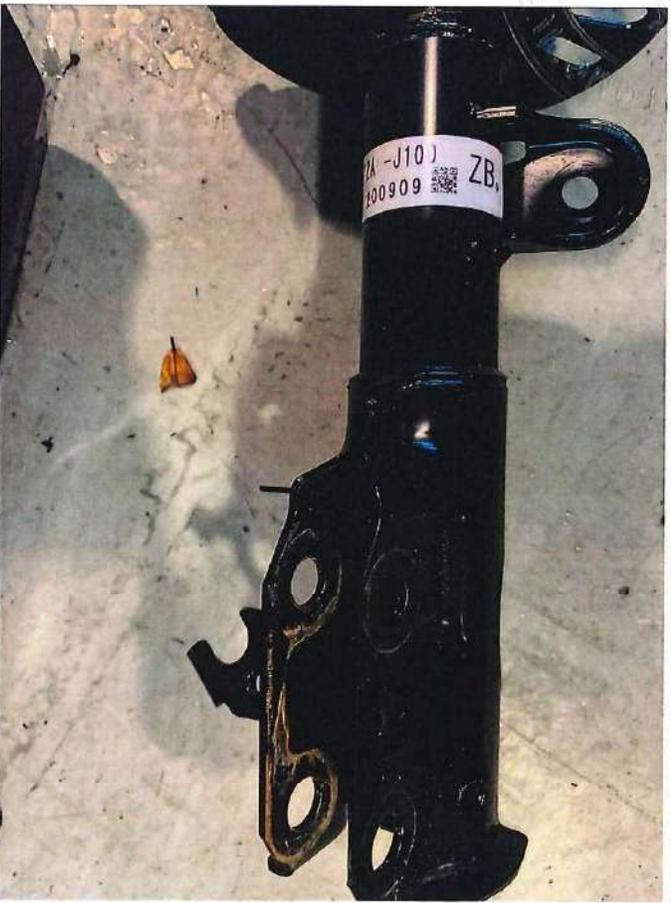
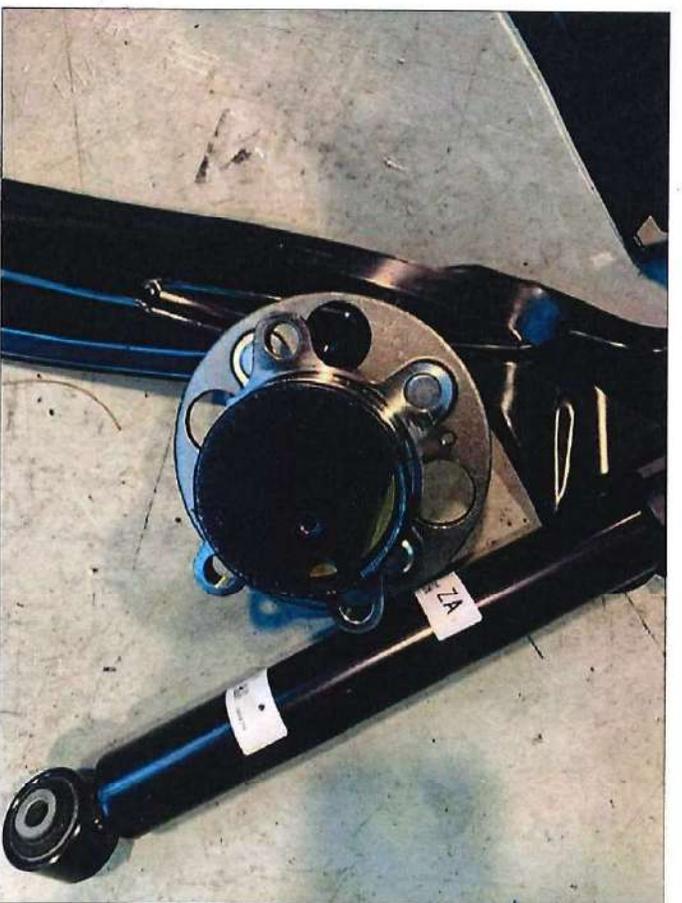
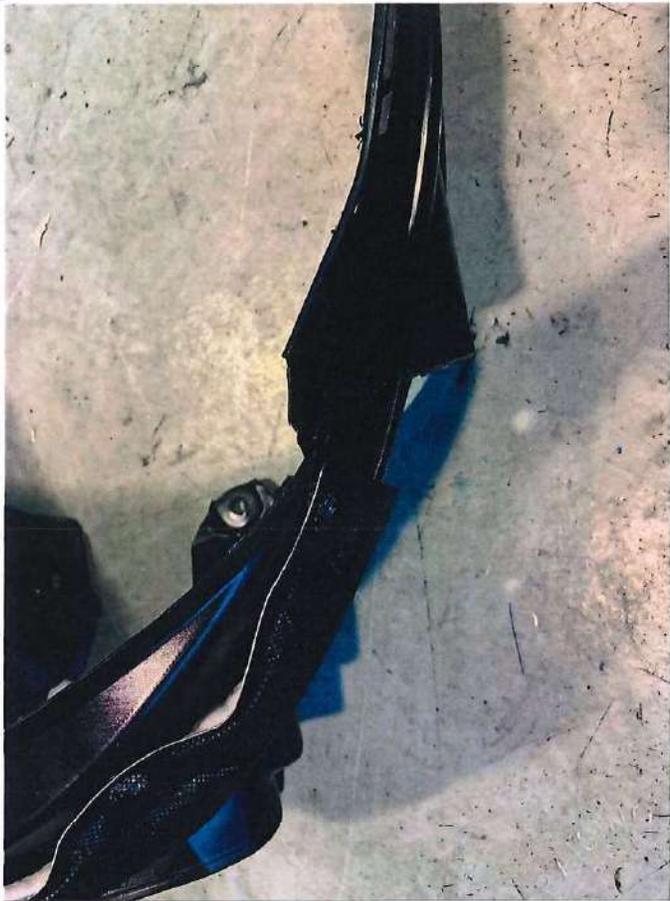
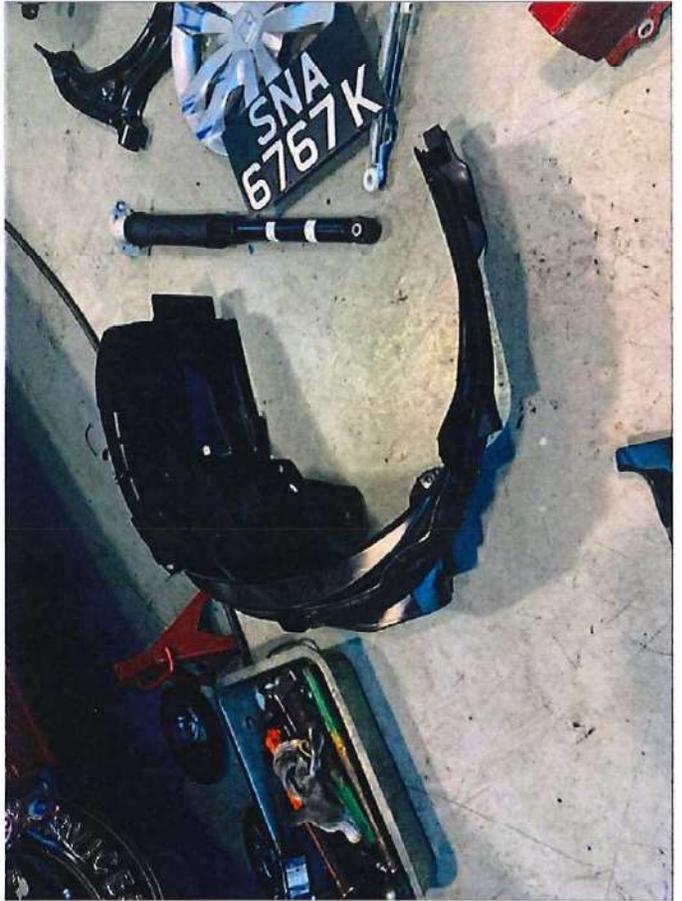
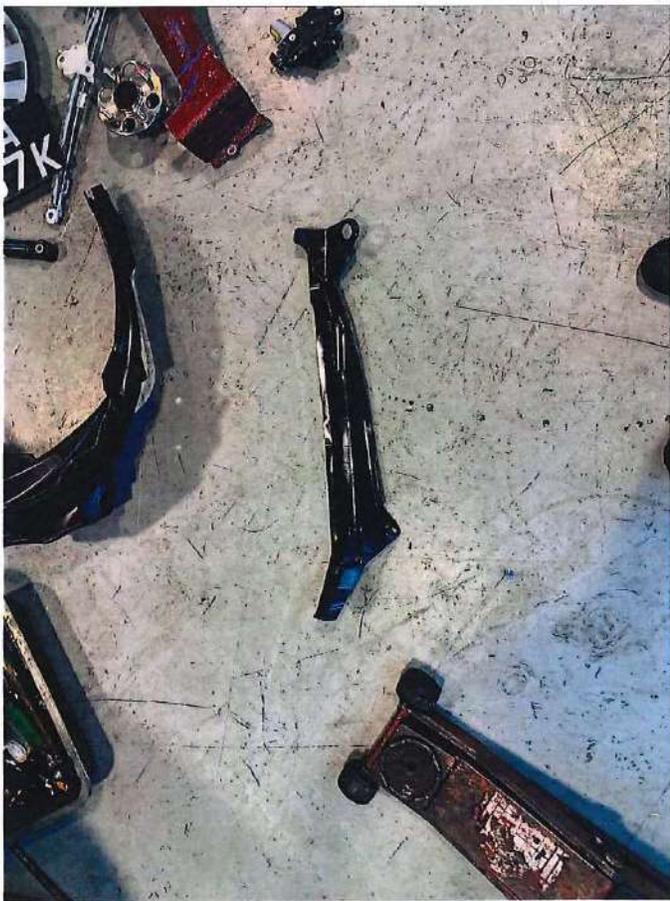
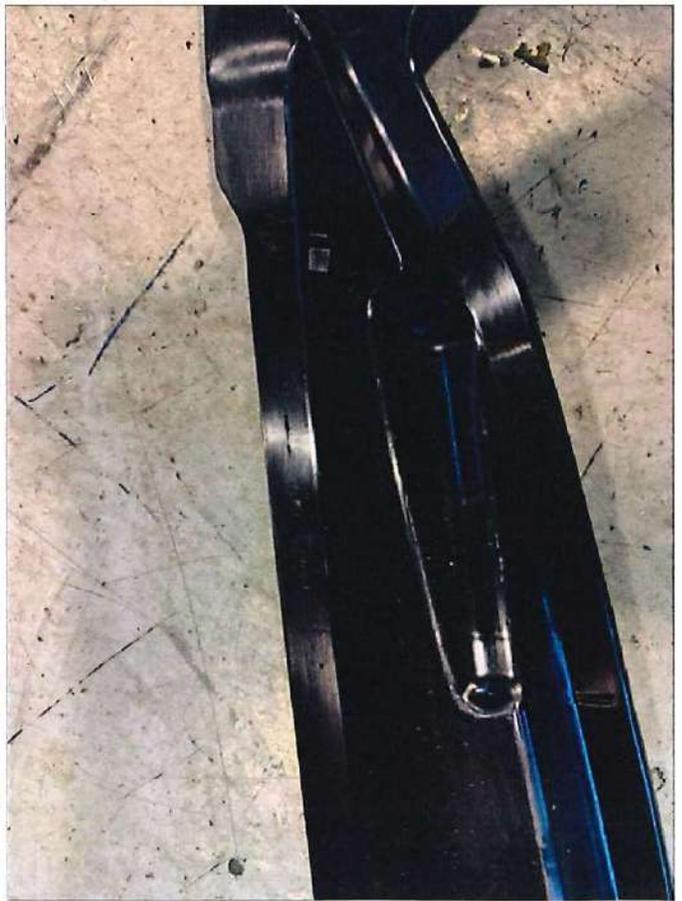
Damages sustained were consistent with the subject vehicle being involved in a collision with another vehicle and the impact was delivered **Diagonally to the RH Front from front to rear; left to right** portion of the vehicle.

The general area of damages is at the **RH Front portion**  
( Please refer to the parts list and photographs as attached for more information )

The estimated repair costs submitted by Messrs **Apex Motoring** is \$ 11,771.70 .  
We have adjusted the cost to \$ 8,044.16 and the repairer has agreed to undertake the repairs at a **Contract Lump Sum of \$ 6,440.00** to a acceptable quality and standards.  
However, we have not given authorization and instruction to the repairer to proceed with the repairs.
