Your Ref: TP/IP/35321/2021
Our Ref : CI/TPD21010819/N

21 October 2021

INSPECTION REPORT OF MOTORCYCLE FBR 5386K

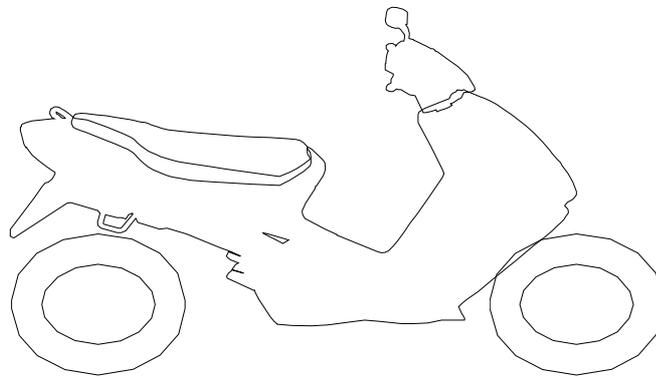
6. The condition of the front tyre of the Motorcycle was observed to be in serviceable condition. We did not observe any tear, burst mark(s) and/or punctured hole(s) on the sidewalls as well as across the tread of the front tyre. The front tyre was observed to be sufficiently inflated for vehicular operation. However we observed a tear on the rear tyre. The rear tyre was also observed to be deflated as a result of the accident. The tyre brand, tyre size and remaining tread depth of the 2 tyres were

Maxxis 140/70 - 14 (4mm)
Cut / Deflated

Dunlop 120/70 - 15 (3mm)
