THIRD PARTY SURVEY **ACCIDENT HAPPENED ON**

18 Sep 2021

Registration No : GBD 4061 C

: Nissan Cabstar

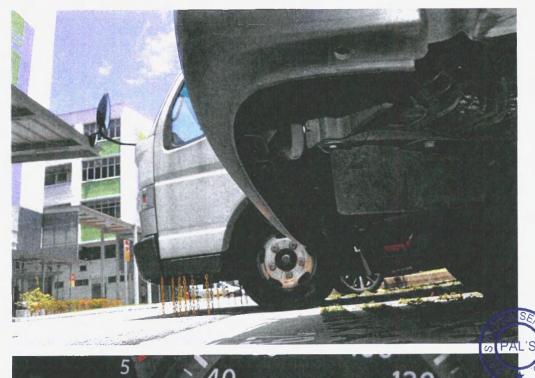
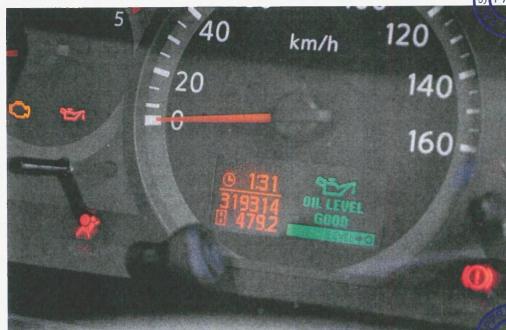
At the time of inspection, we noted that the vehicle has sustained an impact damages on the front n/s portion(s). For more detail of the damages, please see photograph attached.
