# LKK Auto Consultants Pte Ltd

Affiliated to Federation Internationale Des Experts En Automobile				
CHINA TAIPING INSURANCE (S) PTE LTD 3 ANSON ROAD #16-00 SPRINGLEAF TOWERSINGAPORE 079909			Ref: CC6/CTI21012113/Kea3q2	
			Date: 13/06/2022	
			Code: CTI	
<b>1. Policy Particulars :- THIRD PARTY CLAIM</b>				
Insured Veh.	SMK 8910J	Veh. Inspected	SMG 5692D	
Policy No.	DMPCSNW00152992100	Coverage (\$)	0.00	
Claim No.	SNM21D206887/C02	Excess (\$)	0.00	
Assign From		Assign Date	01/12/2021	
<b>2. Vehicle Particulars &amp; Condition</b>				
Make & Model	TOYOTA PRIUS	c.c	1797	
Engine No.	HIDDEN	Year of Reg.	2018	
Chassis No.	ZVW506050829	Colour	METALLIC GREY	
Odometer	262737 KM	Steering	IN ORDER	
Brakes	IN ORDER	Modification	STANDARD ALLOY RIM	
General	GOOD			
<b>3. Conditions of Tyres</b>				
	Size	Make	Balance	
R/H Front Tyre	195/65 R15	SAILUN	8 mm	
L/H Front Tyre	195/65 R15	SAILUN	8 mm	
R/H Rear Tyre	195/65 R15	APLUS	6 mm	
L/H Rear Tyre	195/65 R15	APLUS	6 mm

## ADJUSTMENT ON REPAIR COST FOR VEHICLE NO. SMG 5692D

### PHOTOGRAPHS FOR VEHICLE NO. SMG 5692D

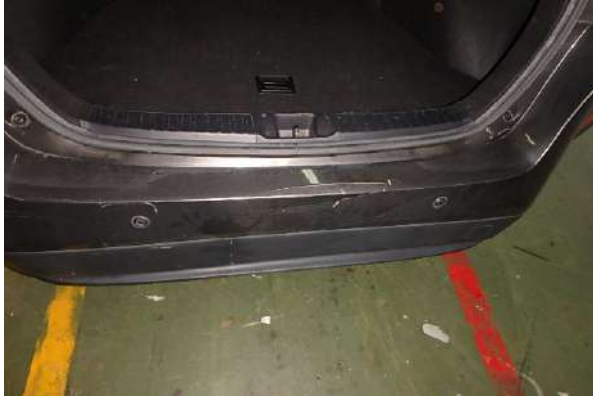
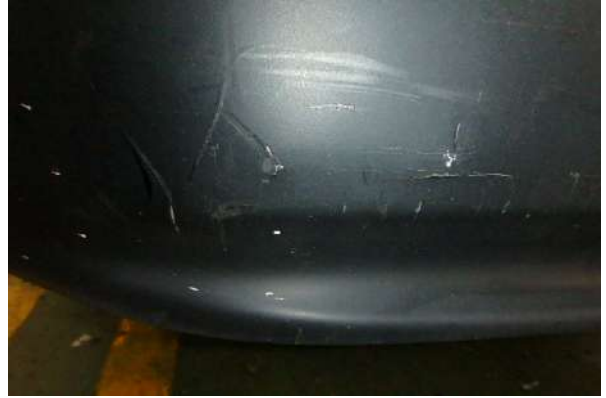
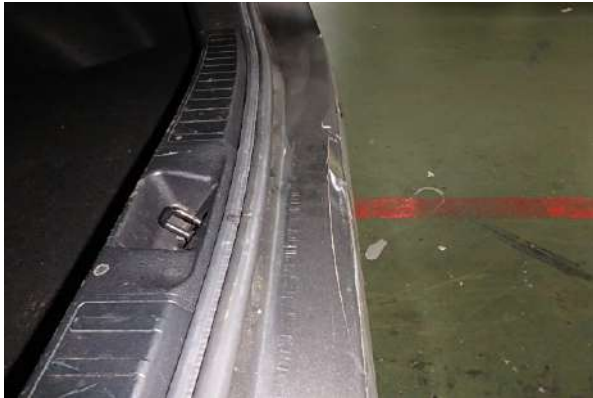
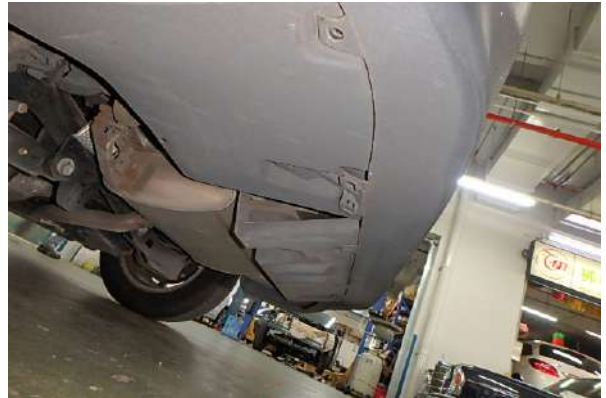
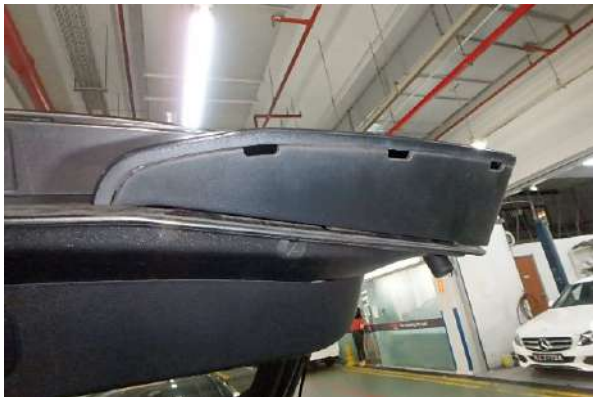
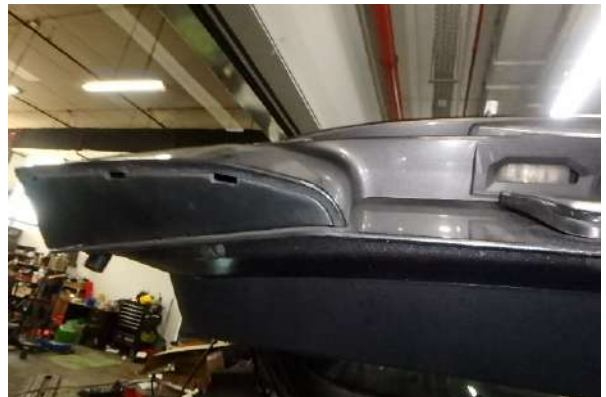
<b>4. Description of Damages</b>				
THE VEHICLE SUSTAINED DAMAGES AT THE REAR PORTION.  DAMAGES SEE DETAILS.				
<b>5. General Information</b>				
Accident Date	26/11/2021	Inspection Date	01/12/2021	
Survey held at	HUI YANG MOTOR PTE LTD BLOCK 176 SIN MING DRIVE #04-02 SIN MING AUTOCARE SINGAPORE 575721			
<b>5a. Remarks</b>				
A)THE INSPECTION WAS CONDUCTED ON A"WITHOUT PREJUDICE" BASIS. B)IN ACCORDANCE TO YOUR INSTRUCTIONS, WE HAVE NOT AUTHORISED REPAIRS.				
<b>5b. Estimate Days of Repair</b>				
ESTIMATED NORMAL PERIOD FOR REPAIR:			<b>4 Working Days</b>
