VEHICLE INSPECTION REPORT

Date : 16 August 2017
Our ref : AA/08/1701/TP

Registration No : SKS 7309 J
Make / Model : Nissan GT-R
Chassis No : R35004341
Engine No : VR38006051A

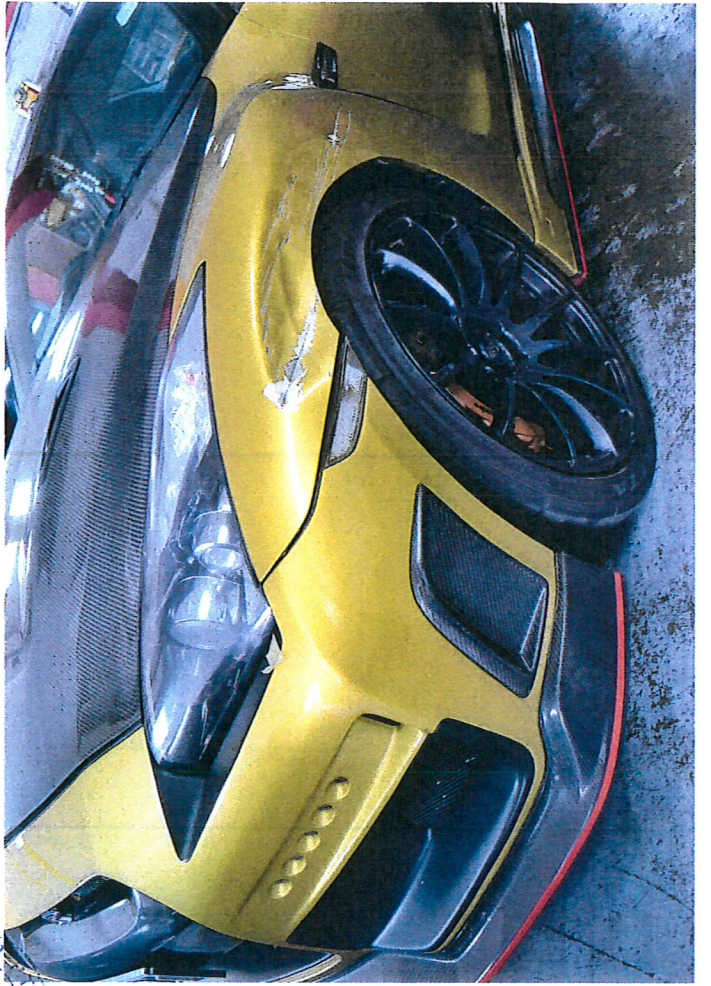
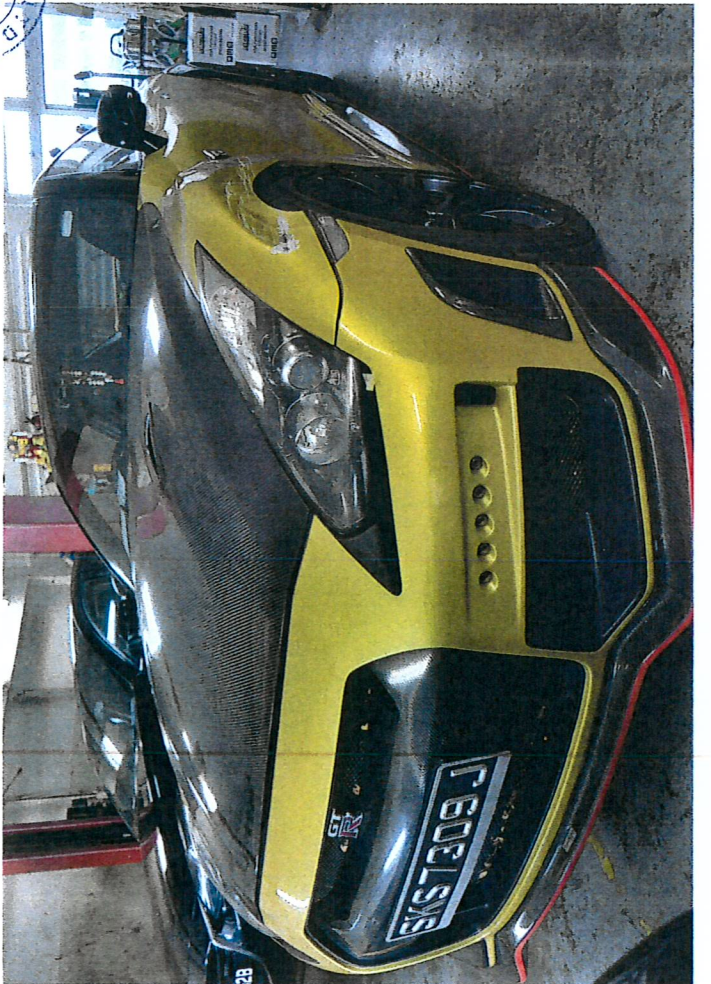
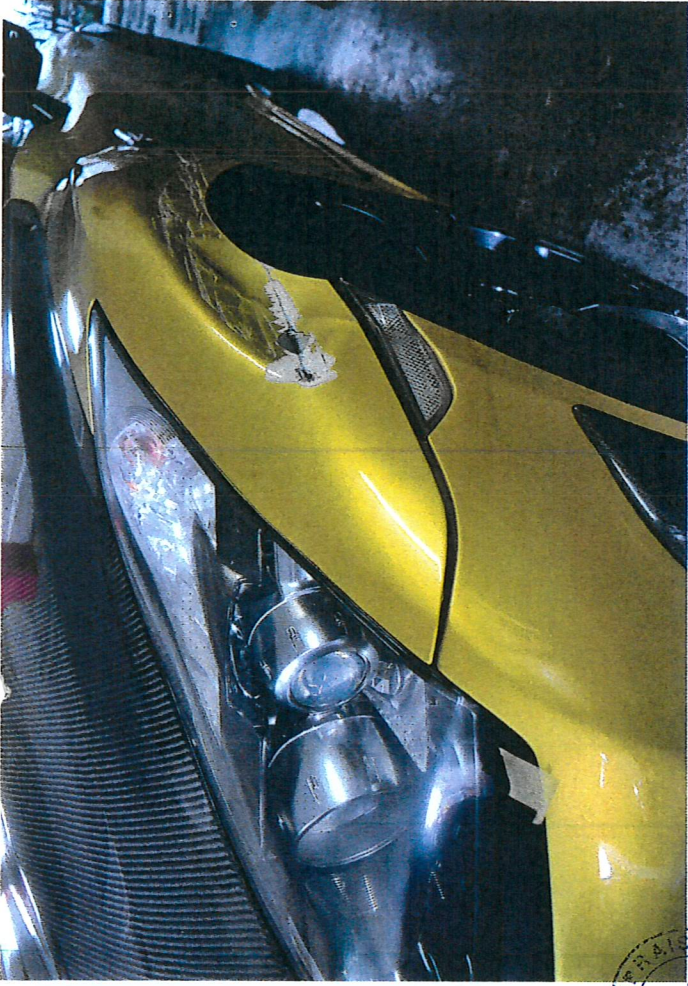
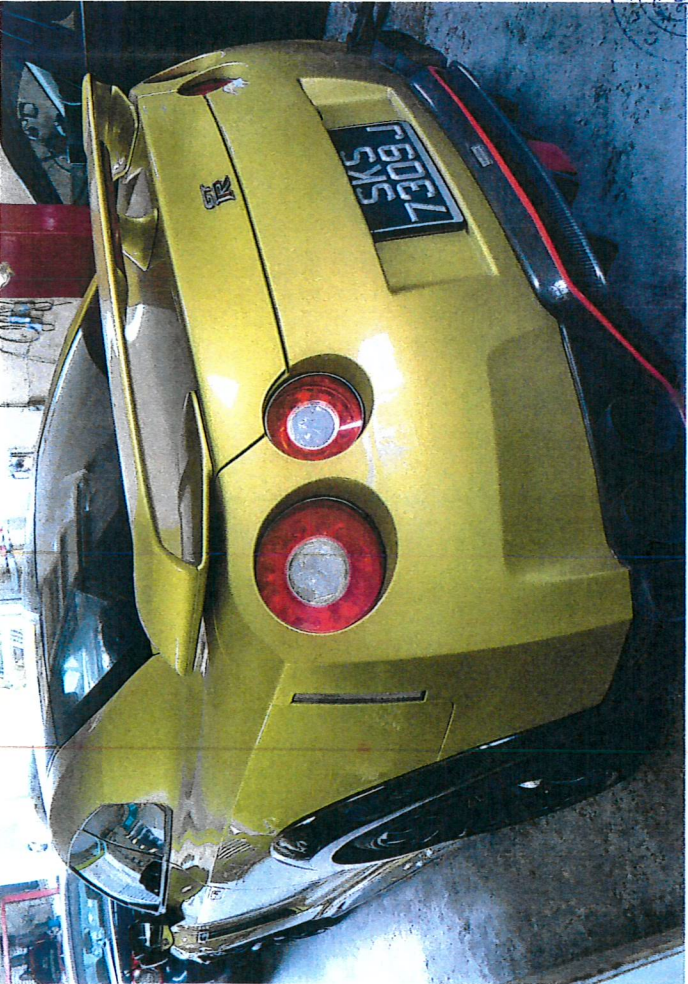
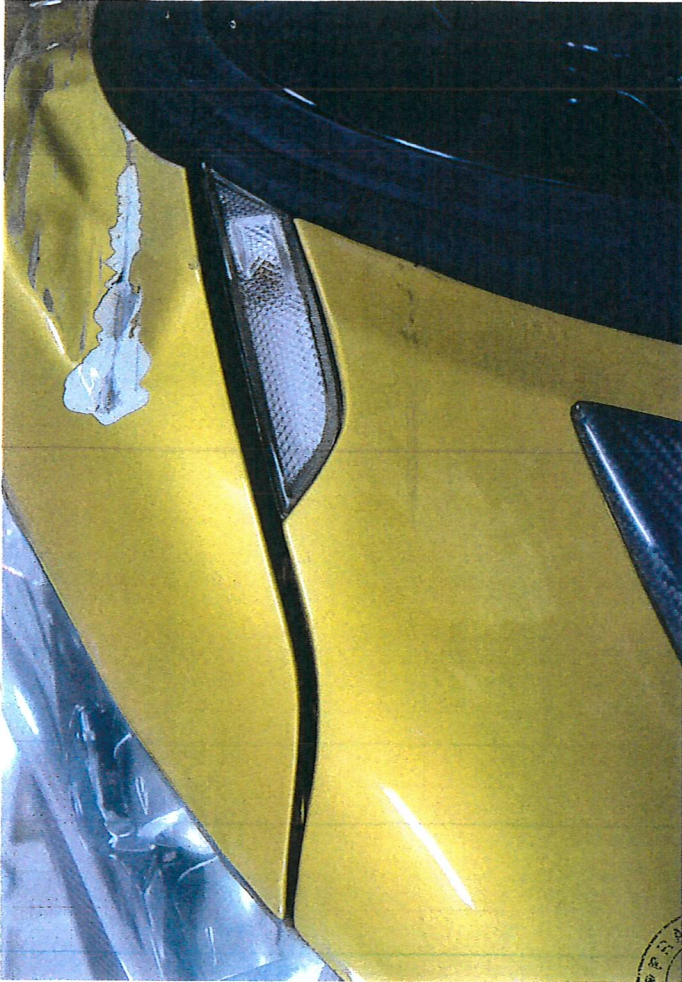
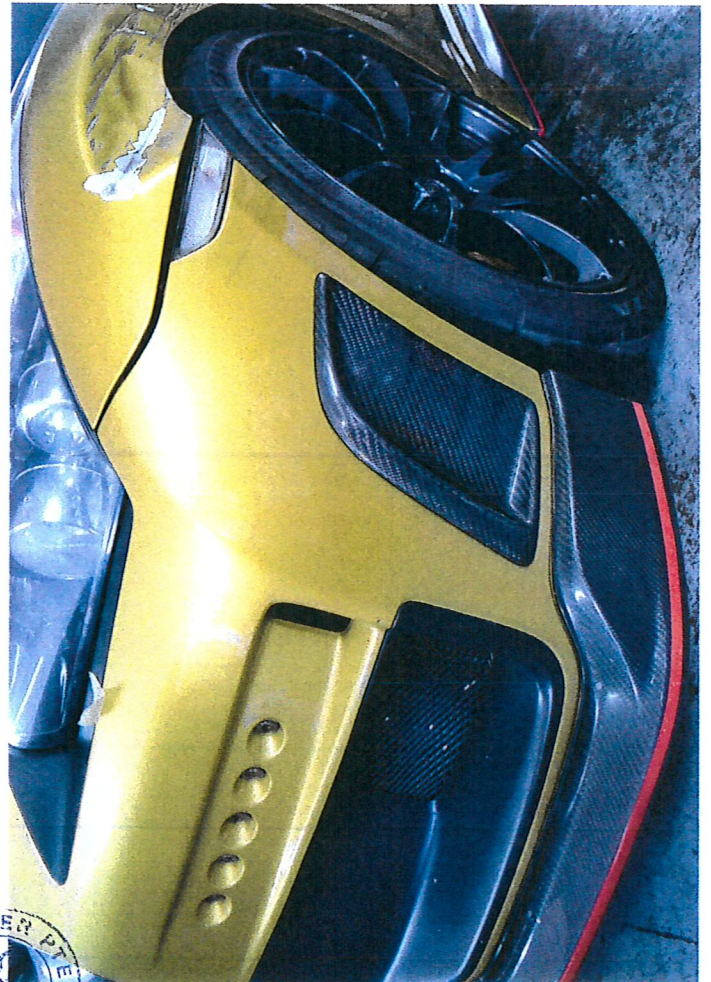
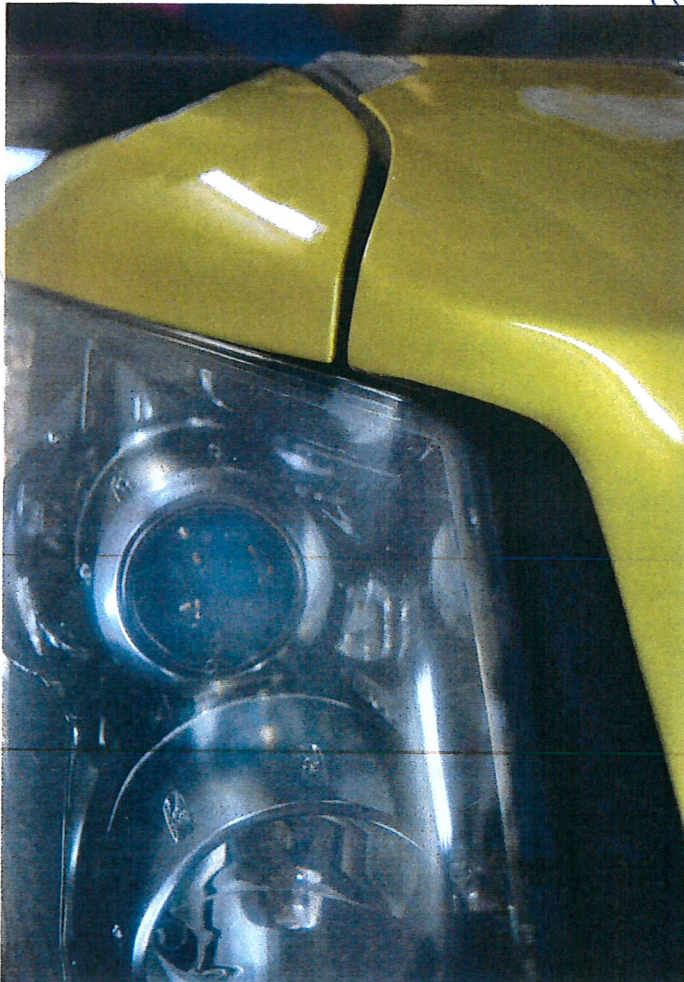
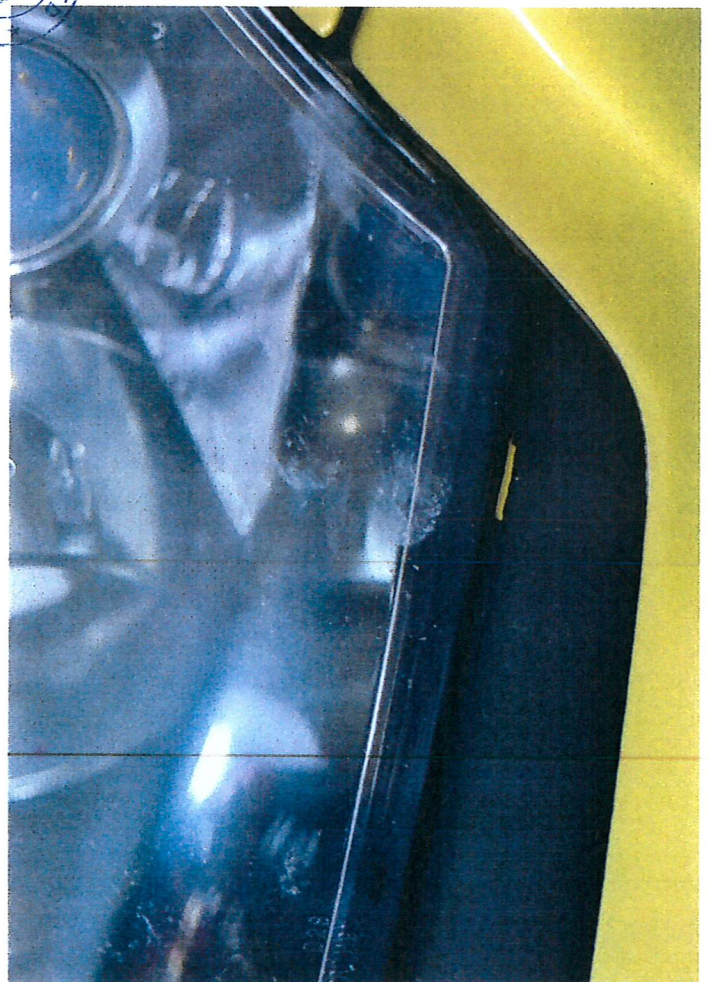
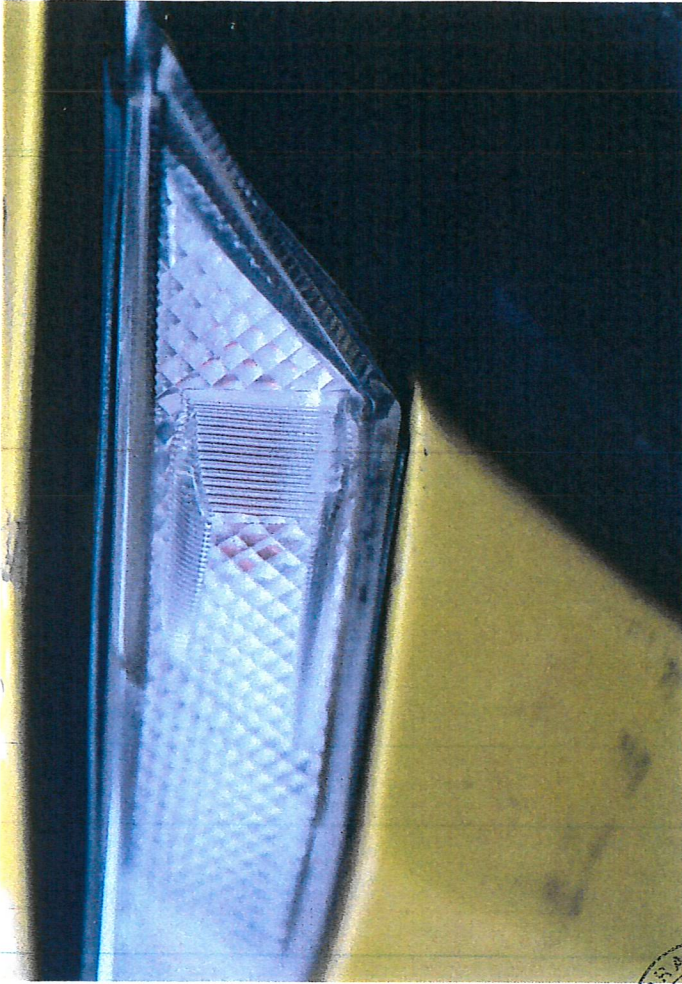
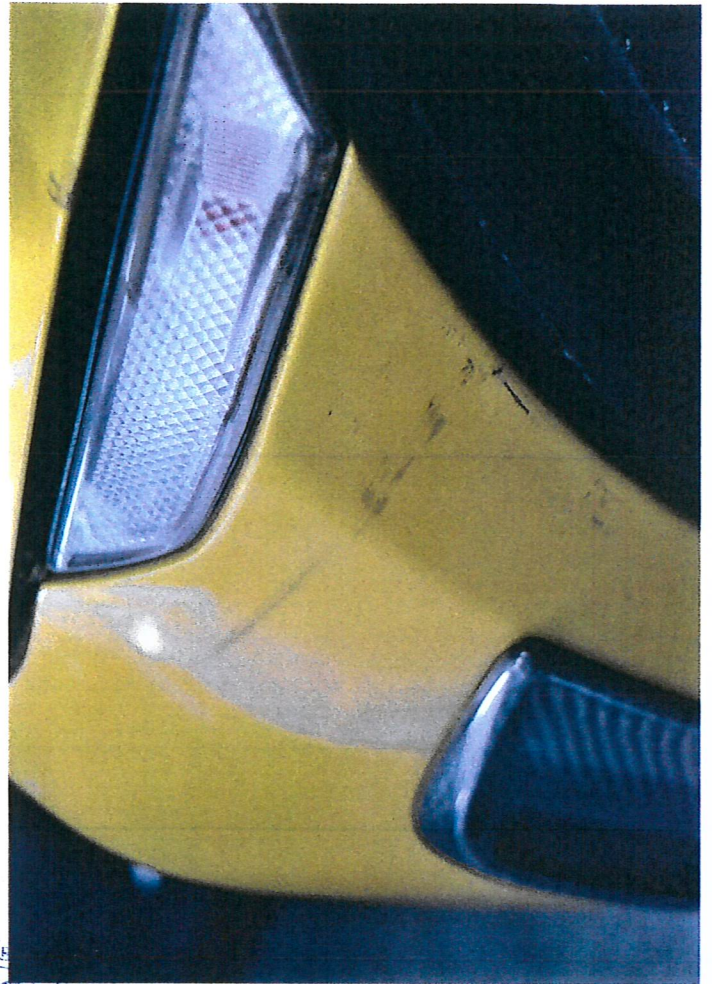
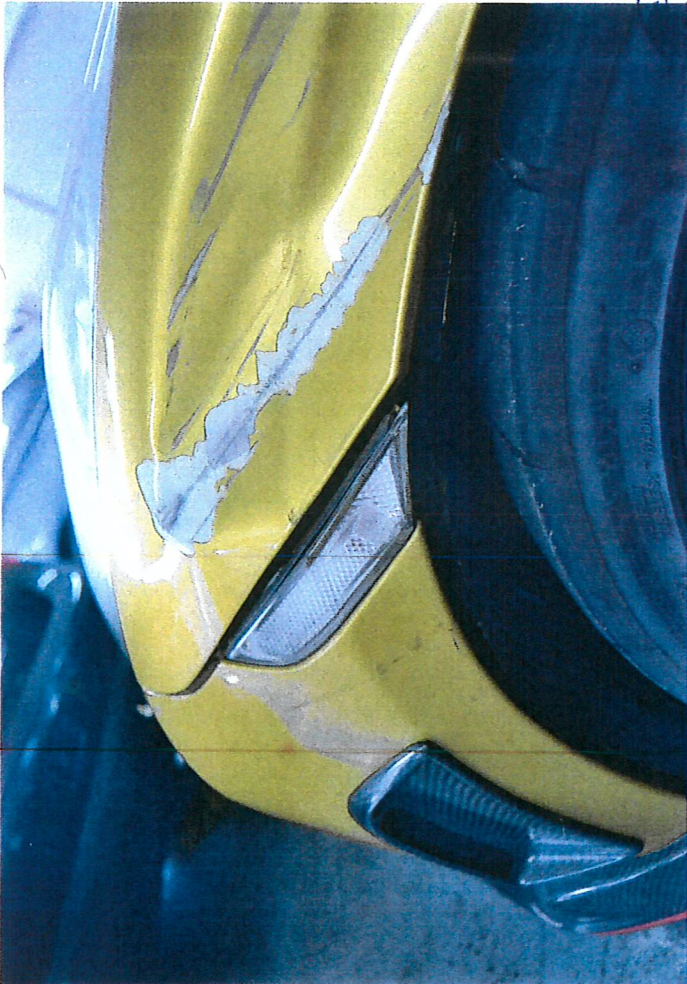
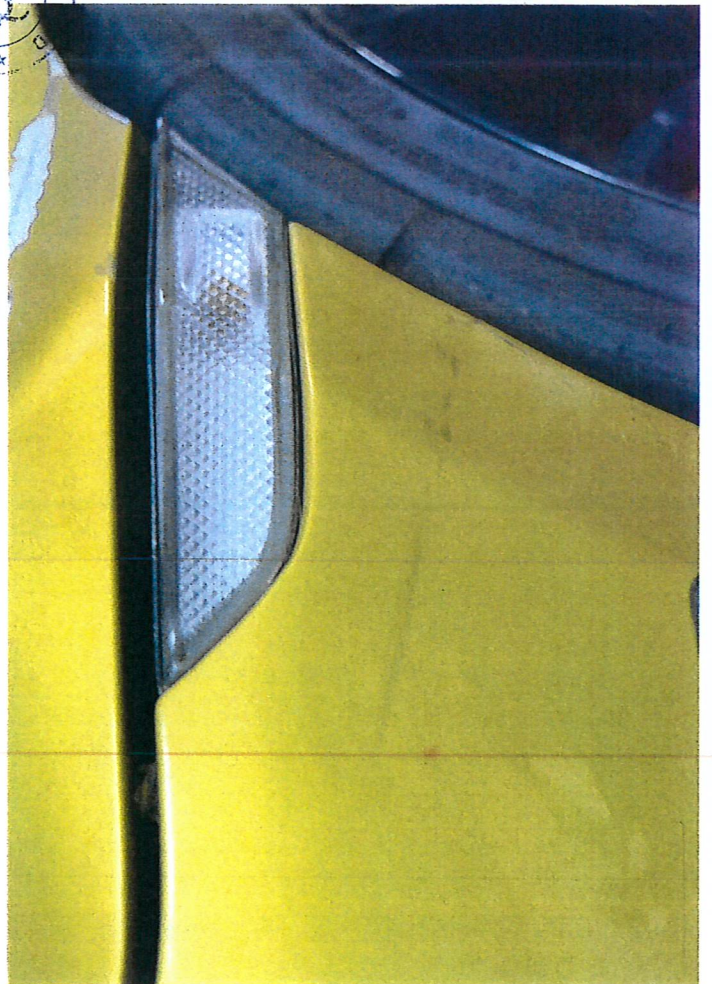
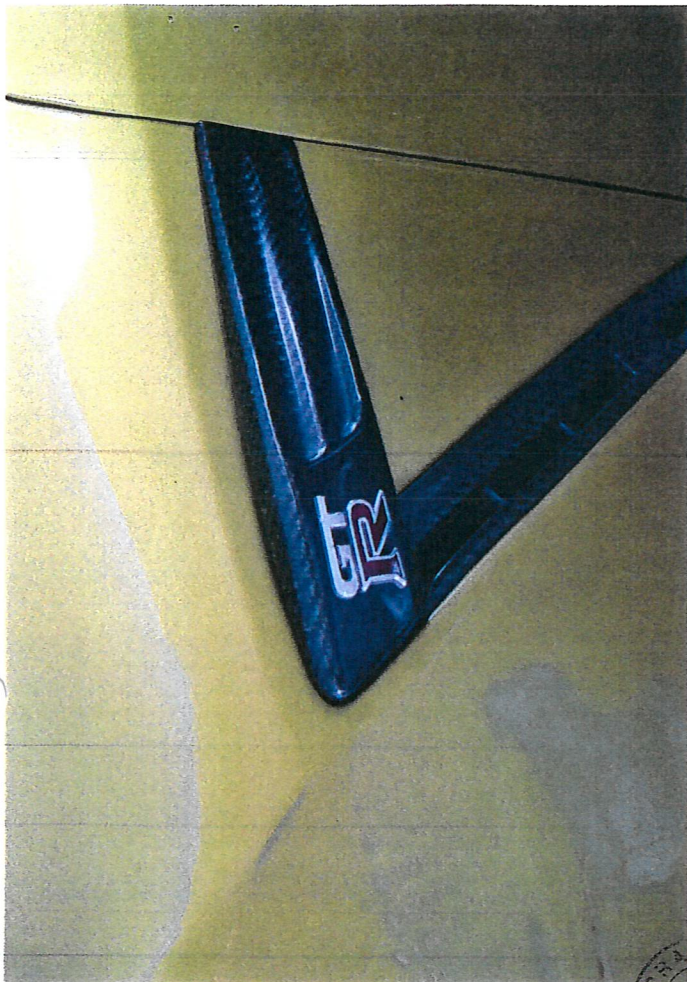
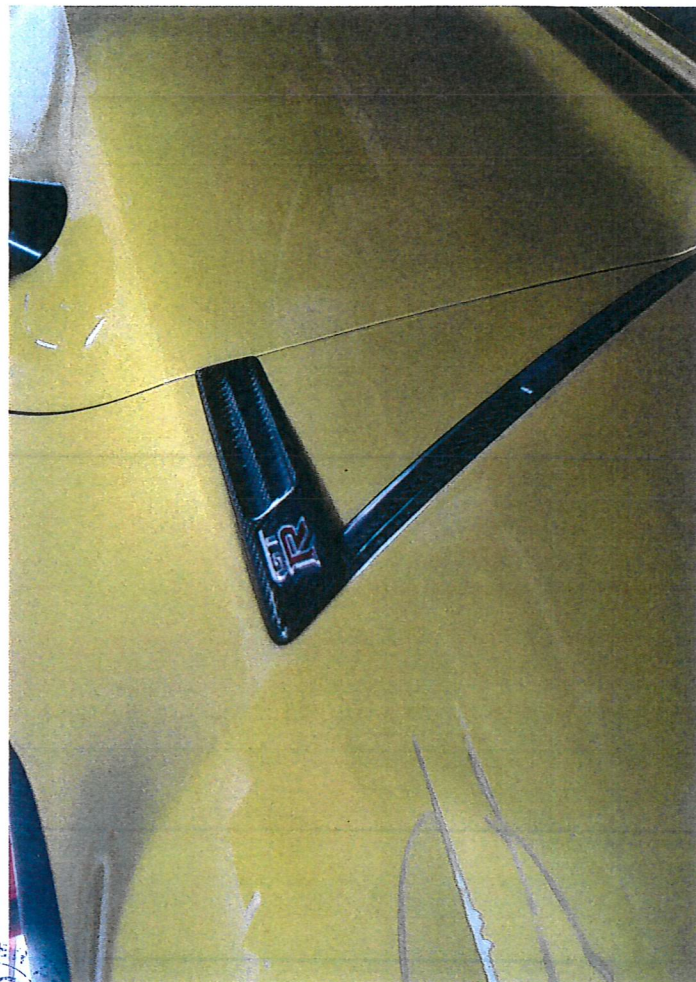
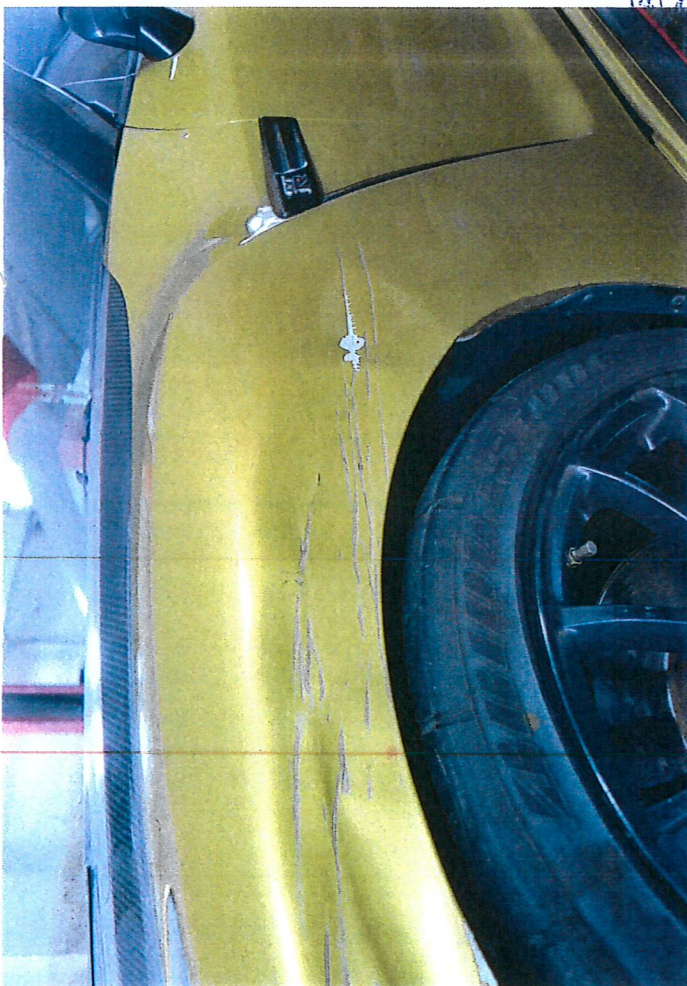
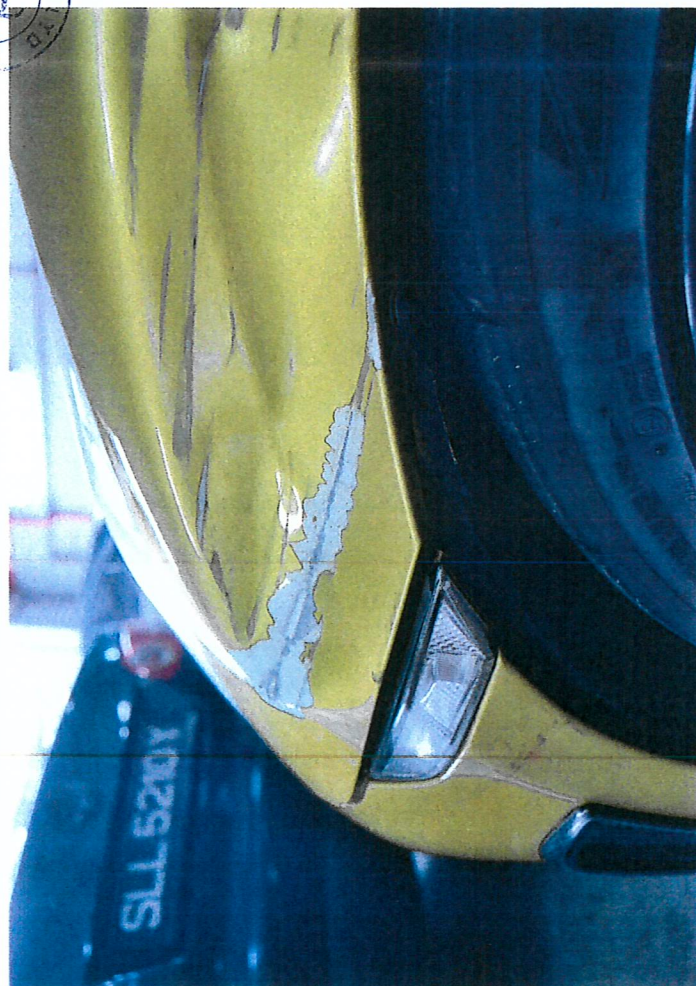
The impact damages sustained on the vehicle at the time of inspection is on the n/s front portion.
(Details refer to the photographs attached)
